EuroVelo 6 – Atlantic-Black Sea
Transdanube.Pearls

Route Assessment of EuroVelo 6 Atlantic-Black Sea

in Germany, Austria, Slovakia, Hungary and Romania
Final Report

Written by Aleksander Buczyński,
Ernst Fahrenkrug and Ed Lancaster (ECF)
November 2018

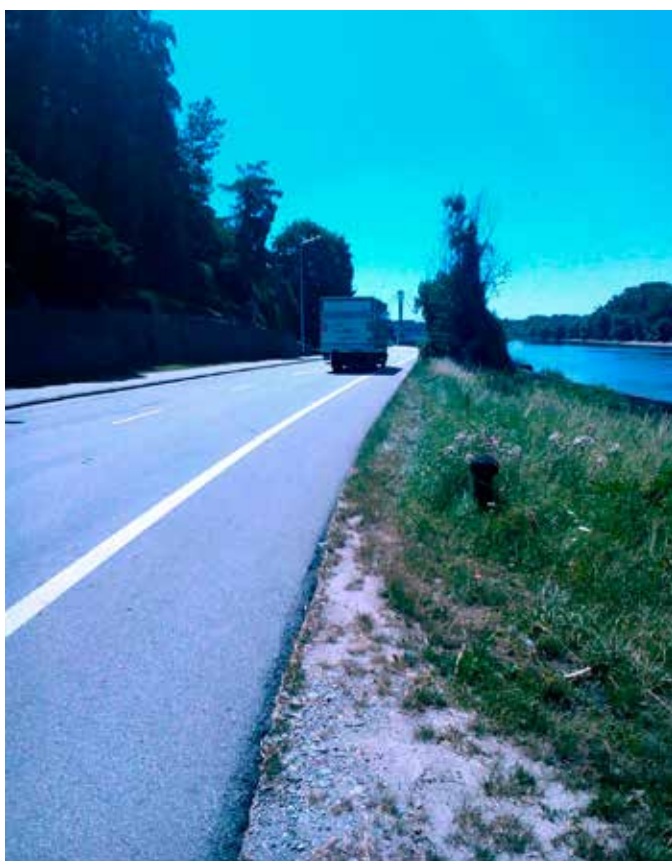
Very high traffic on public road close to Deggenu (section 11). Painted cycle lane/paved shoulder with width of less than 1.5 m.

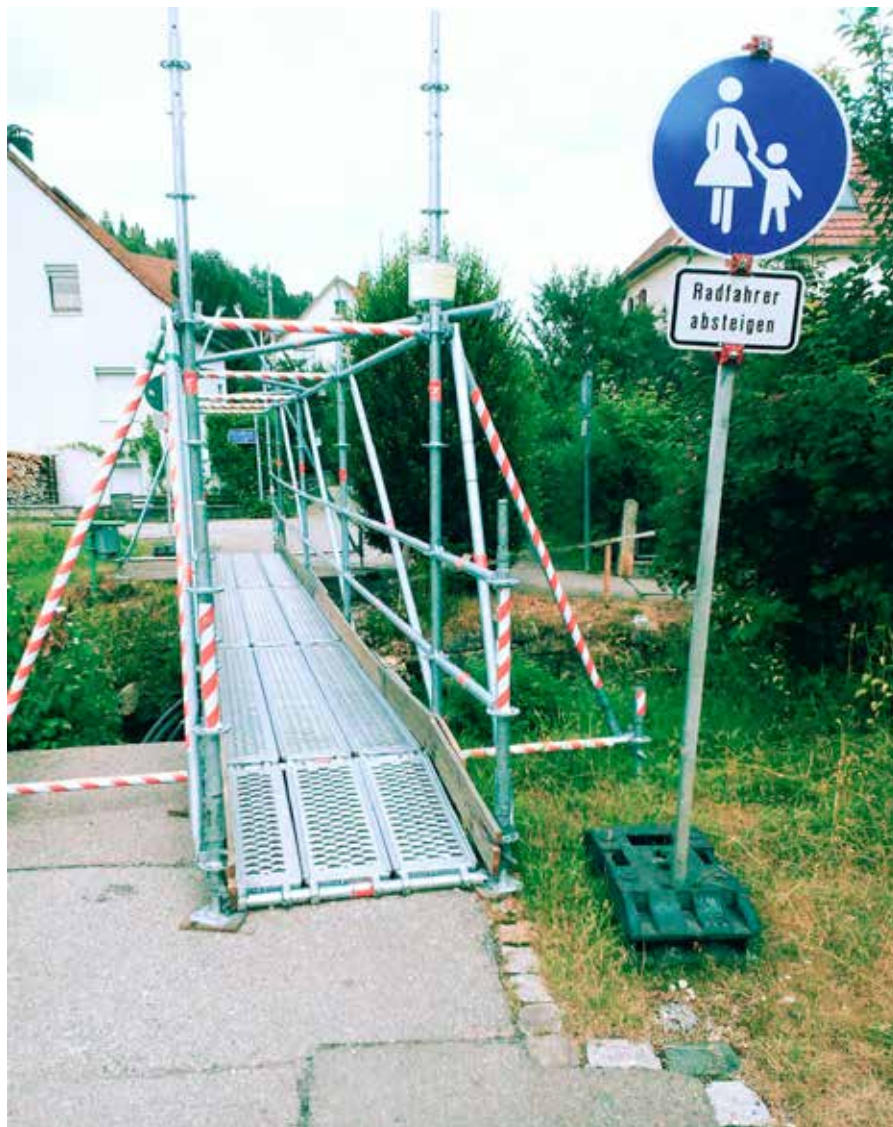
In Tuttlingen (daily section 1), cyclists have to dismount.

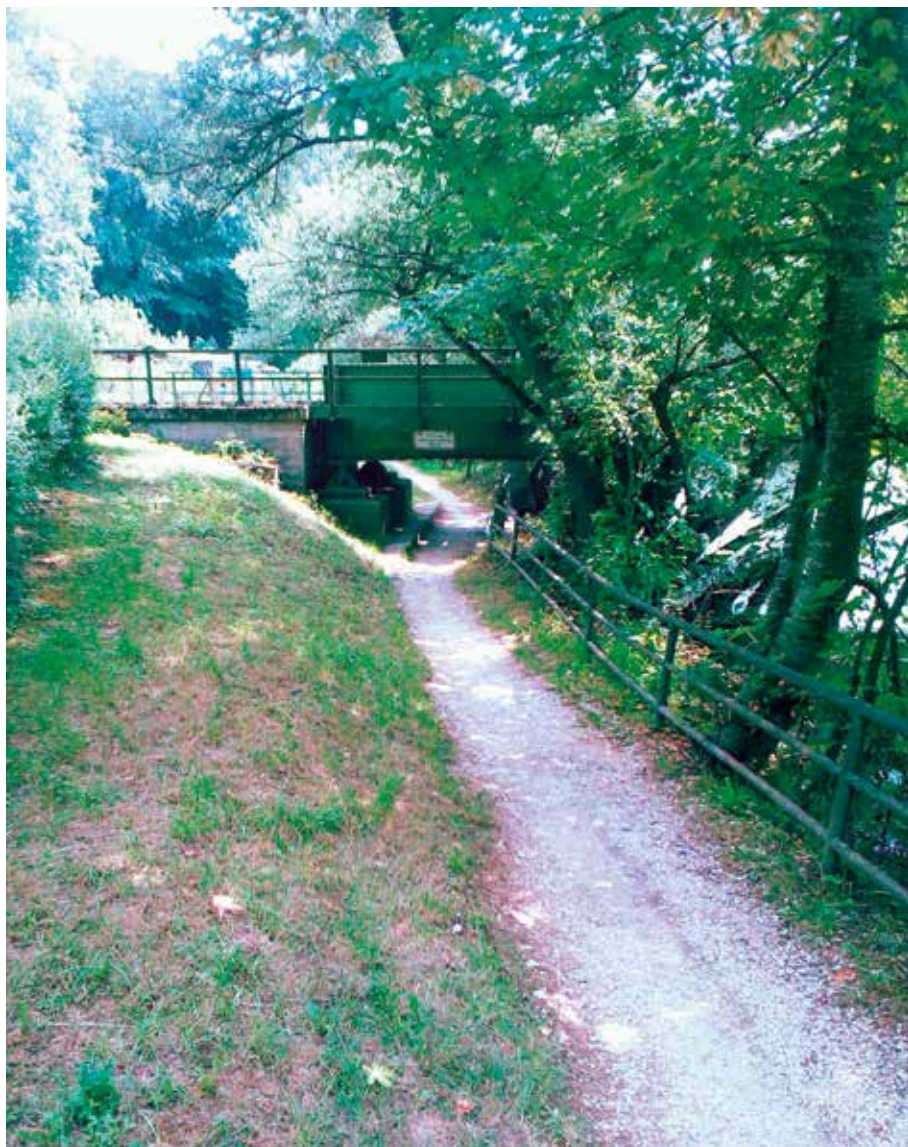
Quite narrow cycle path at entry to Scheer (section 2).

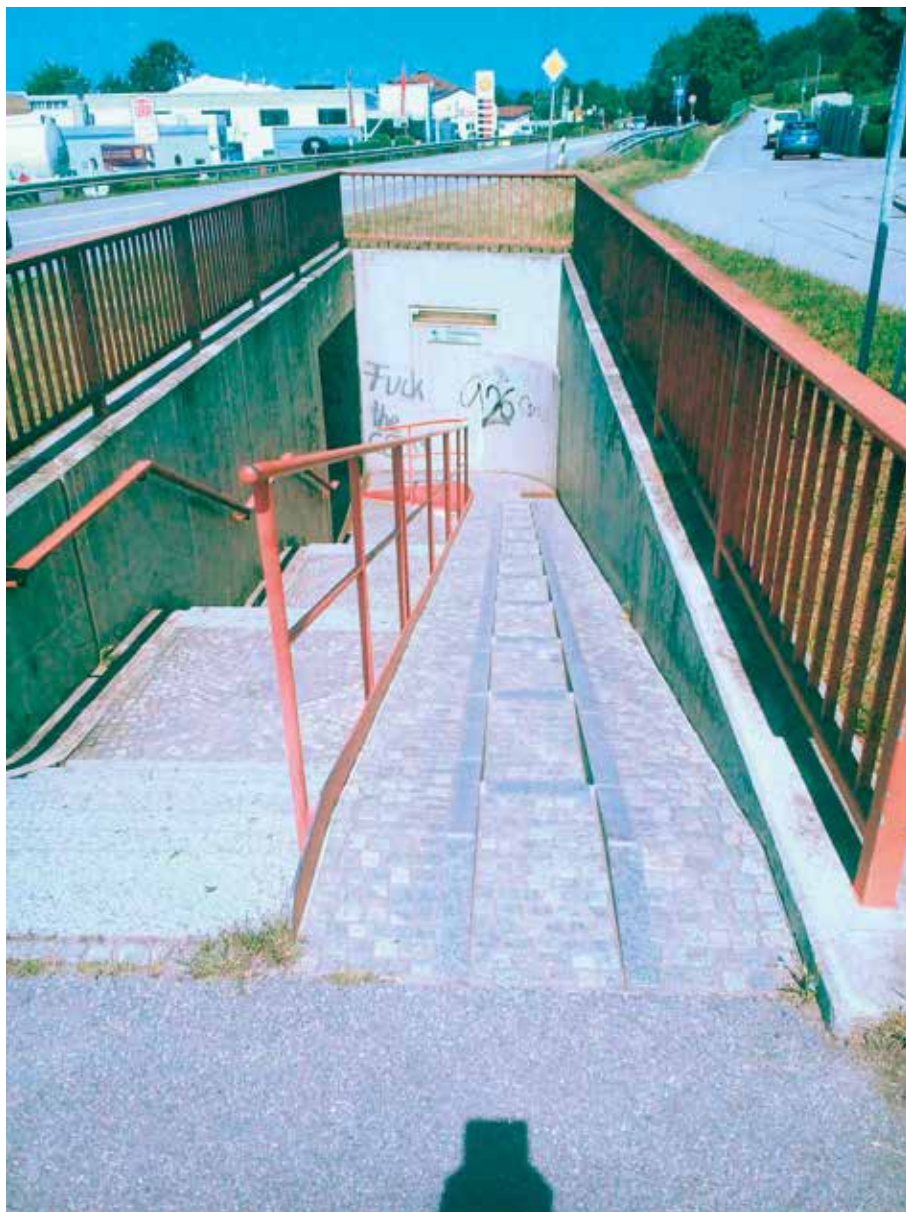
*Stairs with ramp but barely visible sign close to Passau (section 12).
Dark underground passage could also be a social safety challenge.*

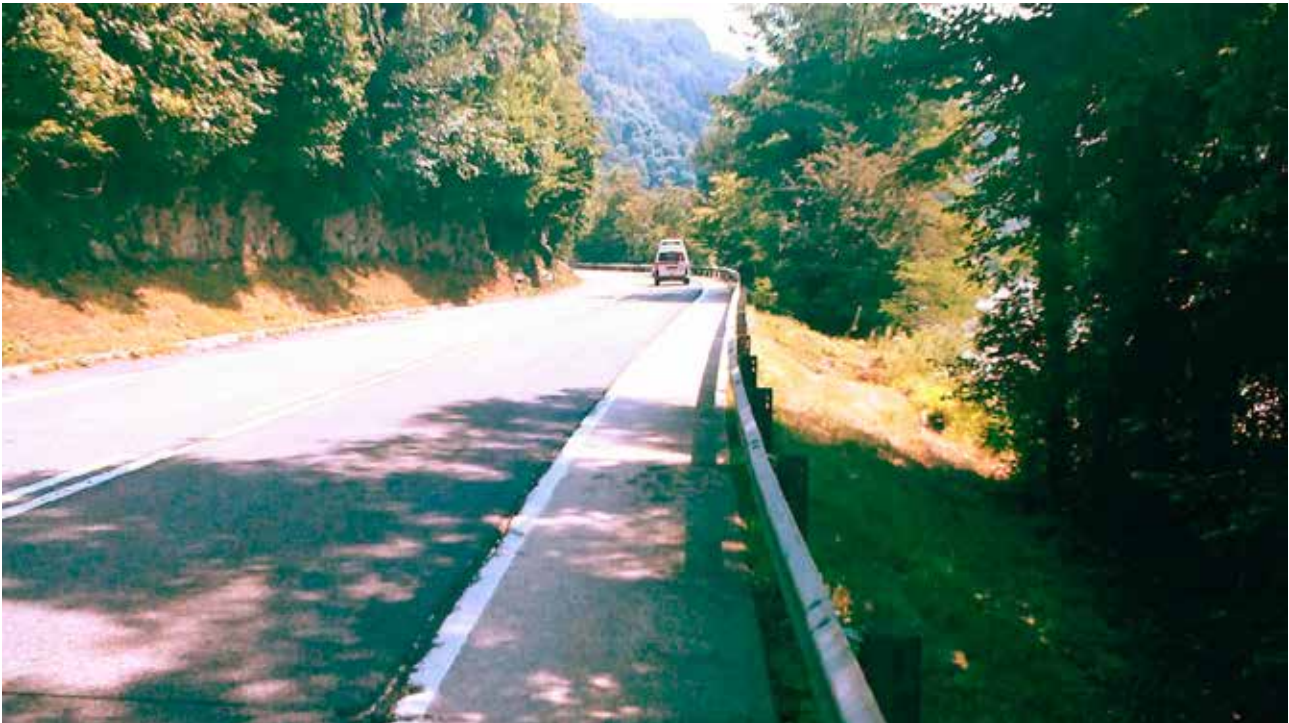
Paved shoulder on road number 3 between Grein and Hirschenau (daily section 17) – too narrow for safe cycling outside built-up area, effective width further reduced by safety barrier.

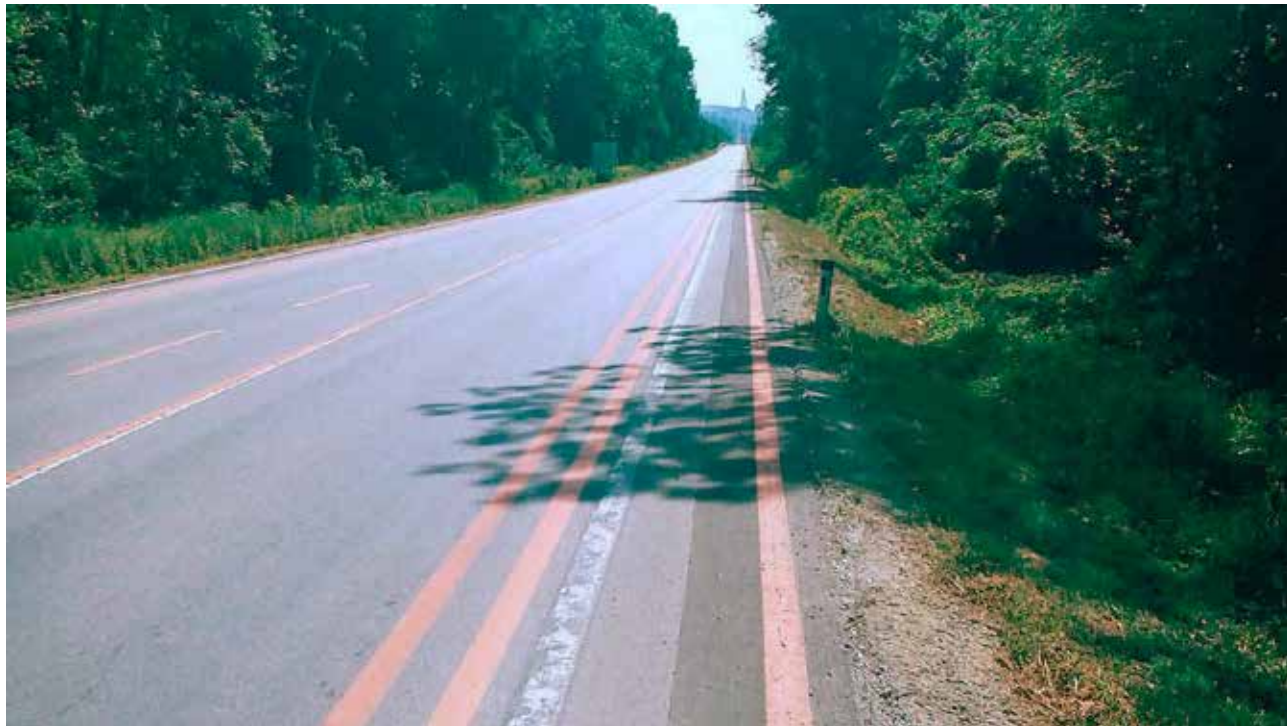
- One minor section in Vienna's city centre (daily section 19), shortly before the Stephansdom (public road, 4,000-10,000 units per day, 31-50 km/h).
- Narrow cycle lane on road no. 49 leading to the Andreas Maurer bridge.

Narrow cycle lane on road nr 49 leading to the Andreas Maurer bridge (daily section 20).

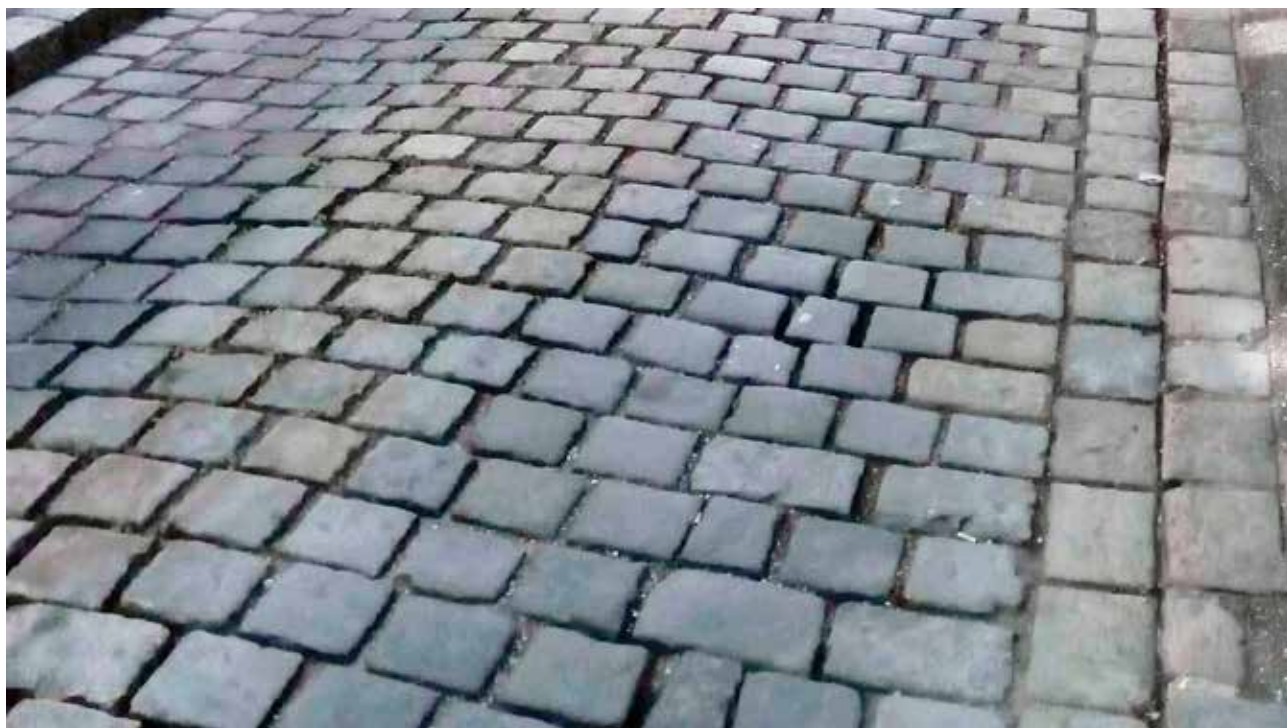
Cobblestones with big gaps in between in the centre of Ybbs an der Donau (daily section 25).

Bike friendly cobblestone treatment in Freiburg im Breisgau – similar measures could be applied in Ybbs an der Donau.

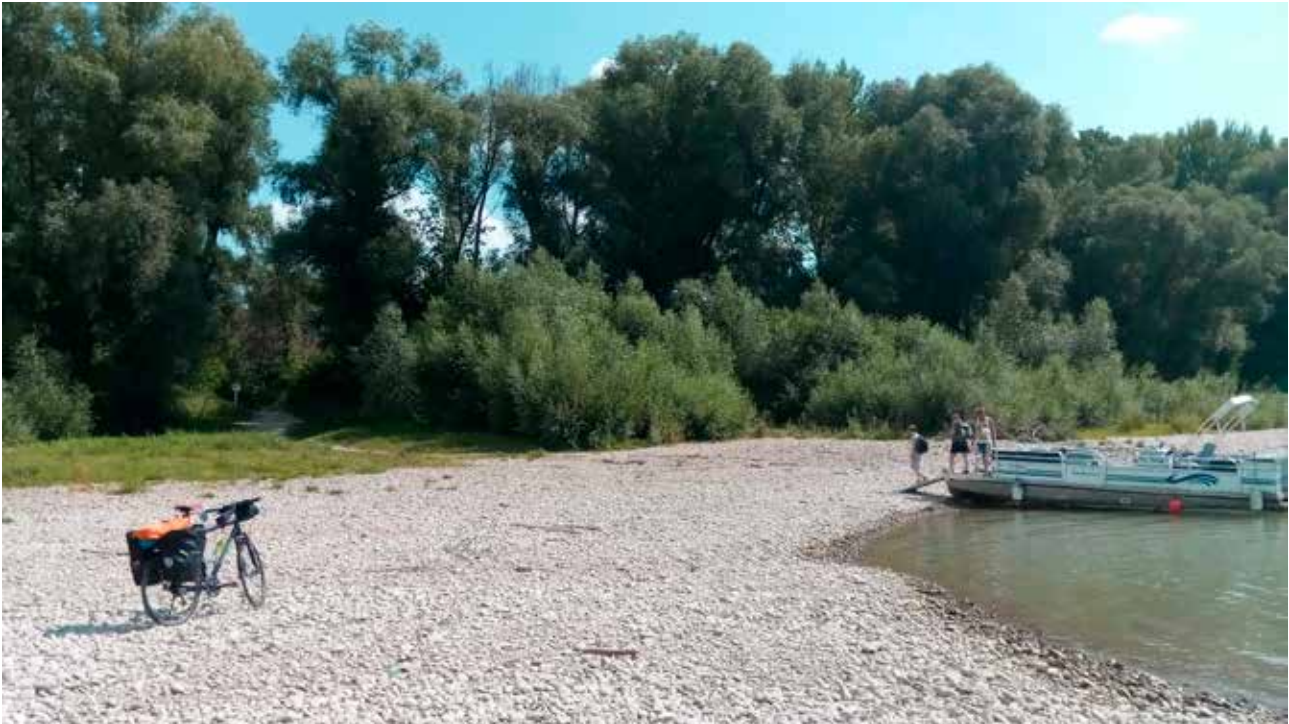
Difficult access to ferry in Haslau an der Donau (pebbles, sand, cobblestones, up to 25% gradient after taking the ferry).

7. Better access to the ferry in Haslau an der Donau; alternatively, the option of developing a cycle route on the southern side of the Danube also between Vienna and Haslau an der Donau (not surveyed) could be explored.
8. Adding missing signs on 78 junctions (most of them in daily sections 17, 19-20 and 28).
9. Integrating EuroVelo logo on signs where it is missing – mostly in daily sections 14-16, 22-23 and 29.
10. Integrate public-transport timetables and explanations on signing into the Austrian websites promoting EuroVelo 6.

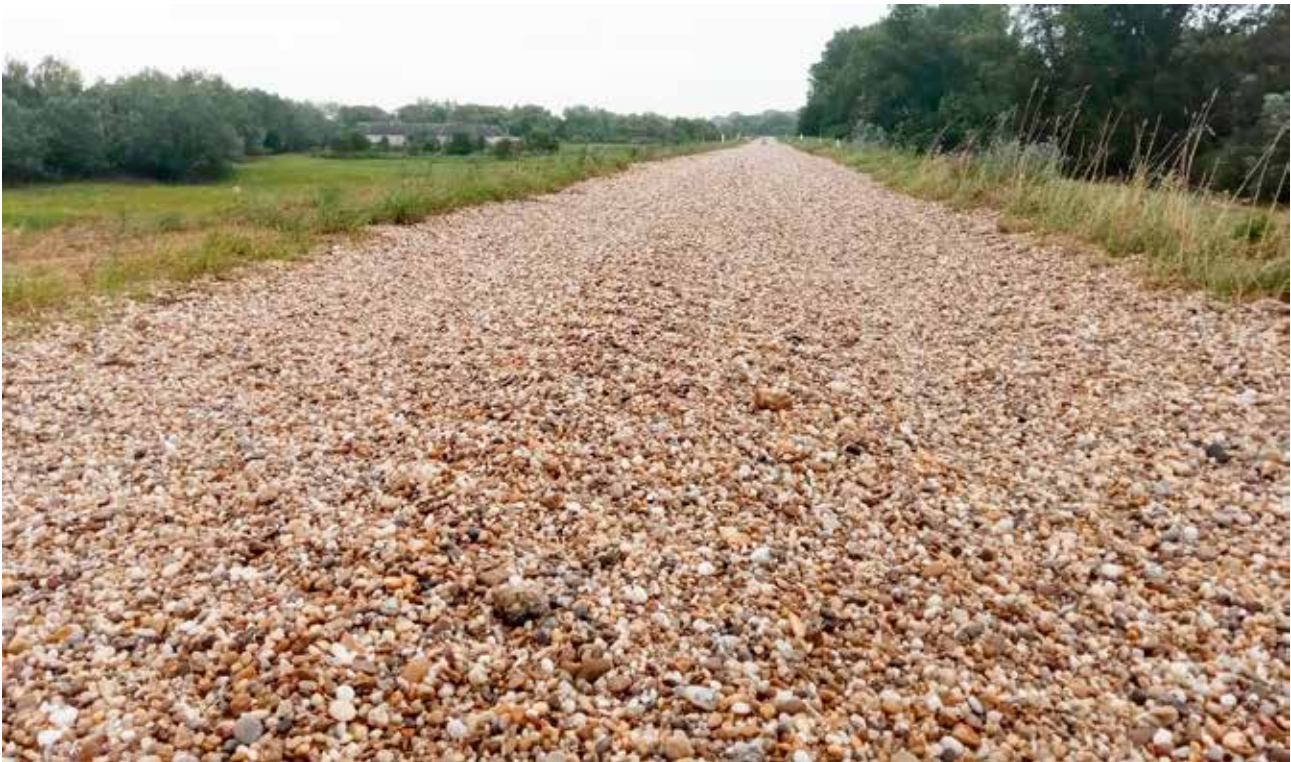
Badly rideable, not consolidated gravel between Velké Kosihy and Nová Stráž.

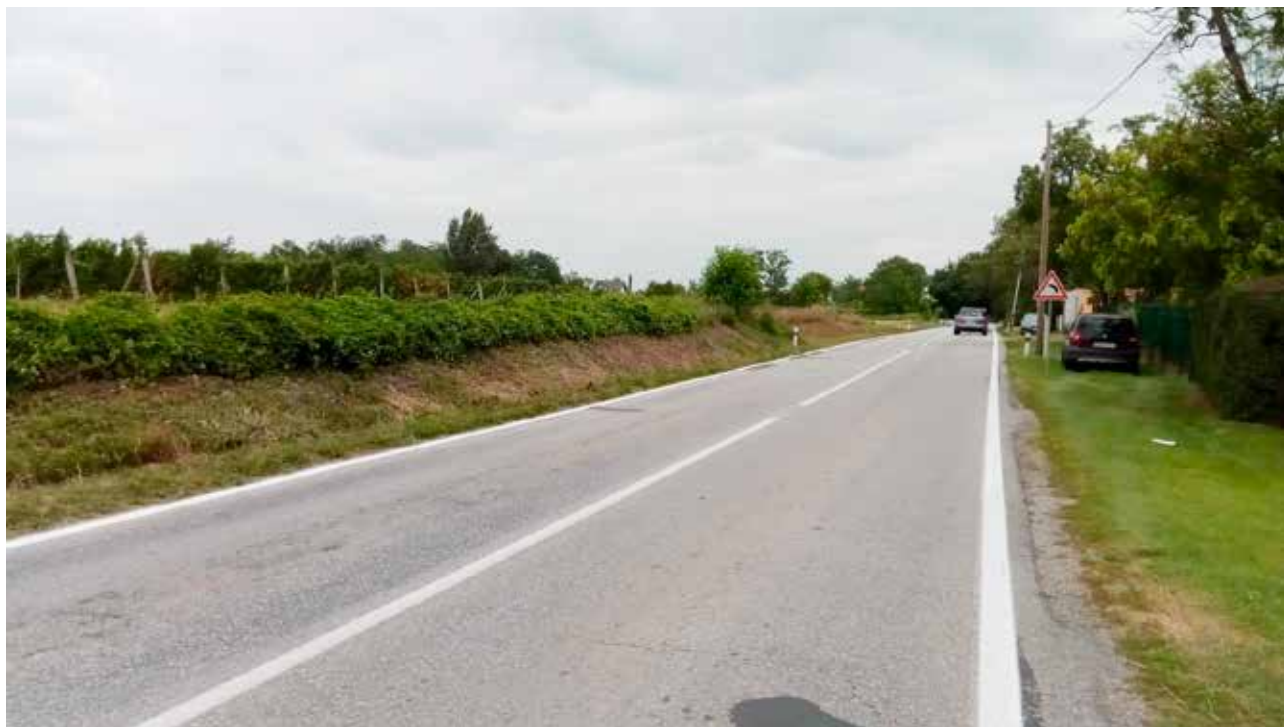
Section on national road 63 between Radvaň nad Dunajom-Žitava and Moča.

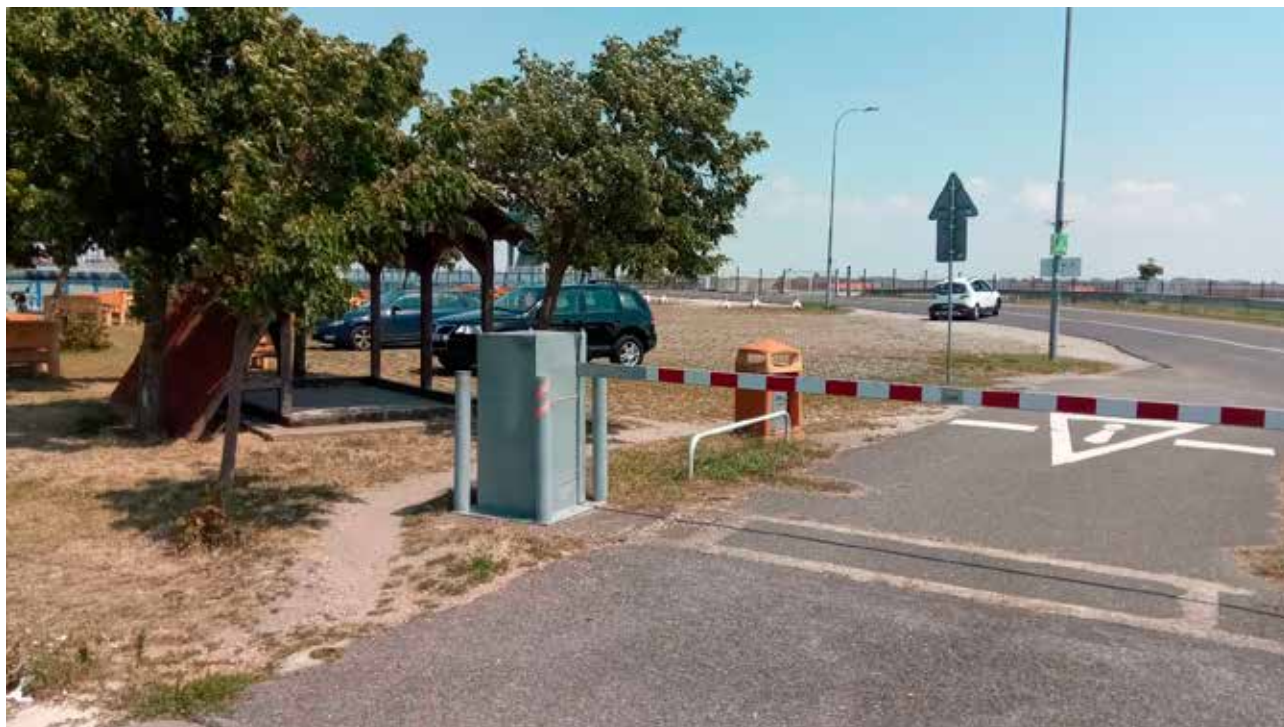
One of the barriers that need to be adapted to meet the Additional European Certification Standard criteria.

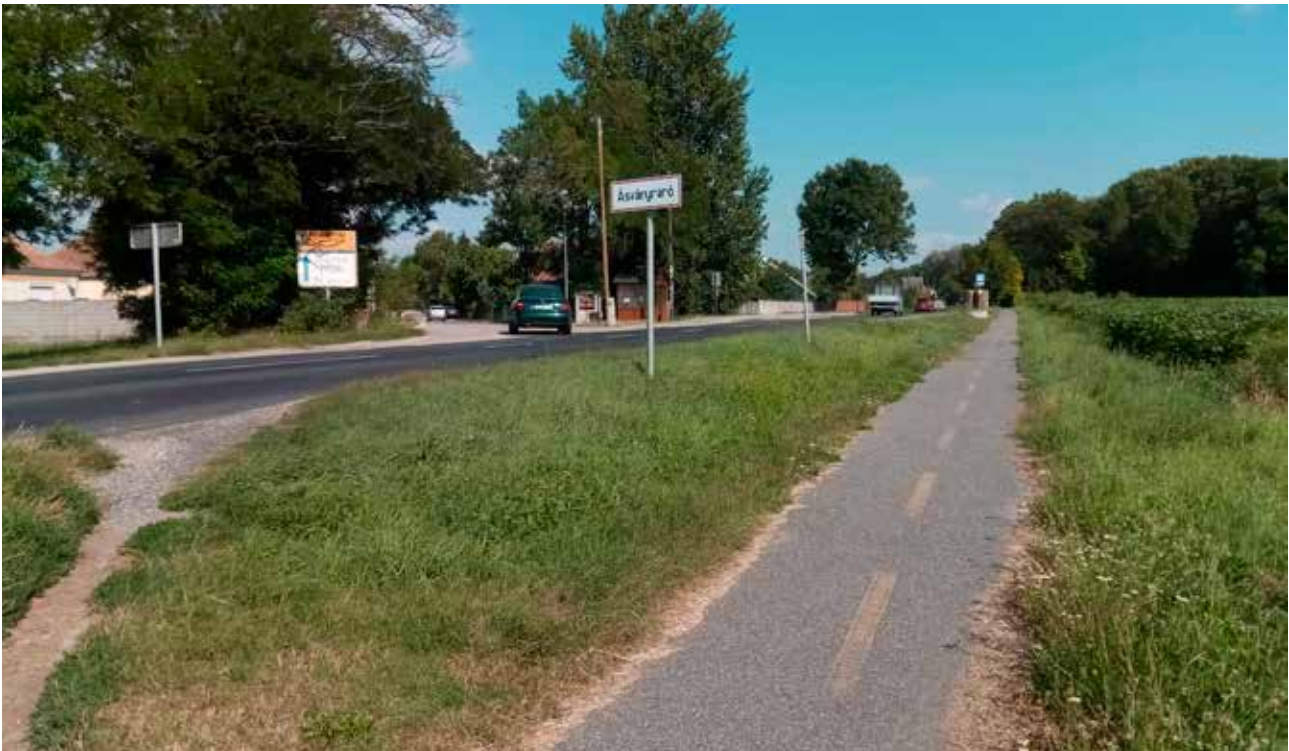
High-quality cycle path, but the maintenance could be improved to prevent the edges from being overgrown.

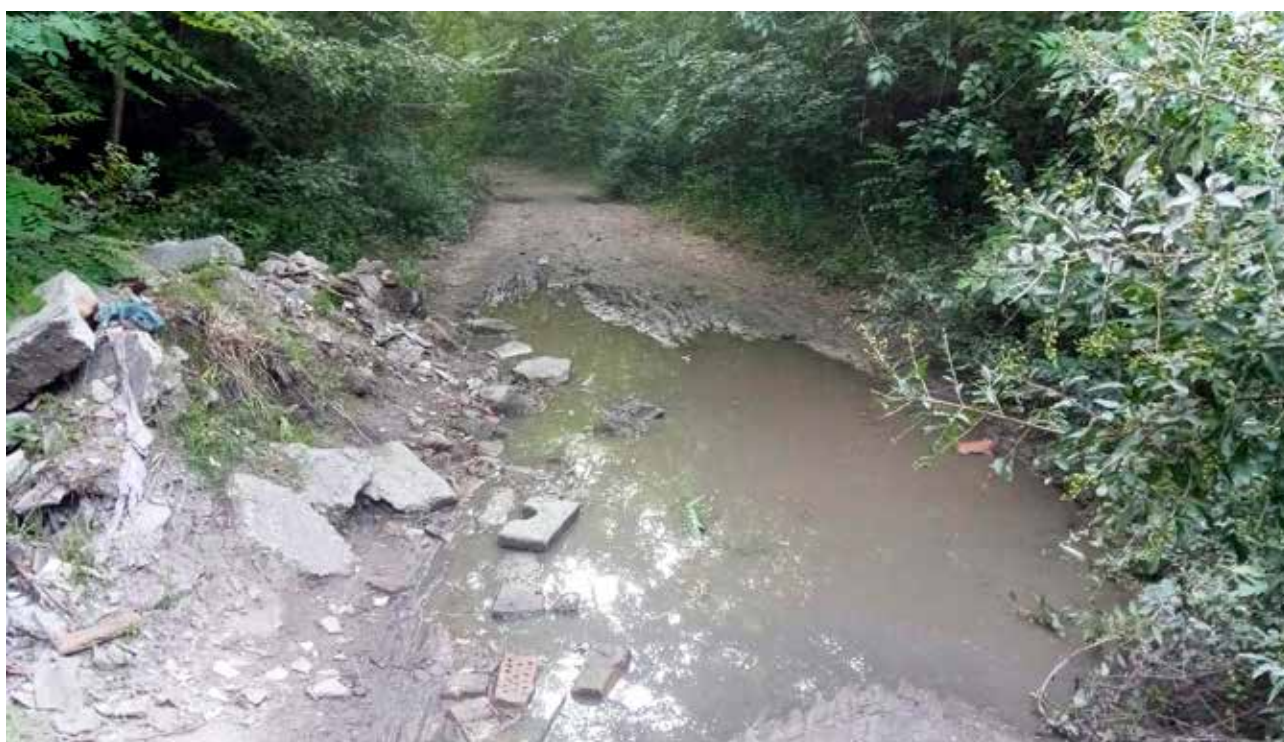
- Most of the badly rideable paths (16 km) in section 43: Ráckeve-Harta;
- Not rideable stretches have been identified in sections 34: Dunaszeg-Ács, 38: Ács-Esztergom, 41: Vác-Budapest and 42: Budapest-Ráckeve.

Badly rideable surface in section 34.

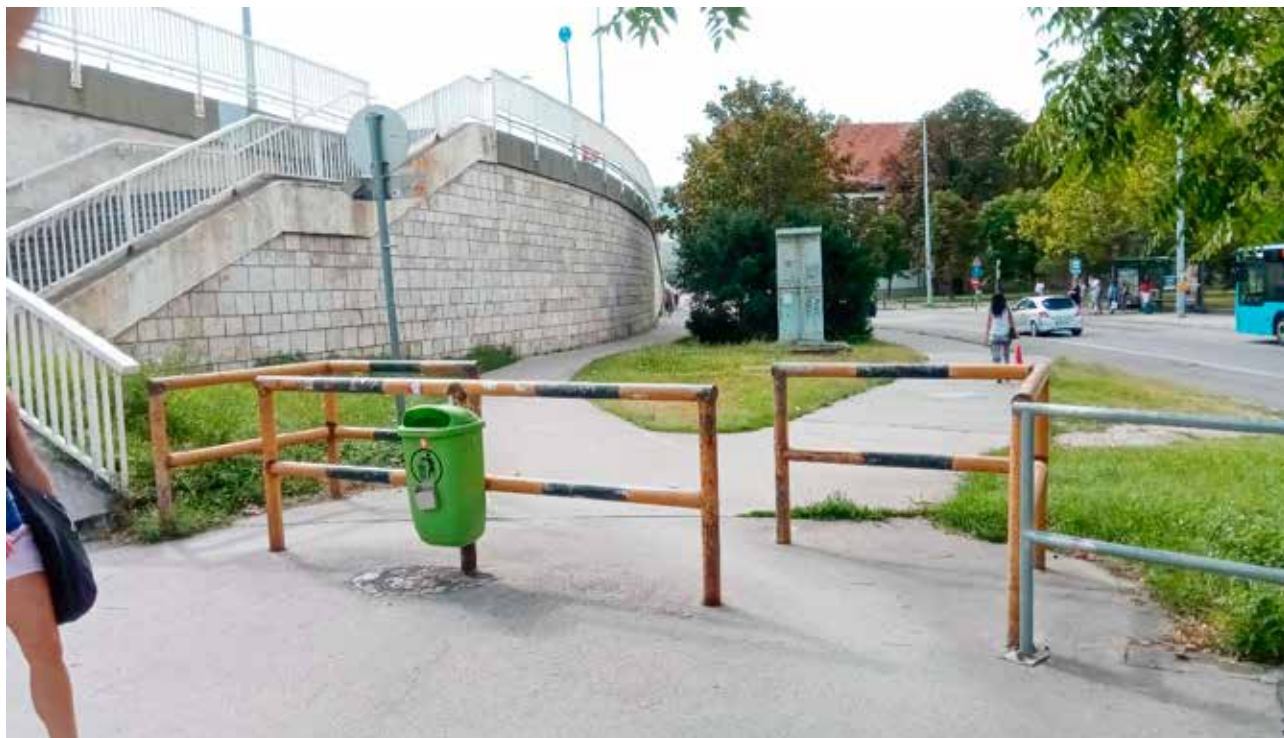
Example of a chicane that is difficult to pass with a tandem or trailer.

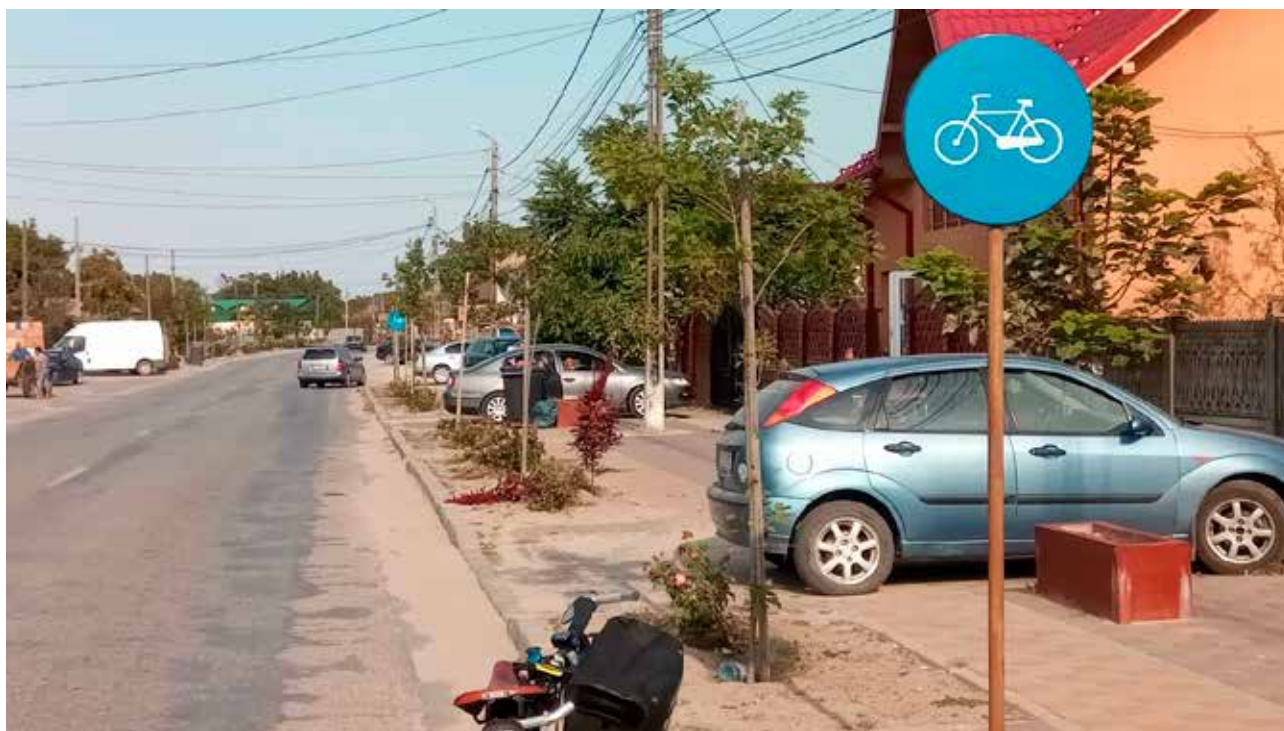
Cycle path in Călărași (the one on daily section 72, not the Călărași on section 78) was completely unusable and therefore not taken into account during the evaluation.

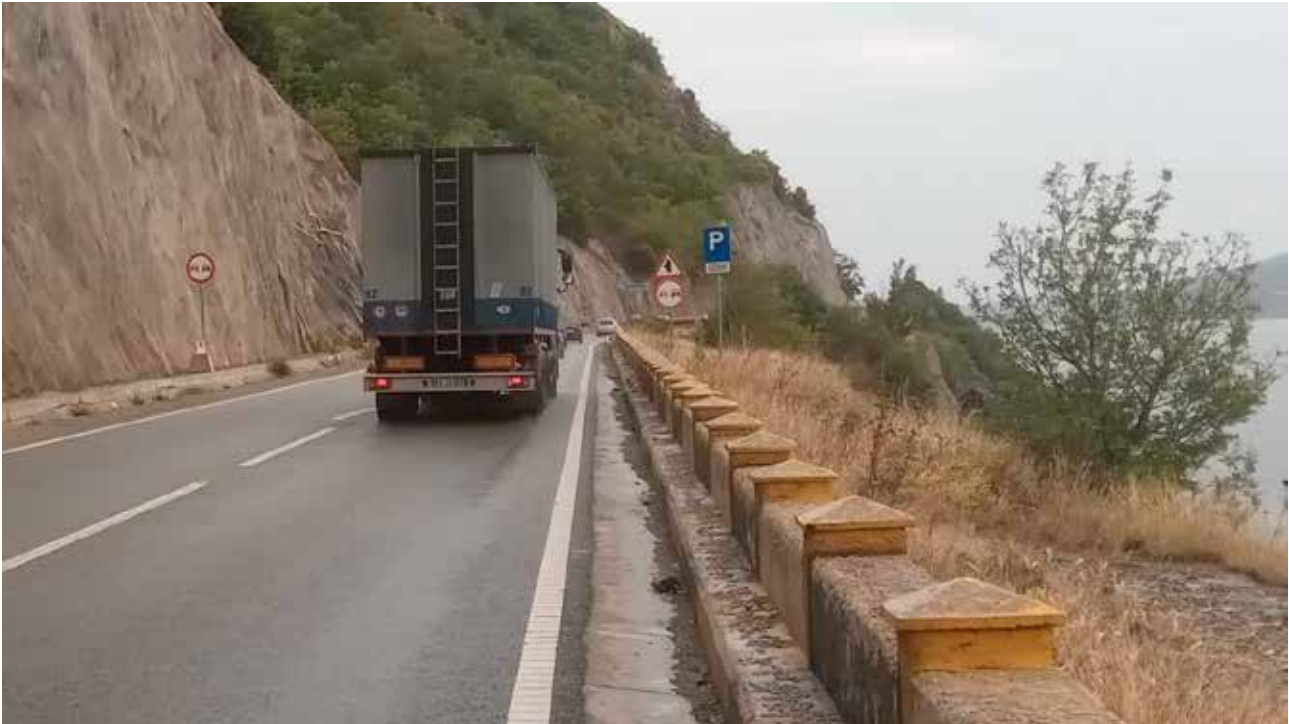
Heavy traffic on the TEN-T road between Orsova - Drobeta-Turnu Severin (daily section 66).

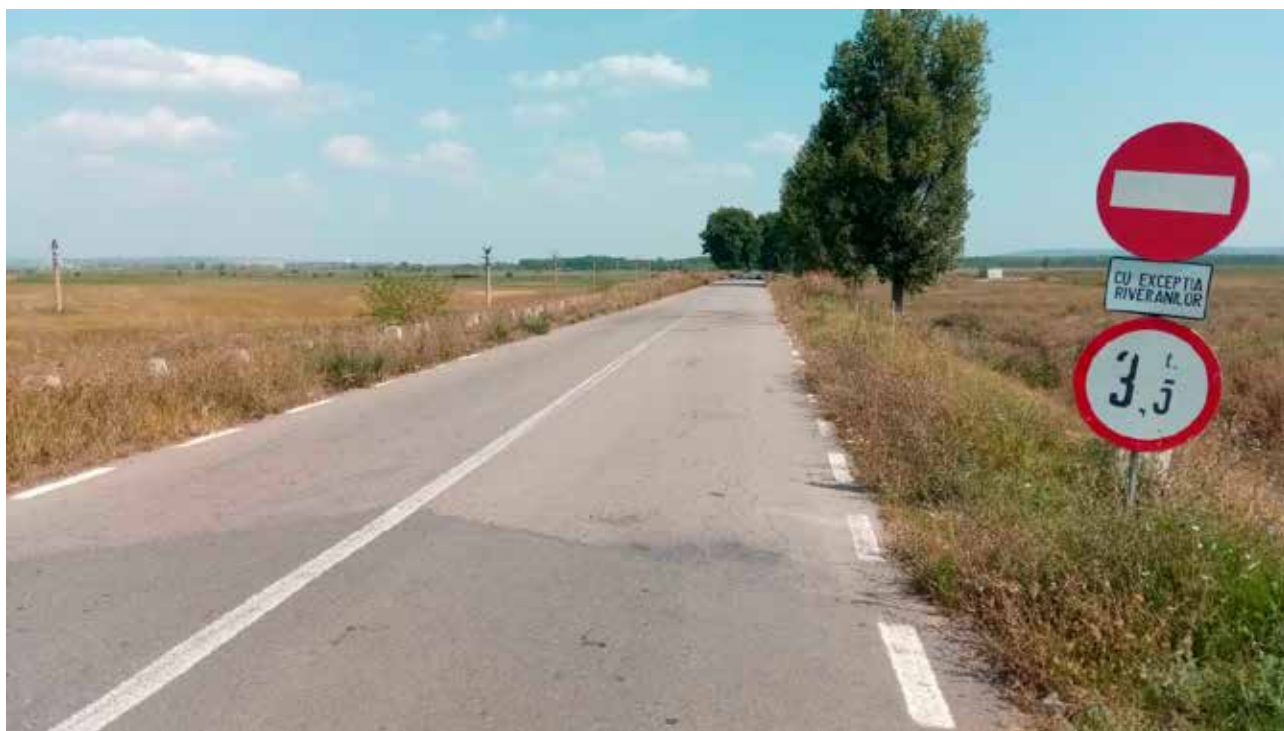
Daily section 73 – entry forbidden, exception for residents, but not for cyclists.
