DAMEN SHIPYARDS “ECOLINER”

Presentation by: Simon Provoost

Damen Shipyards Gorinchem

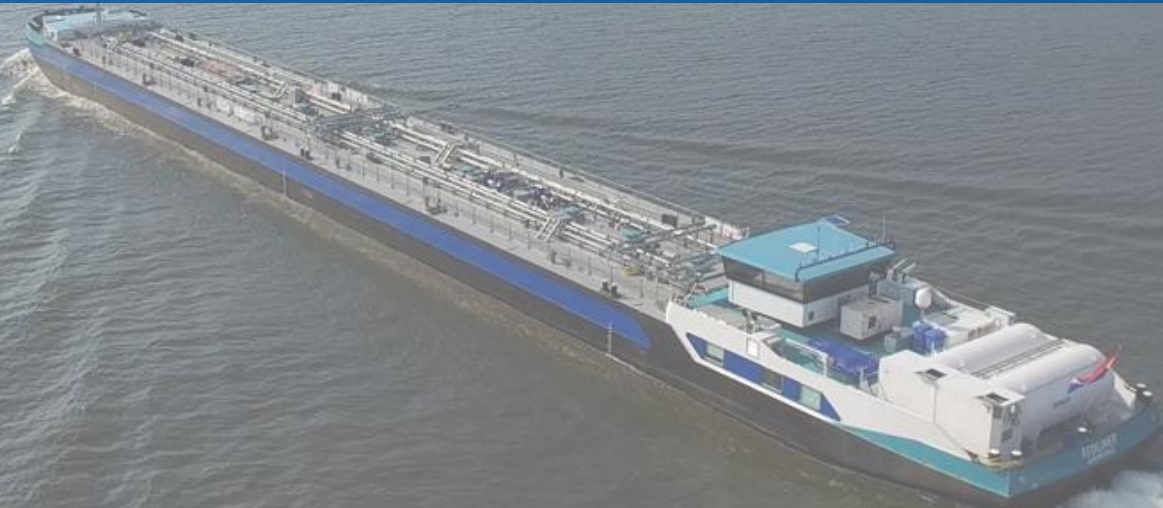
ECOLINER GOALS:

- Low Fuel Costs
- Low Emissions
- Low Operational Cost.

INNOVATIONS:

- 100% LNG Propulsion
- Air Lubrication
- Flex Tunnel (v/d Velden)
- DC system

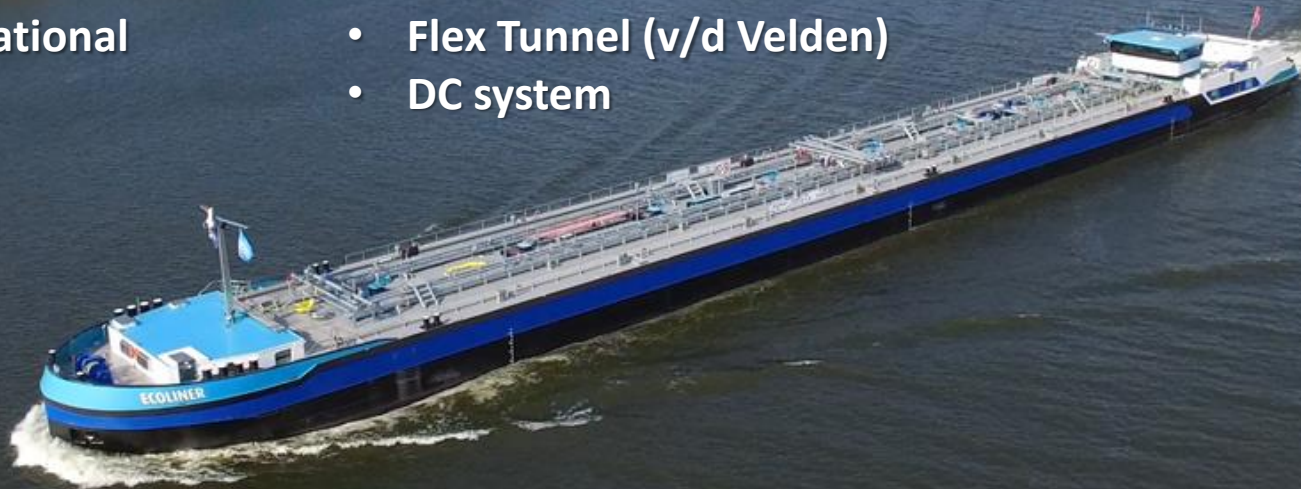
- 4 Gen Sets 285 kw each
- 2 LNG Type C tanks 26 m3 each
- 2 Engine Rooms SB - PS

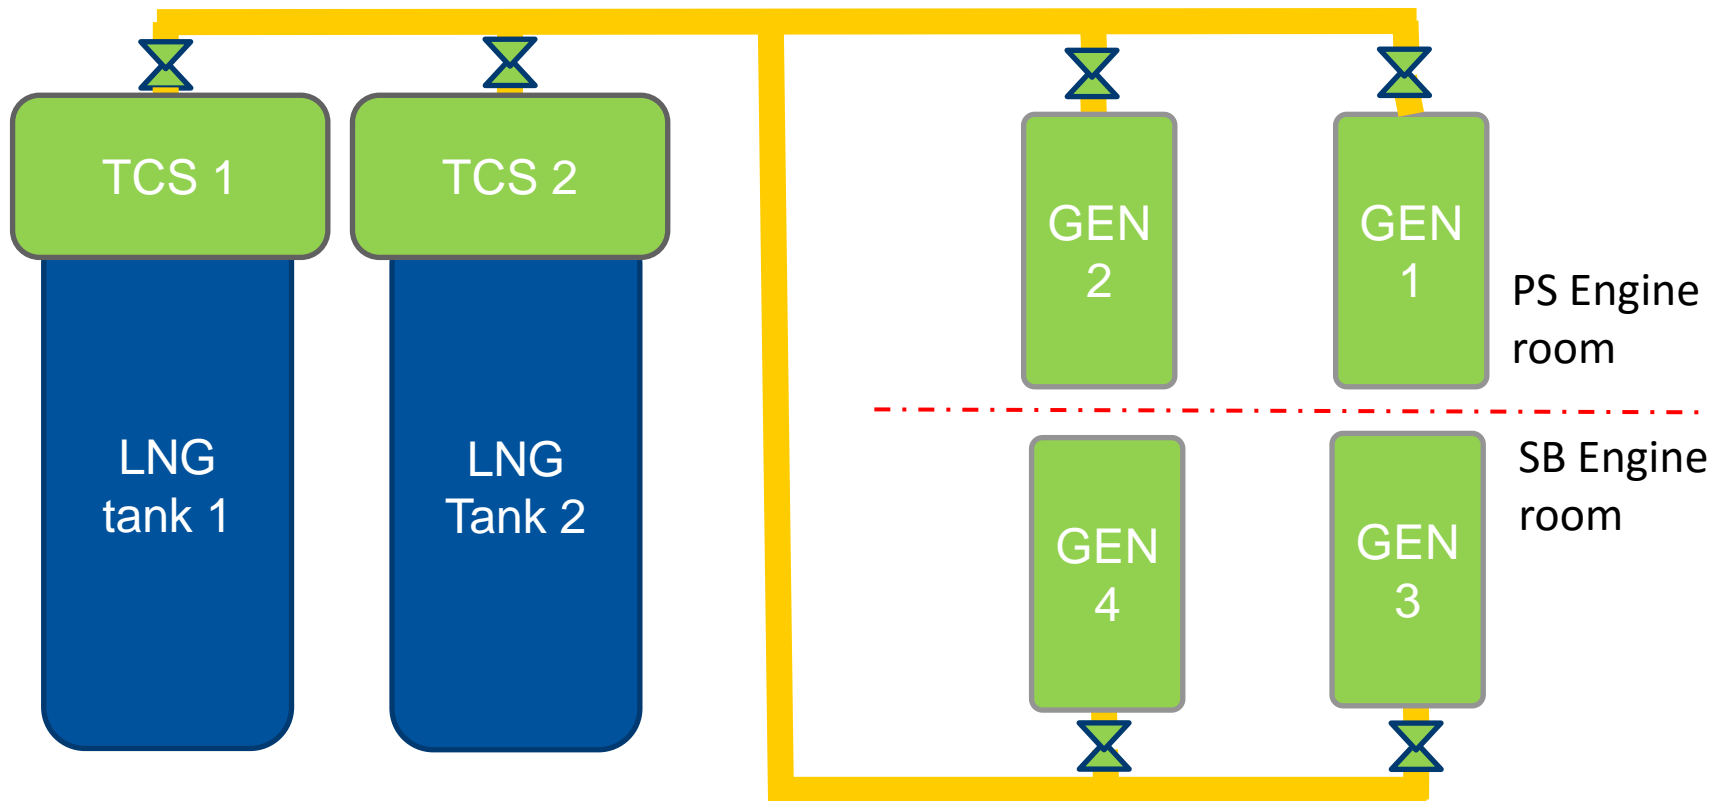
Normal Operation

Normal operation LNG tank 1 supplies gen 1 and 2 with gas
LNG tank 2 supplies gen 3 and 4 with Gas.

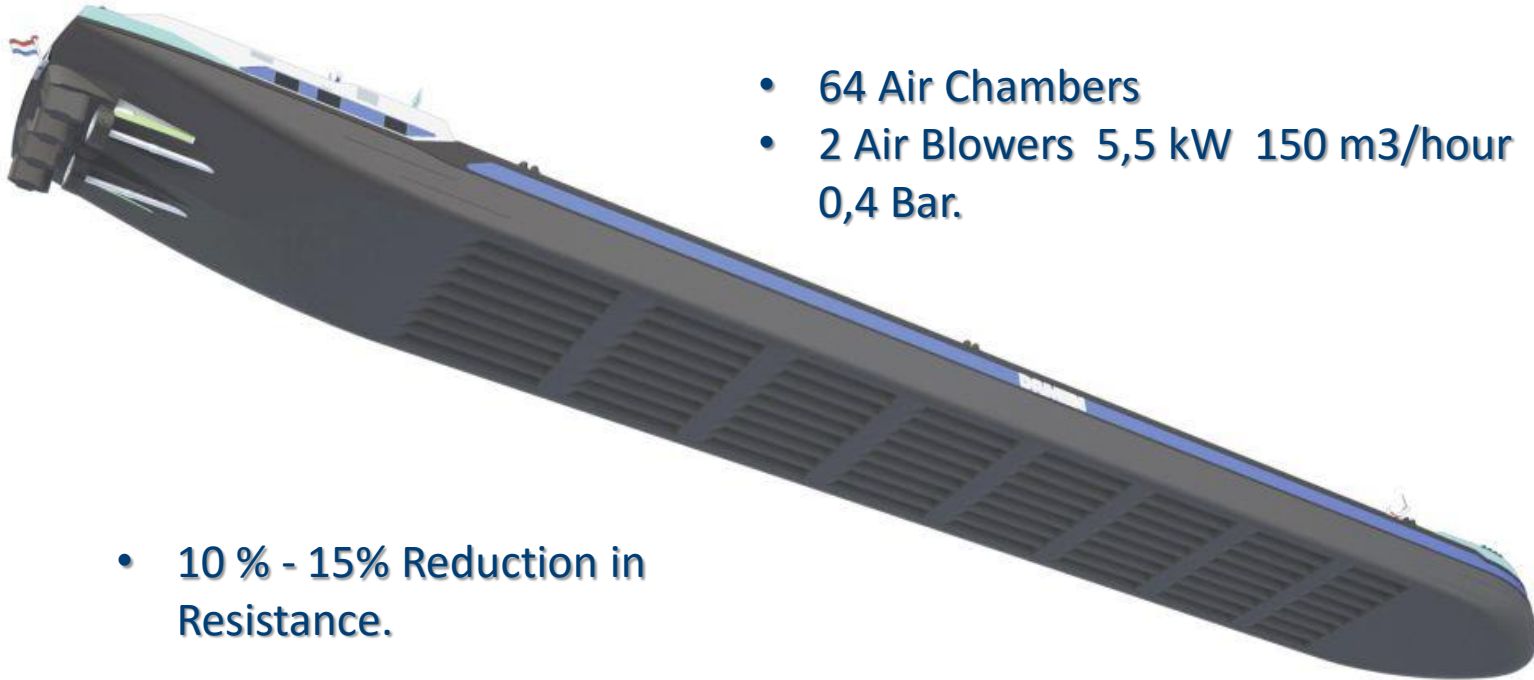
AIR
LUBRICATION

- 64 Air Chambers
 - 2 Air Blowers 5,5 kW 150 m³/hour
0,4 Bar.
- 10 % - 15% Reduction in Resistance.

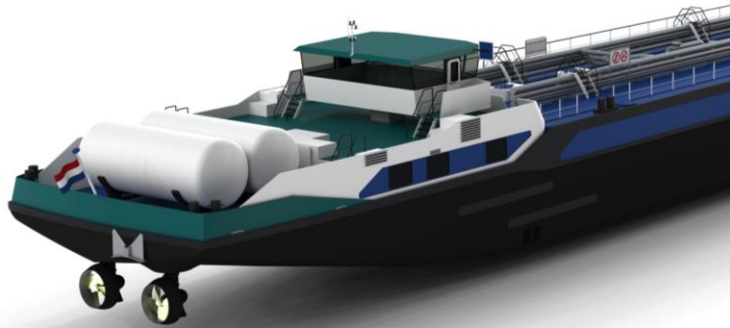
Original design:

- 2 thrusters Diam. 1200 mm

- Low efficiency due to small propeller size.
- Expensive repair in case of damage.

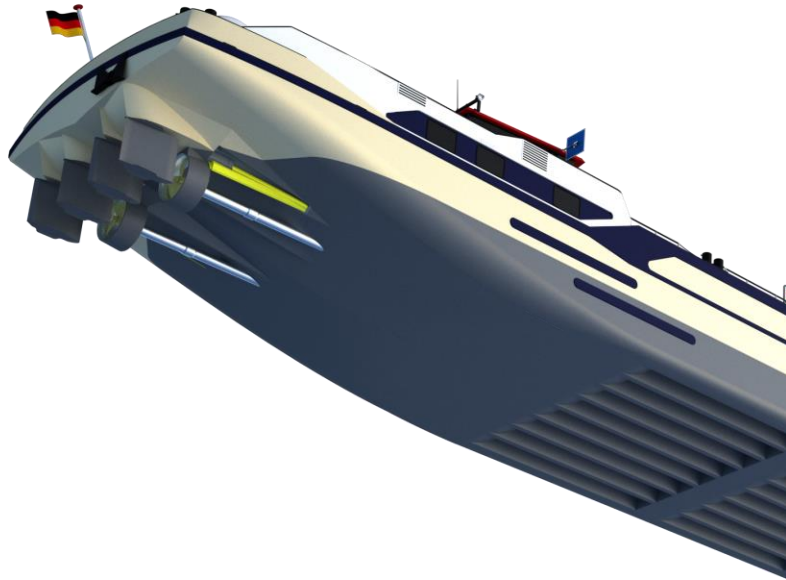
Final design:

- 2 Propellers in Nozzle Diam. 1500 mm
- Flextunnel
- Rudders

- 10% better than thrusters.

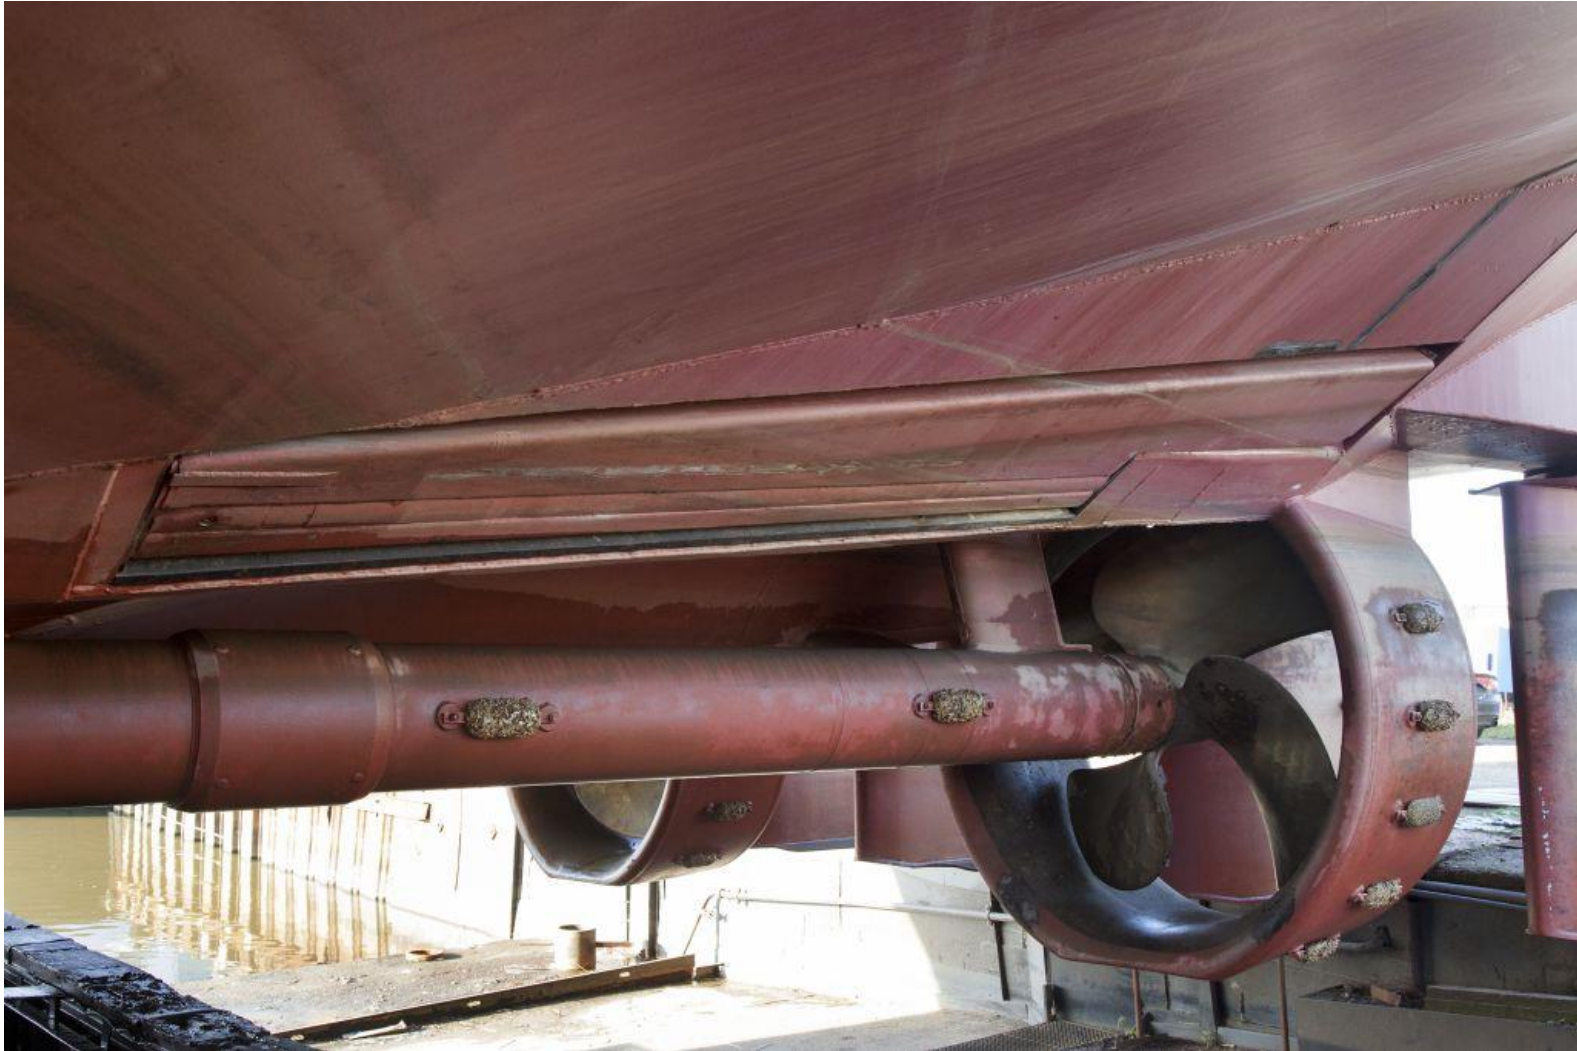
- First bunkering operation April 2016
- First Engine start May 2016
- Recommendation No. 9/2012 of the central commission for the Navigation of the Rhine, dated July 13th 2012.
- Ecoliner in operation since July 2016

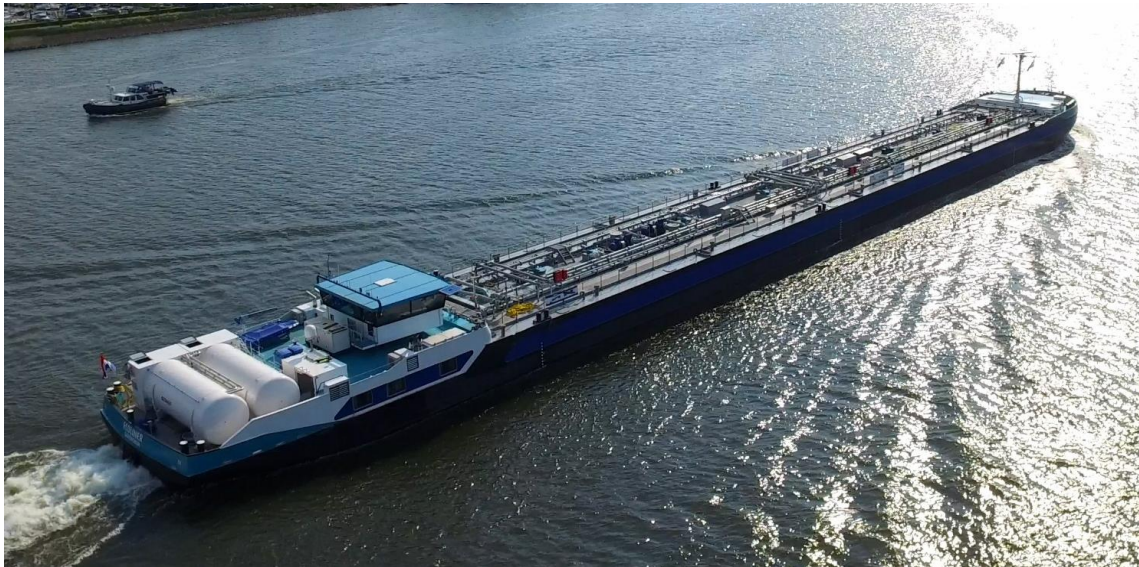
Ecoliner out of service in October 2016:

Several serious problems:

- Several blackouts and unstable Generators.
- Ice in the Tank Connection Space
- Ice below the tank
- Ice below the aftdeck
- Knocking of the Scania Generator
- Explosion in the inlet manifold of the Generator.

Unsafe situation for the Crew in the Engine room and for the vessel in operation.!!

Ecoliner out of service and back to the yard october 2016.

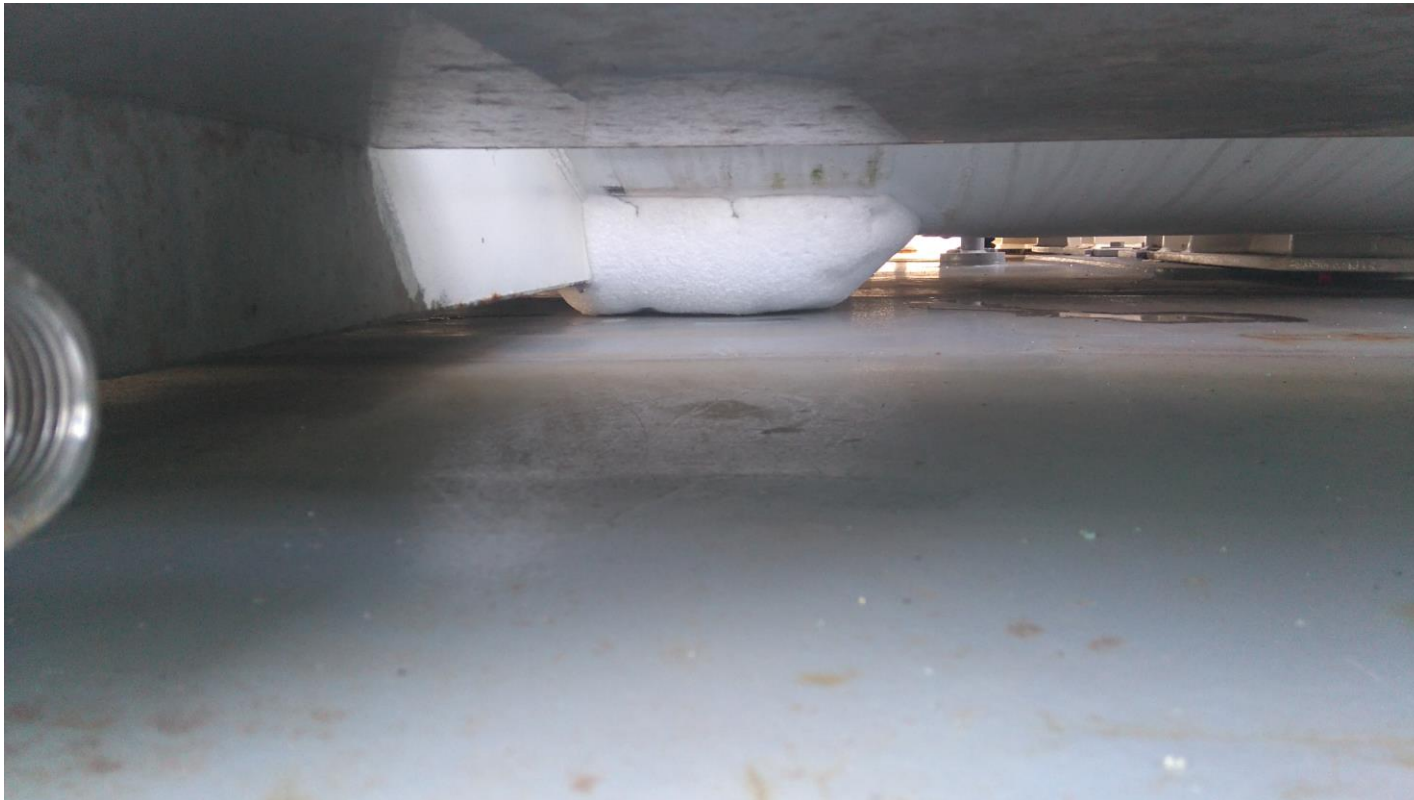
Ice below the tank

- No gas trap(s) (Ice between tank and deck, even underneath deck)
- Holding time (>10 weeks \Leftrightarrow 0,5 bar/24h?)
- No tri cock (tank level reference (at max filling level))
- Filling connection (too small, long bunkering time)

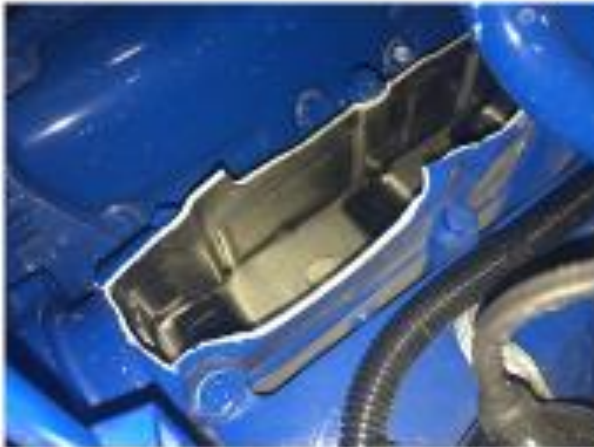
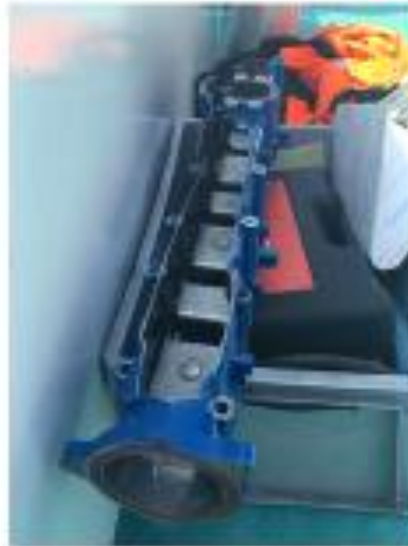
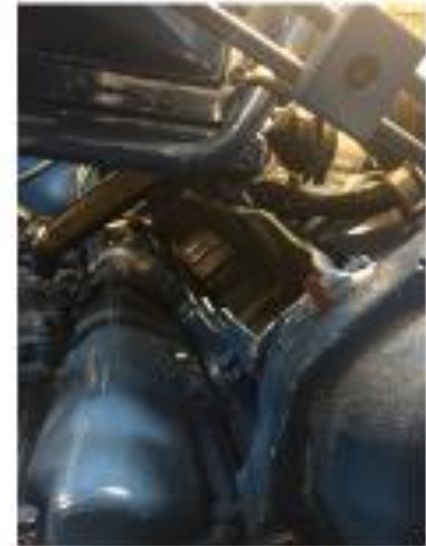
ENGINE EXPLOSION (INLET MANIFOLD DAMAGED)

- LNG out of specification (pressure pulses)
 - Knocking
 - Inlet manifold explosion

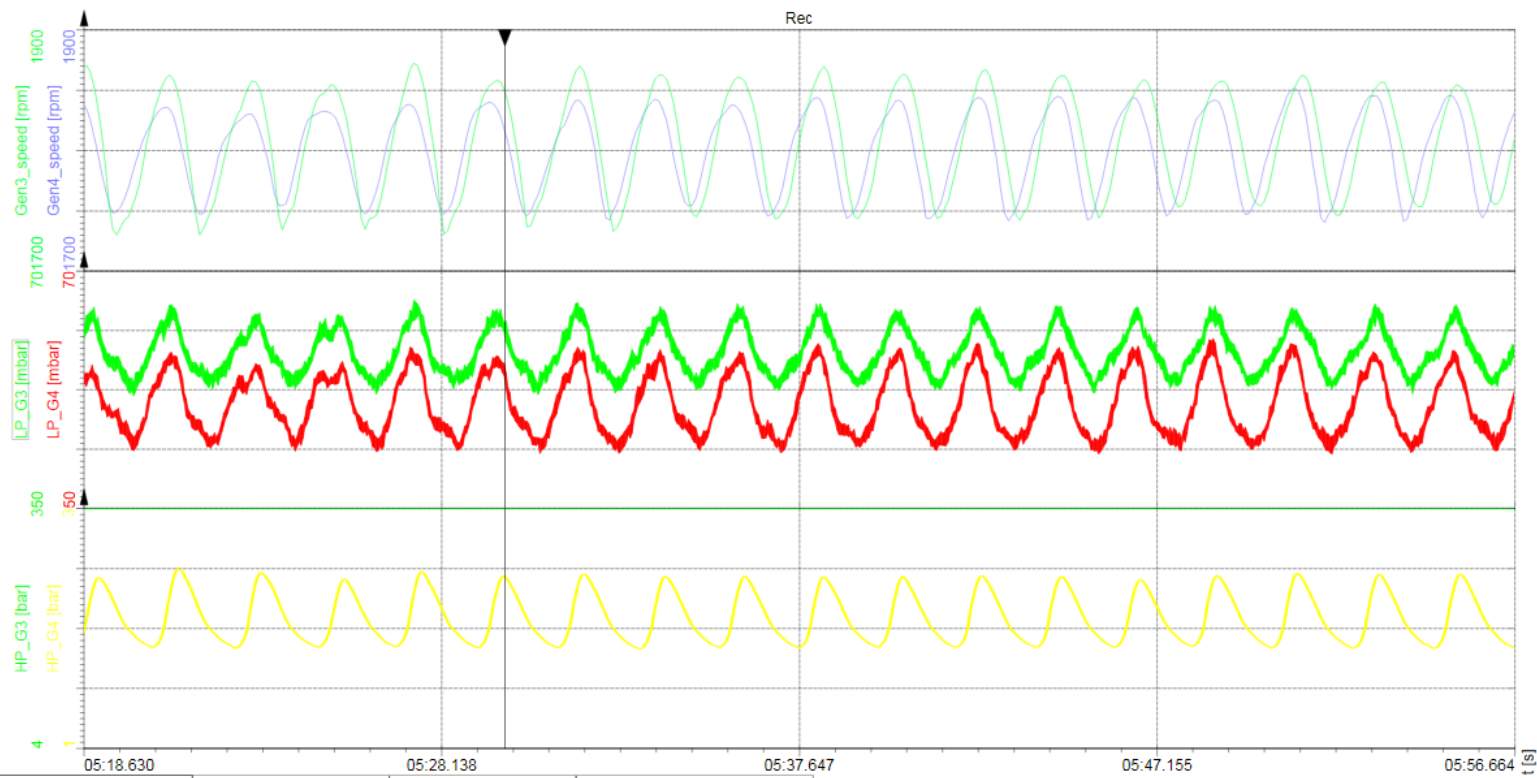
Generators 3 and 4 - 100% Operation on liquid through evaporator

File name: Liq_evap_G3G4_d2.dxd
Date: 01/03/2017; Time: 10:59:09; Show time = 38.034 s f= 0.0263 Hz

LP_G4 [mbar] ACT	Gen4_pwr_DC [kW] AVE	Gen3_pwr_DC [kW] AVE	LP_G3 [mbar] ACT
62.1	268	259	65.6
HP_G4 [bar] ACT	Gen4_speed [rpm] ACT	Gen3_speed [rpm] ACT	HP_G3 [bar] ACT
2.44	1818	1851	2.44

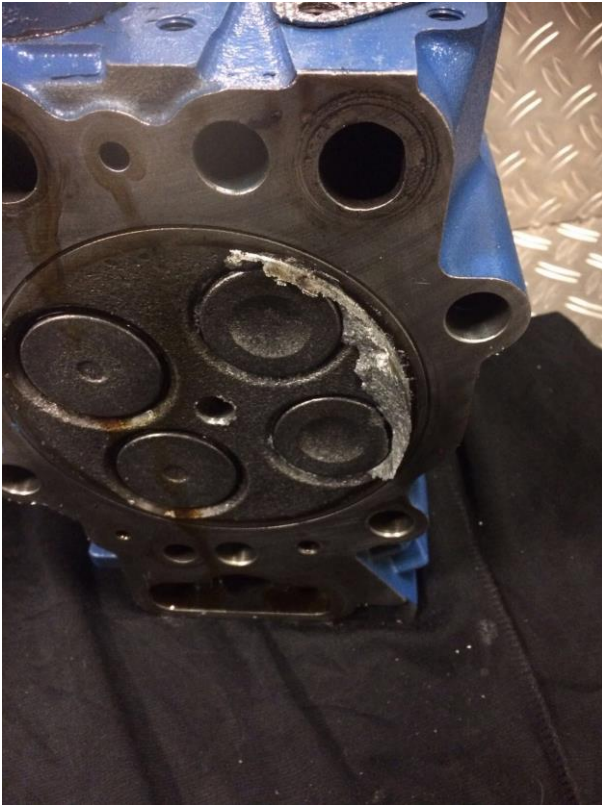
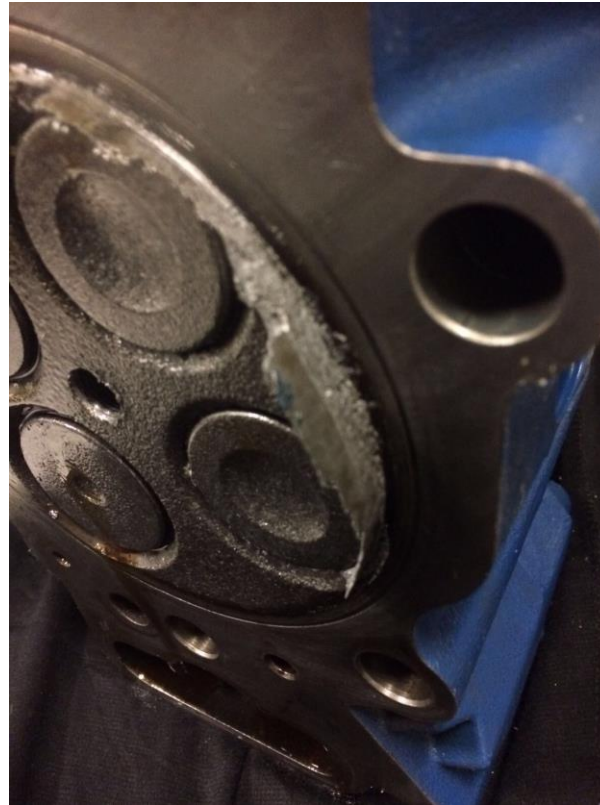
Results of unstable Gas quality!!!

Conclusion:
No stable Gas quality !!!!

- Knocking of Generators
- Damage to Cilinder heads

- Stable Gas Quality.
- Holdtime Storage Tanks
- Reduction of Bunkering time

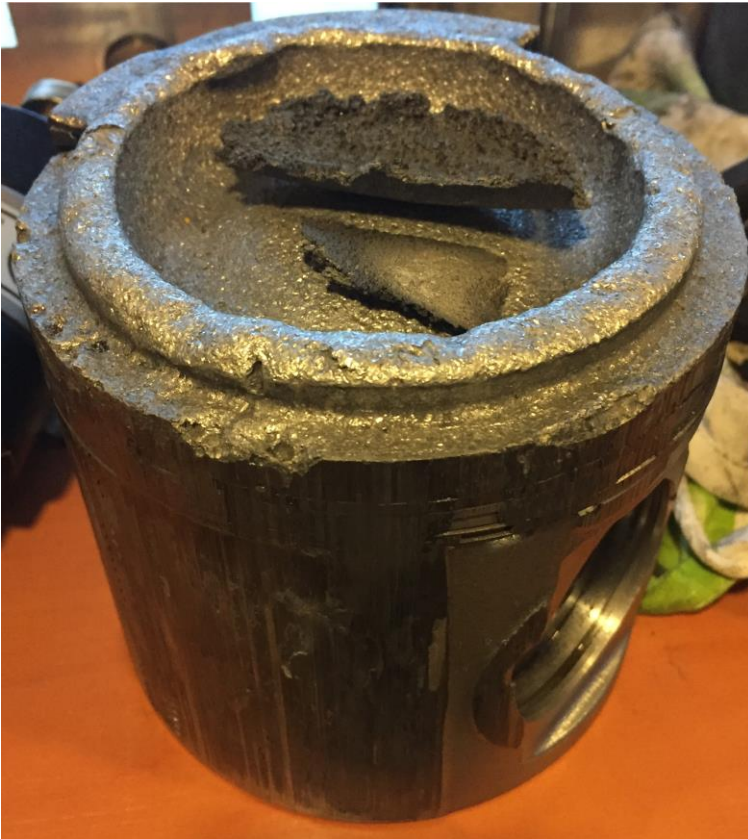
Results of unstable Gas quality!!!

- Knocking of Generators
- Damage to Pistons

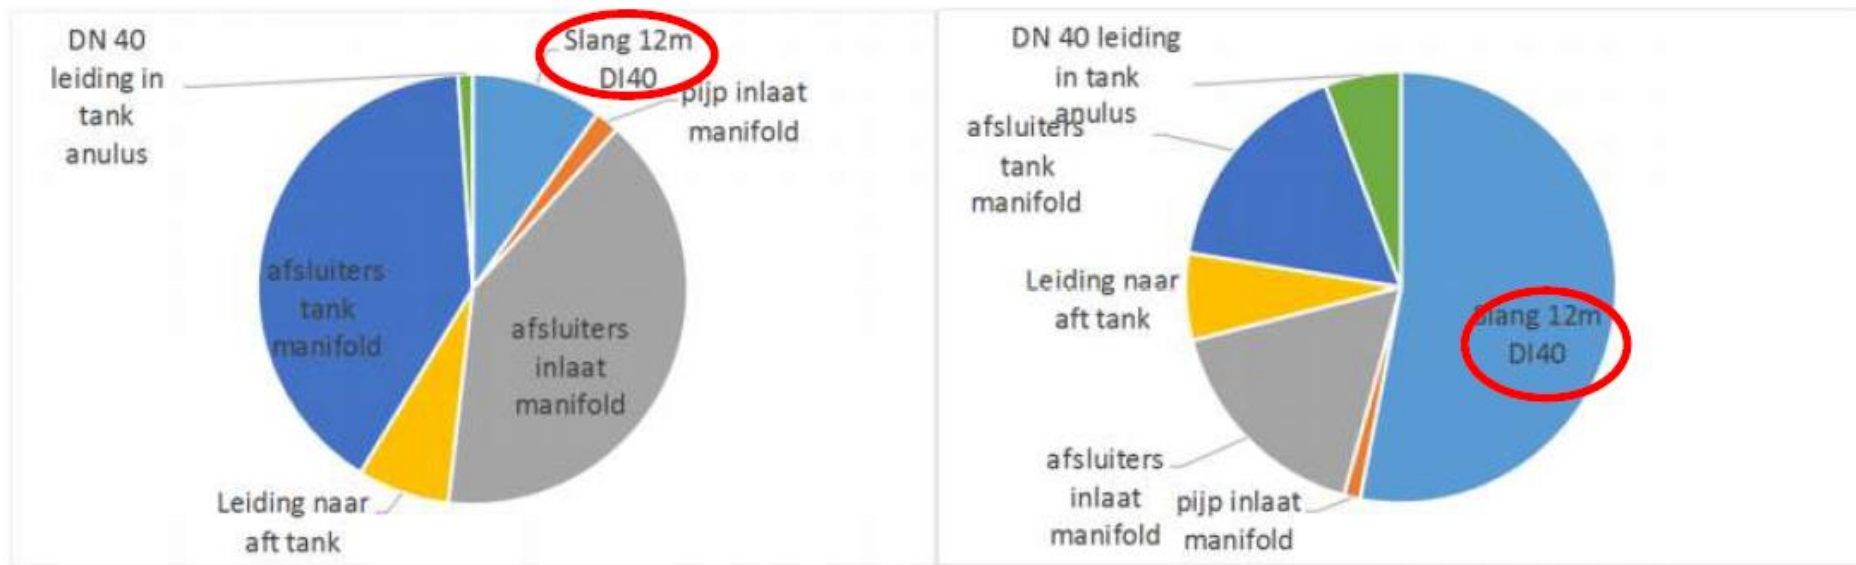
- Reduction of Bunkeringtime

Shown is % of de bottlenecks

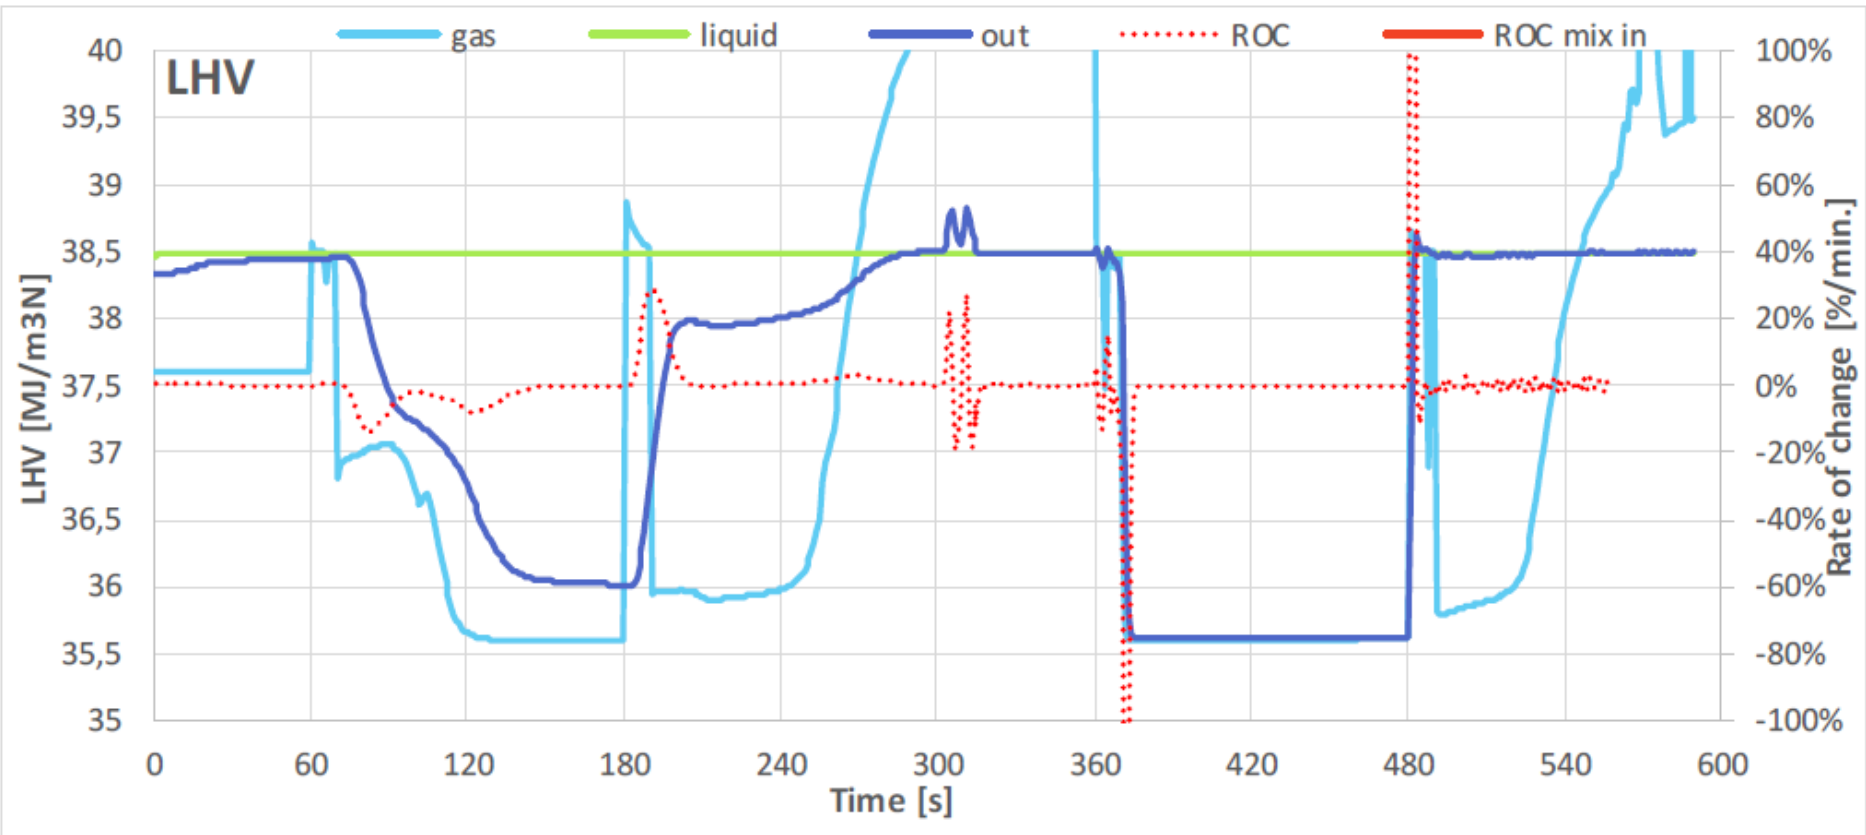
Model analyses of Lower Heating Value during operation
5% change per minute is the max for the generators
