**Conterreg Interreg Danube Transnational Programme IfelineMDD**

# River Training structures and historical mapping

Interreg LifelineMDD, Mid-term conference, 25.11.2021

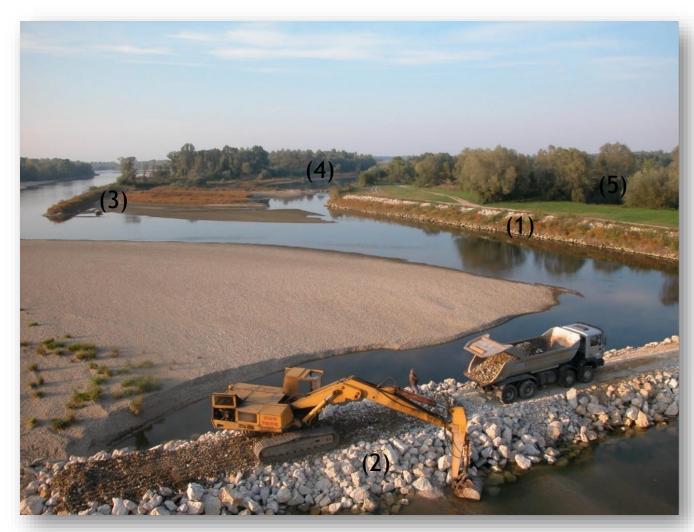
Bank reinforcements (1), groynes (2, 3), transversal fills (4) and flood dyke (5) at Drava to protect infrastructure such as bridges and settlements (Arno Mohl).

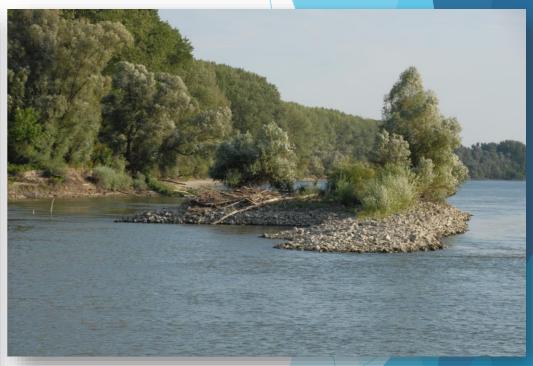
Disconnected T-Groyne in Danube for water way transport to stabilize fairway (Wolfgang Kraier).
