RADAR

O.T.3.1.e Pilot Actions on 4 (6) Road Safety Thematic Areas

TA3 ITS - HUNGARY

RADAR – Risk Assessment on Danube Area Roads

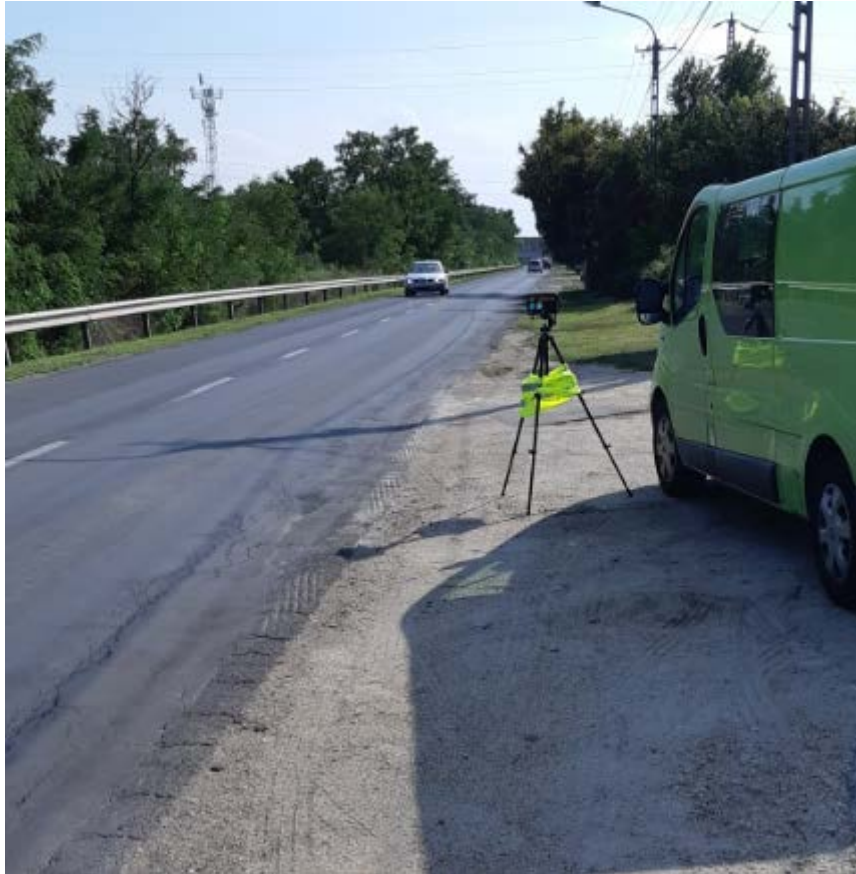
Figure 7: Using FamaLaser III to model a fixed site speed camera

According to our assumptions, the used speed camera placed at a clearly visible place near the road is appropriate for modelling fixed cameras, which are also well known and visible for the drivers, especially for those who travel at the road section regularly. The main reason of this surrogate was that it made it possible to make speed measurements at the selected road sections also without the device. Detailed introduction of the locations can be found in chapter 3.3.

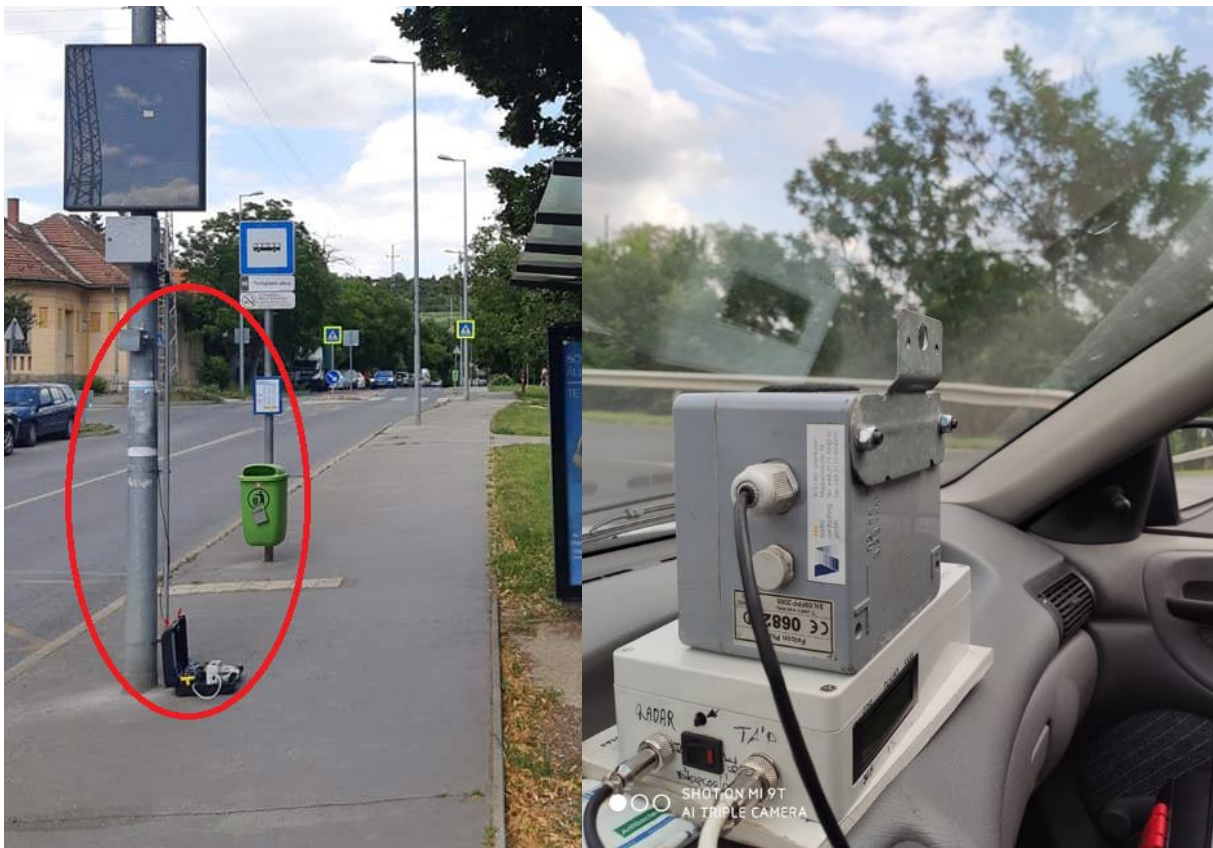
Figure 8: The measuring equipment - Falcon Plus II intelligent microwave detector

For the measurements we used a digital Falcon Plus II intelligent microwave detector with an ARM⁶ based computer (self-developed by KTI's subcontractor). The measurement principle of this detector is based on the Doppler effect. The detector unit is bouncing a microwave signal off to a desired target and analysing how the motion of the object has changed the frequency of the returned signal. Calculations of the Doppler effect accurately determine the velocity of the detected objects. Our unit has both a counting and tracking function. The equipment can also detect if the vehicle is arriving or leaving, therefore it is able to detect movement either uni- or bidirectional. During the measurement, the computer is recording the exact time and location of the measurement and the time vs. speed data continuously in microsecond intervals from the first moment the vehicle is within the range until it is detectable. Several speed samples are available for each vehicle, therefore speed vs. time or distance curves can be also generated. The radar unit is also equipped with a sophisticated communication module to provide the data remotely even during the measurement real time or afterwards.

The maximum range of the equipment is 50 meters, but can vary according to weather conditions, colour and size of the measured vehicle, etc. The equipment can detect vehicles almost up to its own location (line), therefore we considered the last measured point 1 meter away from the equipment.

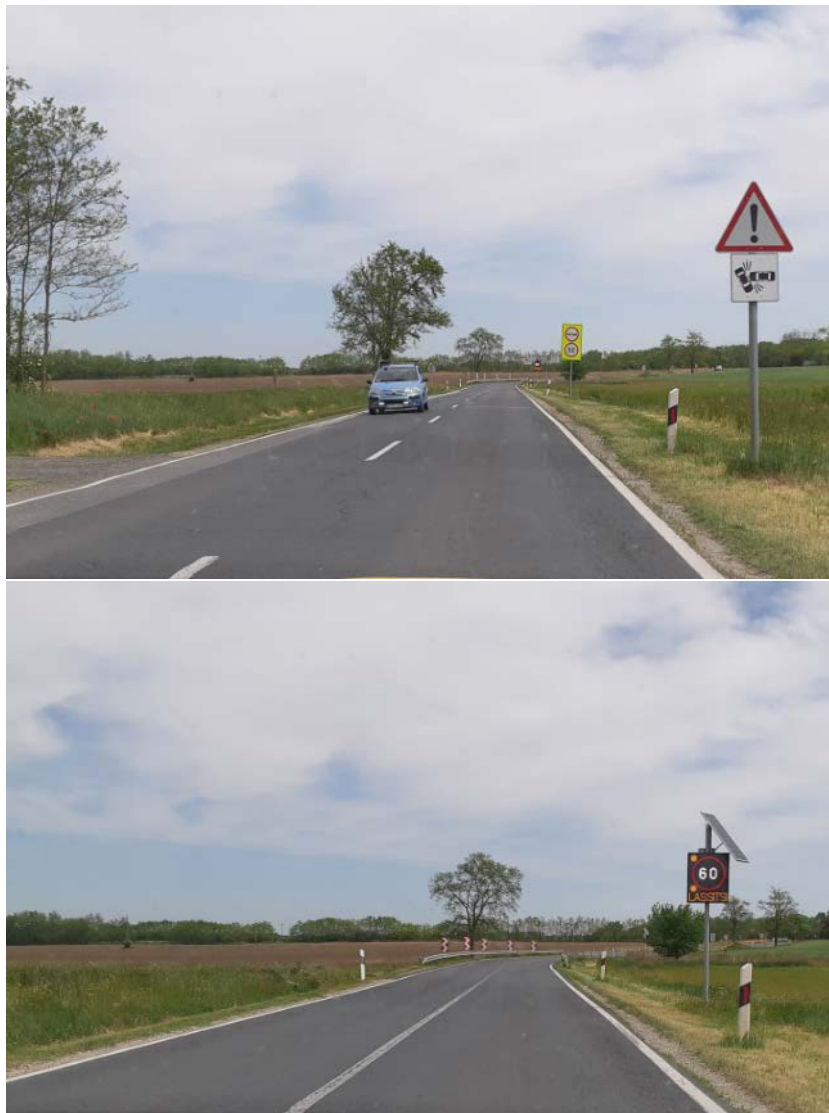
Figure 9: Measured section on road 83 with vehicle activated 60 km/h speed limit display

The measured road section is located in a rural area near the town of Győrszemere, on road 83 at the 63+360 km section. The section is on a 2x1 lane road and located before a small radius right curve. The 60 km/h speed limit board was placed there recently 60 m from the curve, in company of the 60 km/h speed limit sign 130 m from the curve. "No overtaking", "Right hand curve" and "Narrow road ahead" warning traffic signs are also placed before the curve. The "No overtaking" sign is 130 m before, the "Right hand curve" and "Narrow road ahead"

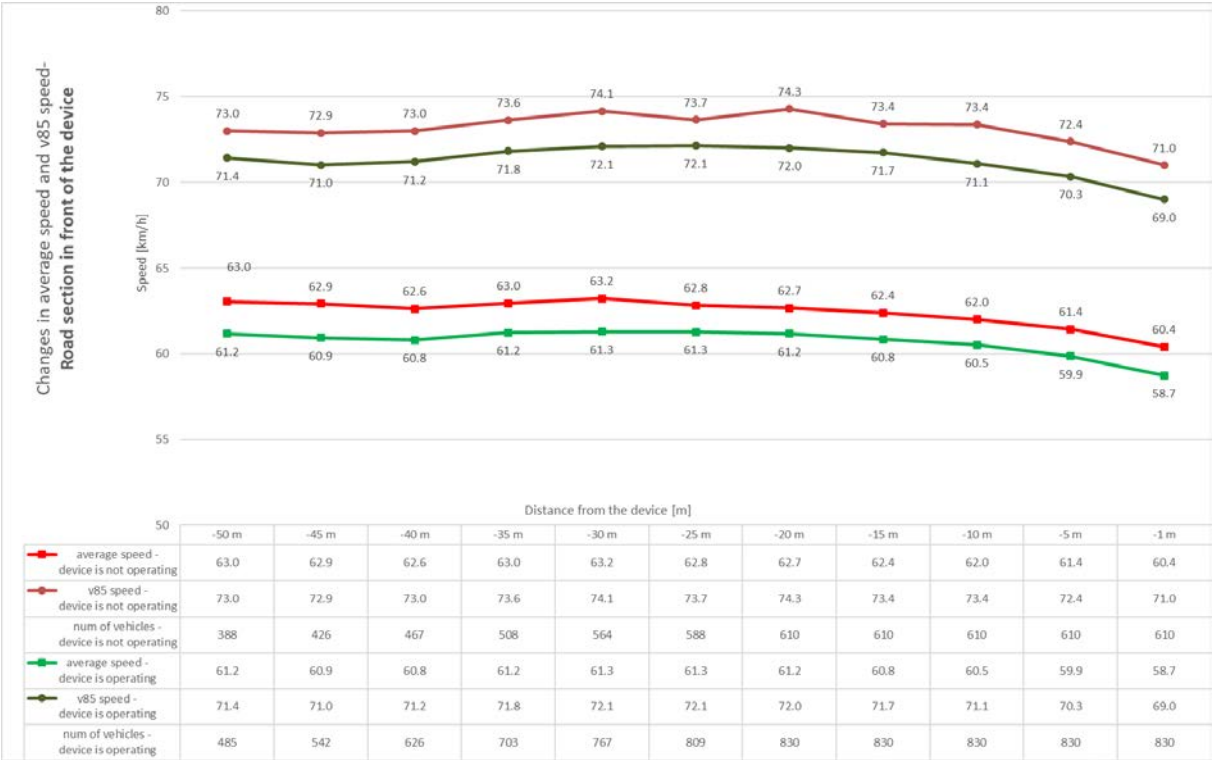
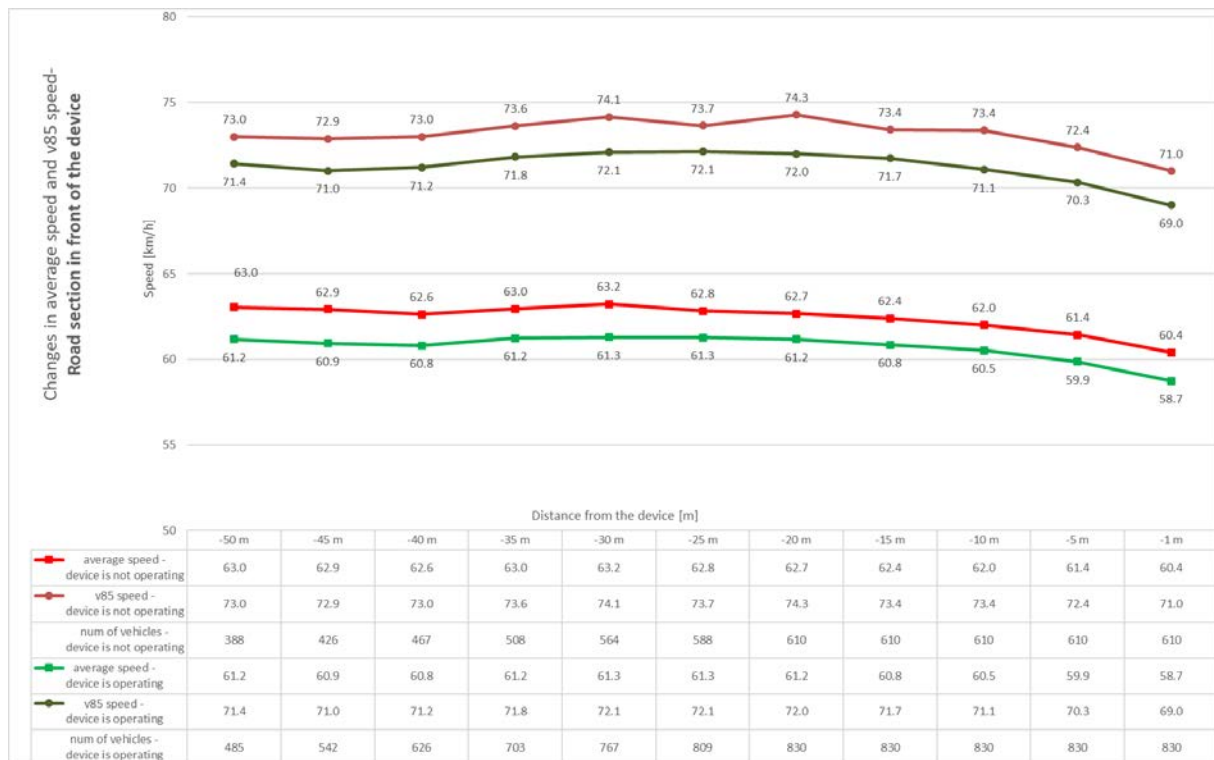
Figure 10: Average and v85 speeds in front of/behind the device- Györszemere, road 83

Values of the average and v85 speeds at different distances (both in case of the road section in front of, and behind the speed limit display) have been presented in the following Figure. Red lines indicate those cases when the device was not operating, green lines indicate data measured while the speed display was in operation. The number of measured vehicles has also been indicated.

No significant differences were found in case of the further data on driver behaviour. Most of the drivers reduced their speed (79-80%) while they were approaching the device, due to the characteristics of the road section. However, when the device was in operation, a slightly higher proportion of drivers reduced their speed. The biggest difference (3.9%) was observed in the ratio of vehicles reducing speed by at least 6 km/h, among the drivers who exceeded the speed limit at the first measured point. However, it should also be noted that in case of the operating state of the device, the proportion of vehicles increasing speed when leaving the line of the display was higher. Compared to the non-operating state, this suggests that there were drivers who only slowed down/drove at a lower speed until the line of the device, and they accelerated after passing it.

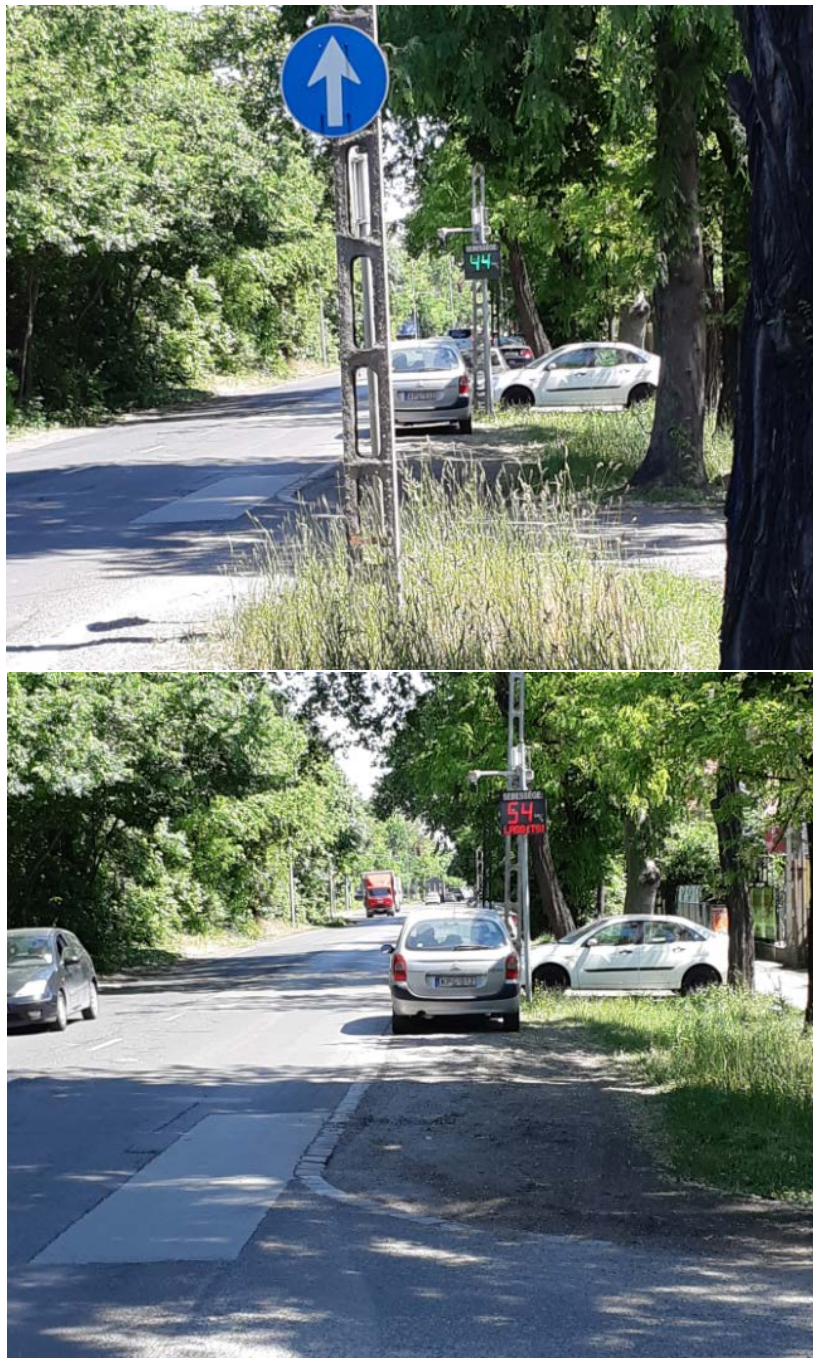
Figure 11: Határ road with vehicle activated speed warning sign

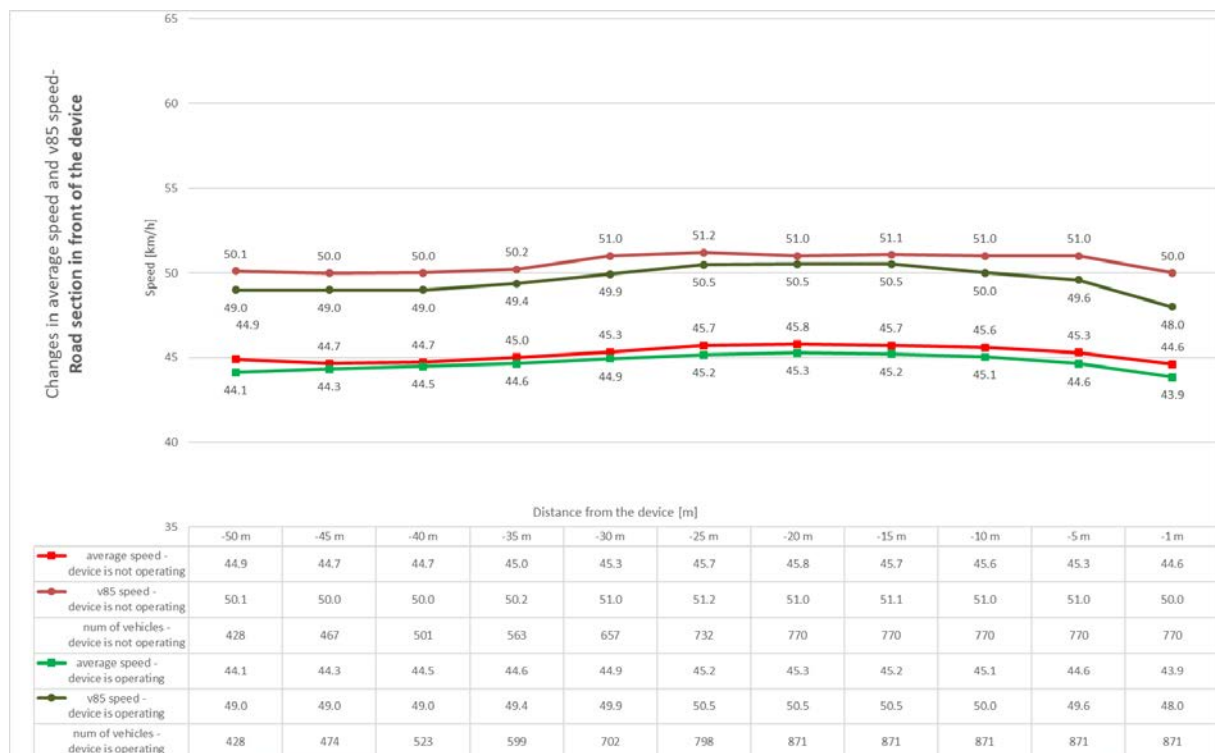
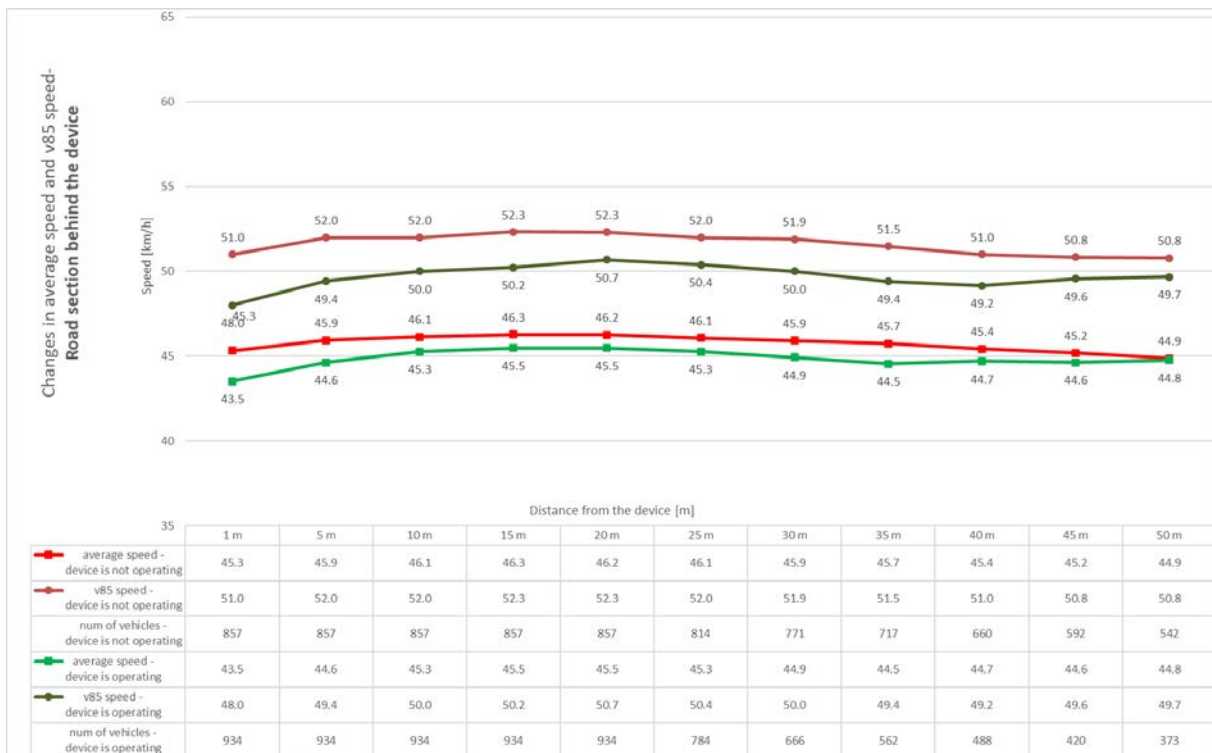
Figure 12: Average and v85 speeds in front of/behind the device- Budapest, Határ road

Values of the average and v85 speeds at different distances (both in case of the road section in front of, and behind the speed display) have been presented in the following Figure. Red lines indicate those cases when the device was not operating, green lines indicate data measured while the speed display was in operation. The number of measured vehicles has also been indicated.

At this location, there wasn't any factor (a sharp curve, pedestrian crossing, etc.) influencing traffic at the measured road section (except for the vehicle activated speed display). We can see that the average and v85 speeds were fairly constant both 50 meters in front of, and 50 meters behind the device. However, the biggest difference in the shape of the red and green curves can be observed at the line of the speed display (at 1 m, and -1 m), where speeds were lower when the device was operating. Note that in this case, the speeds were increasing behind the device, reaching the same (or even slightly higher) speed level that was measured 50 meters in front of the device.

The main differences of the observed data from the previous location may be explained also by the following facts: due to higher traffic level, speeding is less common here. Furthermore, the drivers may see their own speed on the display only late due to traffic, so the speed reducing effect of the device arises later, only at the line of the display. These assumptions are also supported by the data of the following table. While the proportion of speeding vehicles was 25-50% at the rural road, this value ranged between 9 and 22% in this downtown section. The ratio of vehicles exceeding the speed limit was 4-8% lower in the different sections when the speed display was operating.

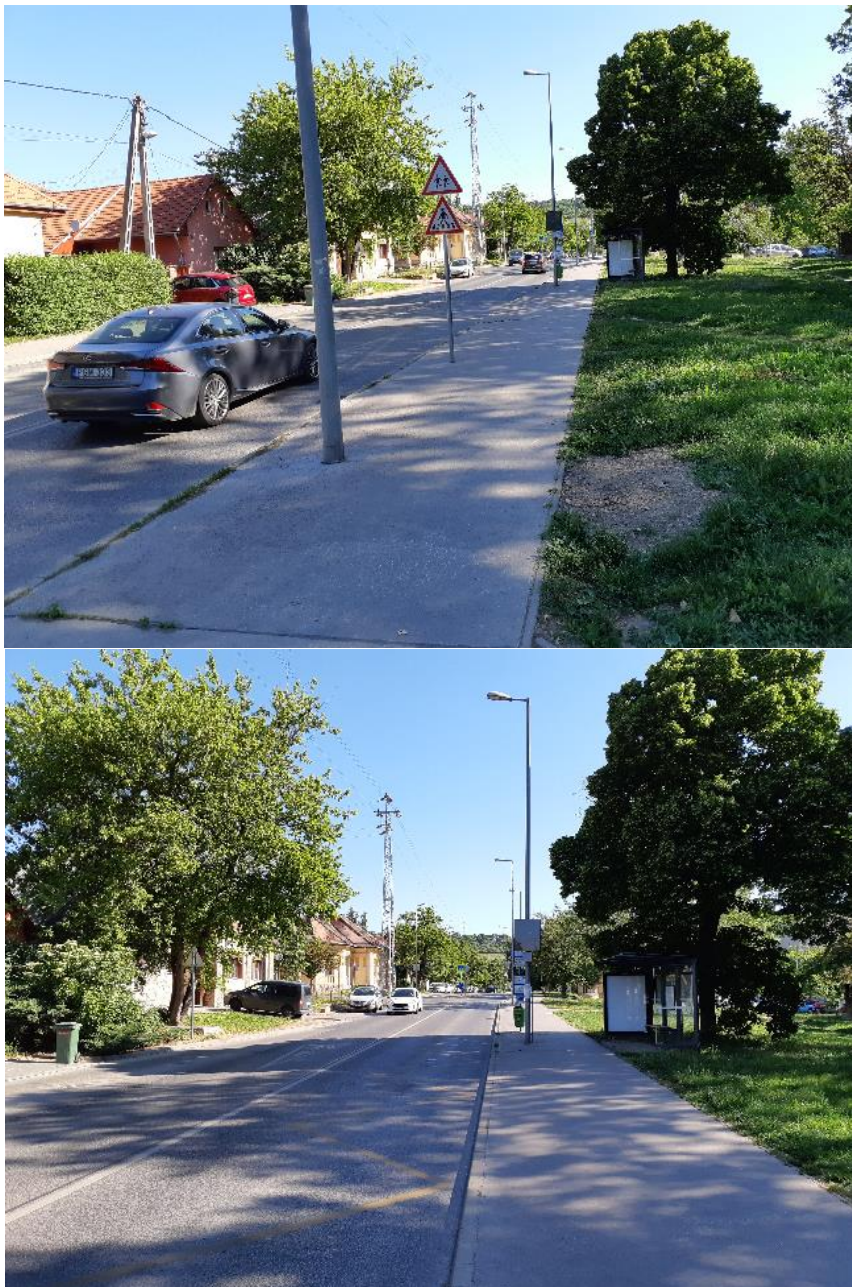
Figure 13: Measured section in Ezüsthely street with vehicle activated speed warning sign

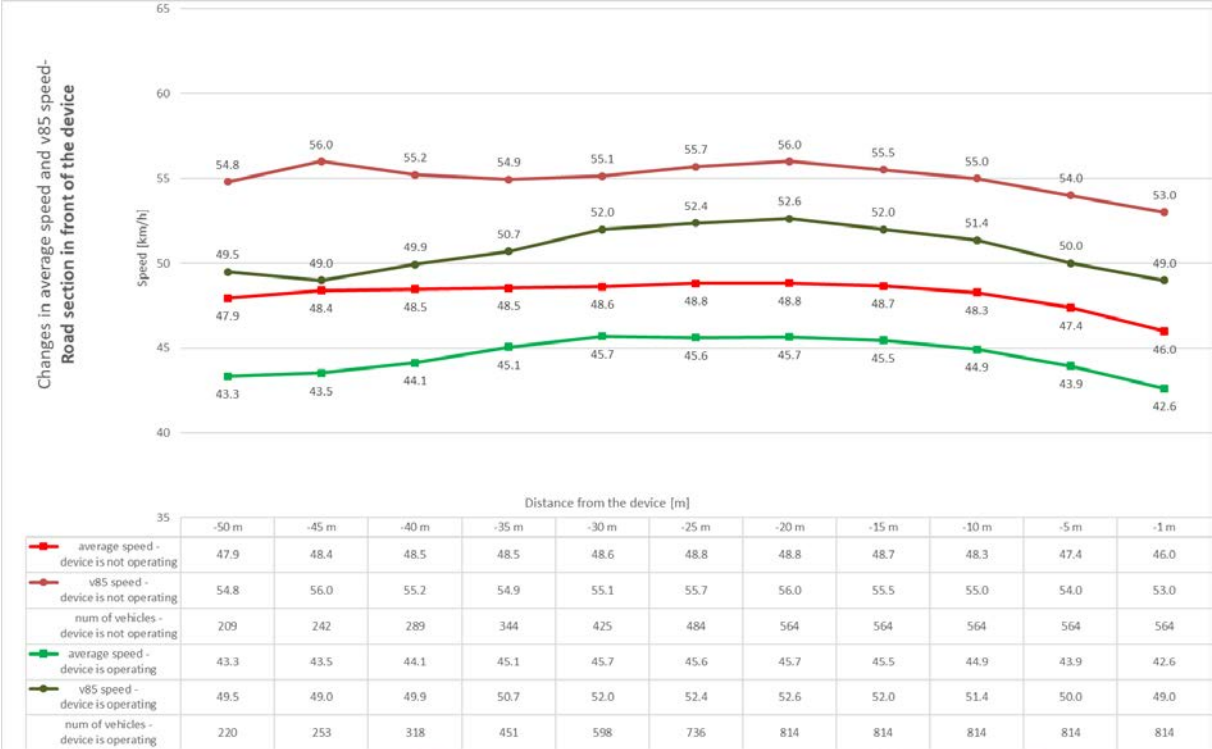
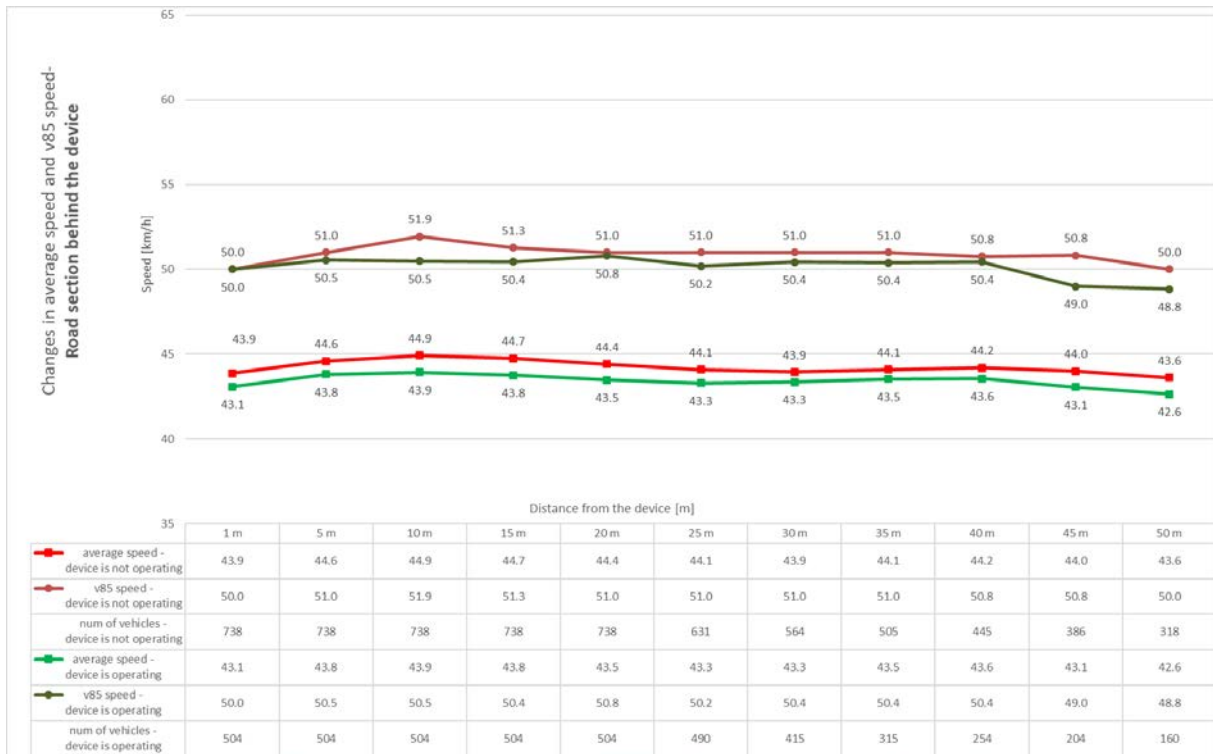
Figure 14: Average and v85 speeds in front of/behind the device- Budapest, Ezüsthely street

Values of the average and v85 speeds at different distances (both in case of the road section in front of, and behind the speed limit display) have been presented in the following Figure. Red lines indicate those cases when the device was not operating, green lines indicate data measured while the display was in operation. The number of measured vehicles has also been indicated.

At this location, average speeds were lower than, and v85 speeds were somewhat over the speed limit. Compared to the previous locations, the difference between speeds beside the operating/non-operating state of the speed limit sign was bigger. The v85 and average speeds were 3-7 km/h lower when the speed limit display was in operation. The biggest difference could be observed at about 40-50 meters in front of the device.

We can conclude that, because of lower traffic level, the average and v85 speeds were somewhat higher here than in case of the other measured urban section (Határ road). In parallel we found that the effect of the vehicle activated speed limit sign was higher. The significant speed reducing effect (especially at 40-50 meters in front of the device) can also be seen based on the data of the following tables.

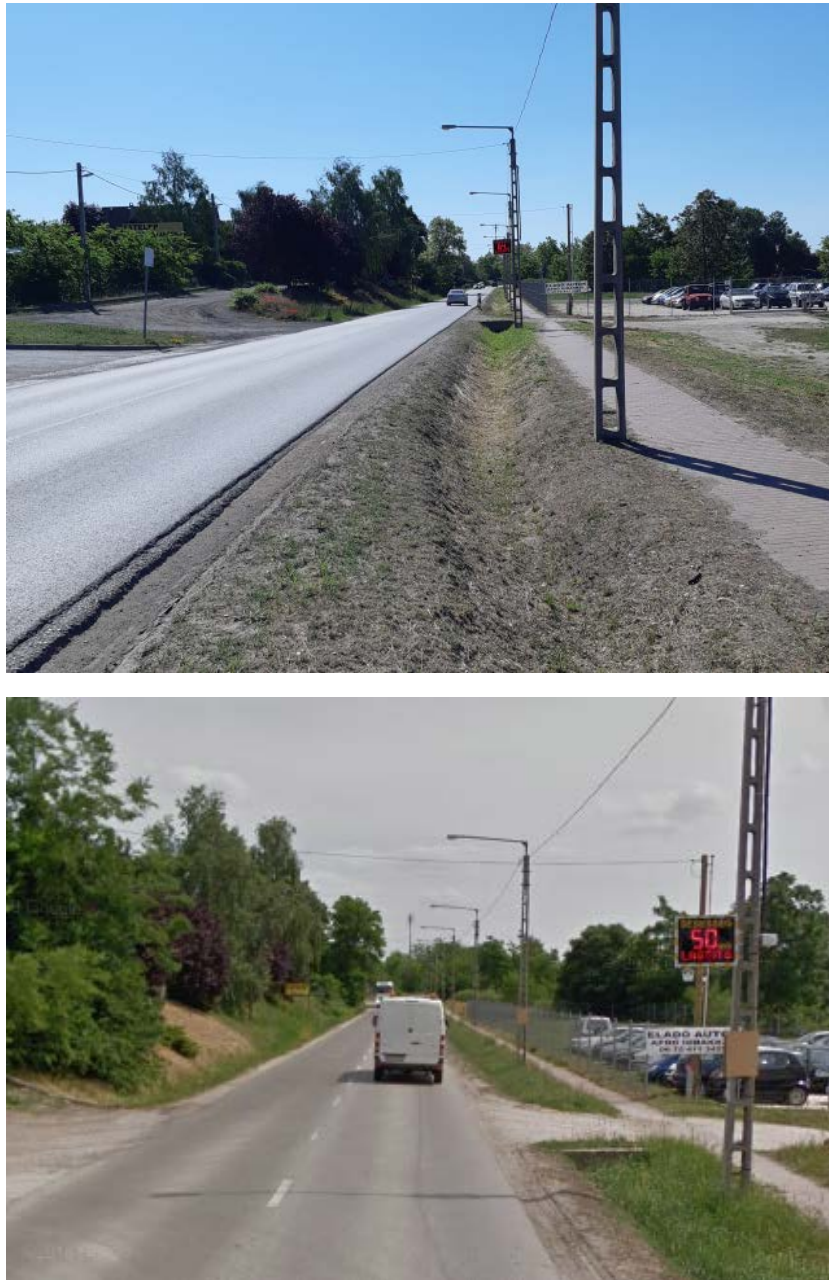
Figure 15: Órbottyán (road 2104) with vehicle activated speed warning sign

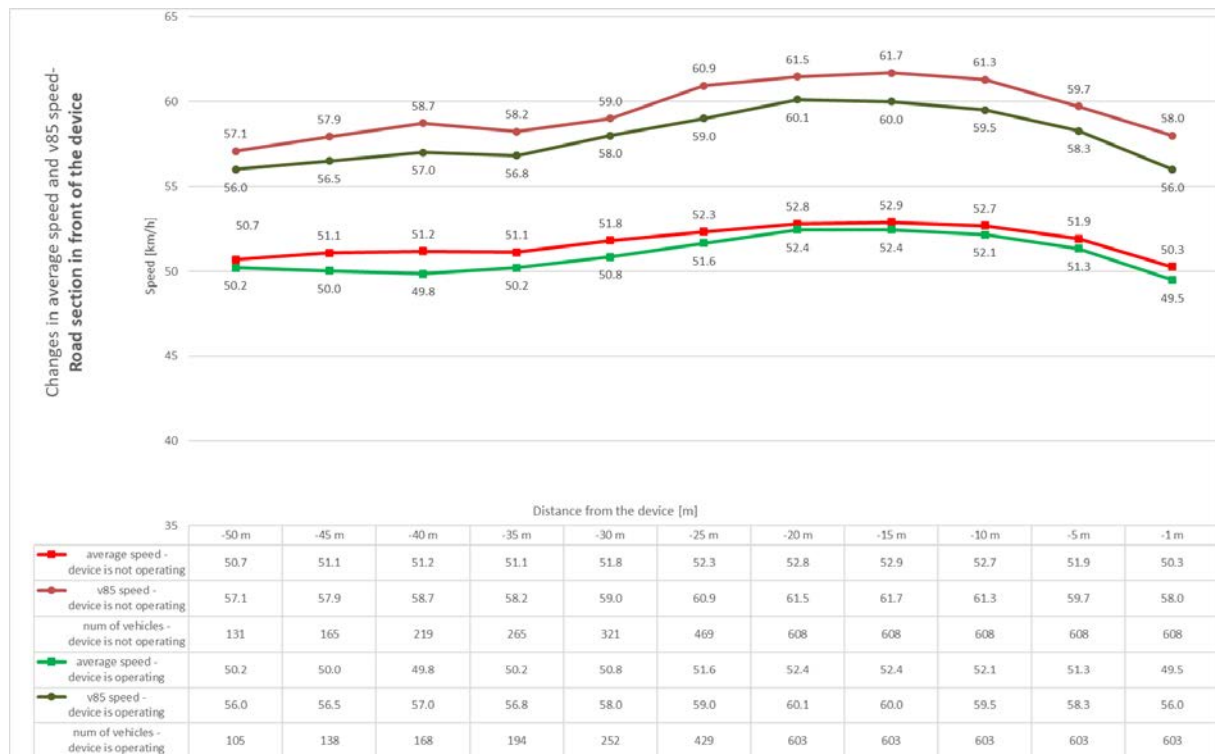
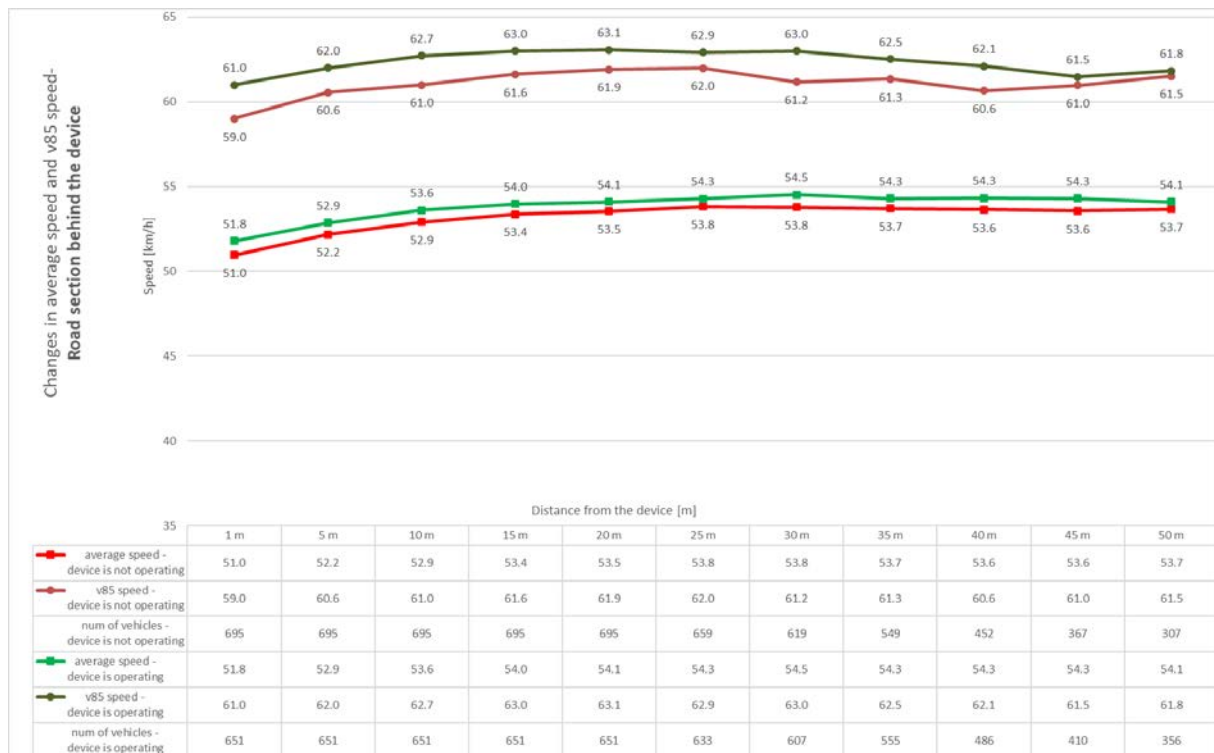
Figure 16: Average and v85 speeds in front of/behind the device- Órbottyán, road 2104

Values of the average and v85 speeds at different distances (both in case of the road section in front of, and behind the speed display device) have been presented in the following Figure. Red lines indicate those cases when the device was not operating, green lines indicate data measured while the speed display was in operation. The number of measured vehicles has also been indicated.

Similar to the results of Határ road, only a very slight speed reduction was observed here (speeds were 1-1.5 km/h lower when the vehicle activated speed display was operating), even though the average and v85 speeds were high compared to the previous two urban road sections. There was no significant difference in the shape of the curves, in both the operating and non-operating states of the device, the vehicles slightly increased speed at the measured first 30 meters, and then reduced it until the line of the device. In case of vehicles leaving the device, speeds in case of the operating state of the device were higher than in the other case. These values suggest that this device (placed inside the city border but close, with an environment that shows rural territorial character) had only very limited effect on vehicle speeds.

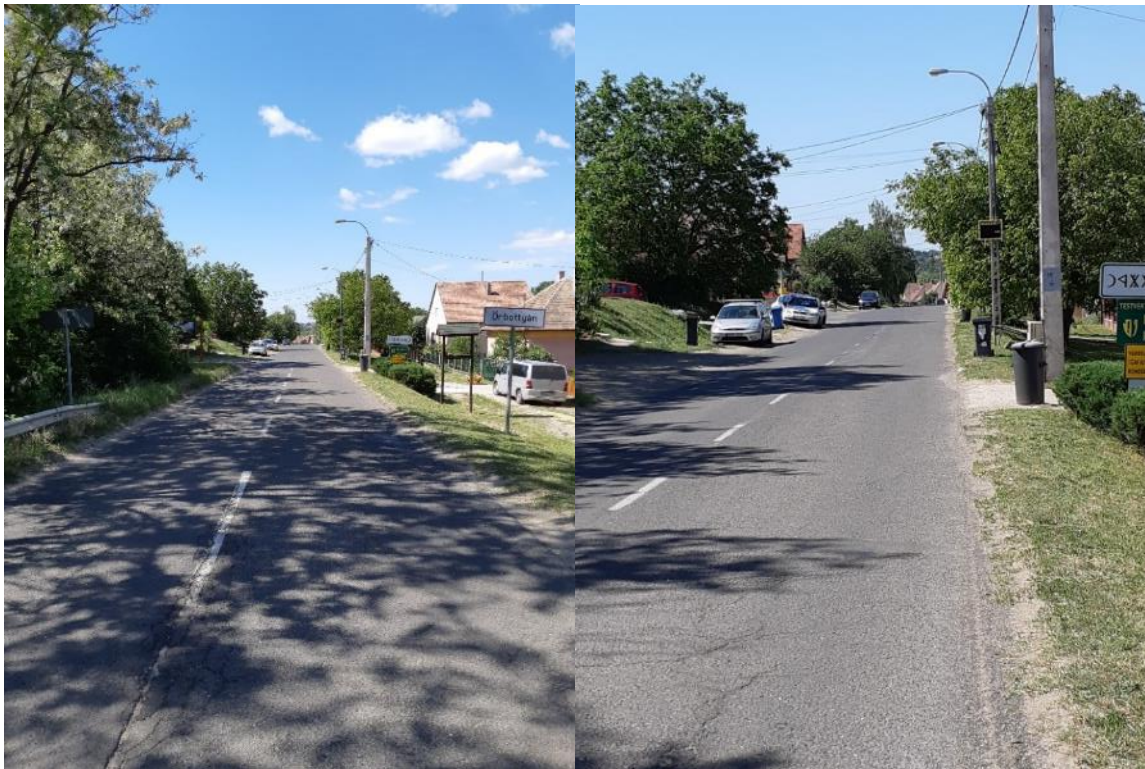
Figure 17: Órbottyán (road 2103) with vehicle activated speed warning sign

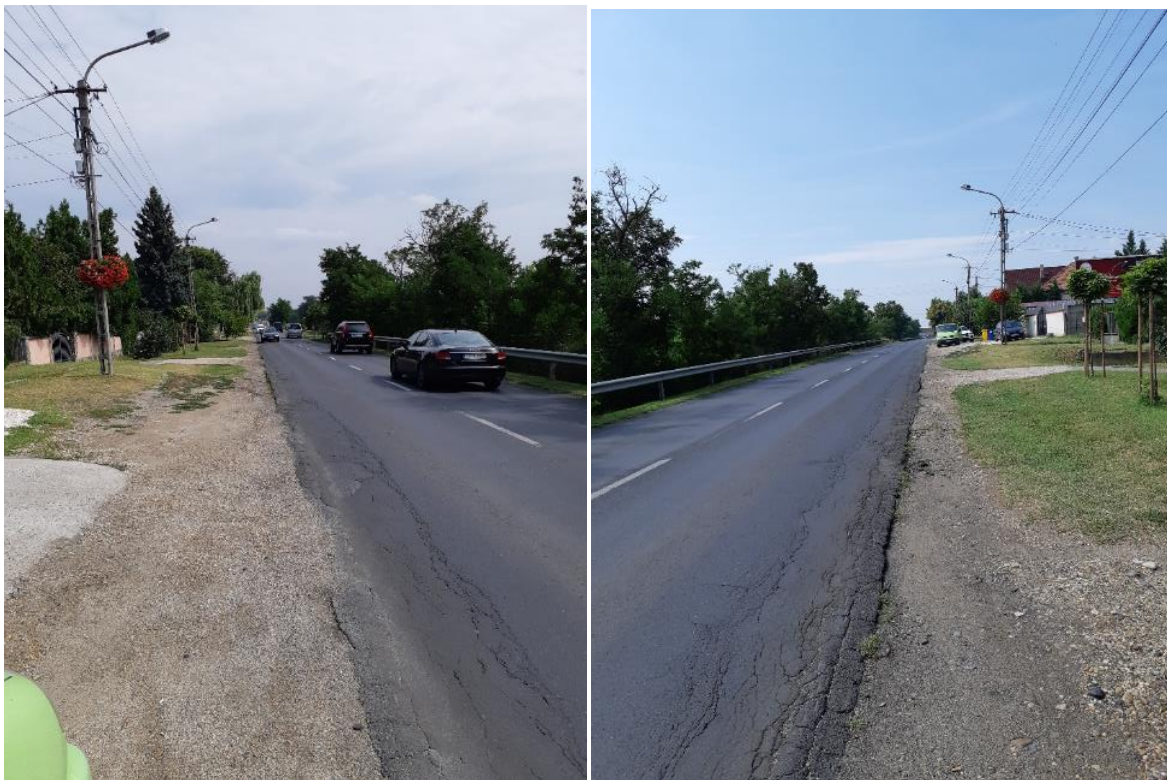
Figure 19: Measured section in Dunaharaszti

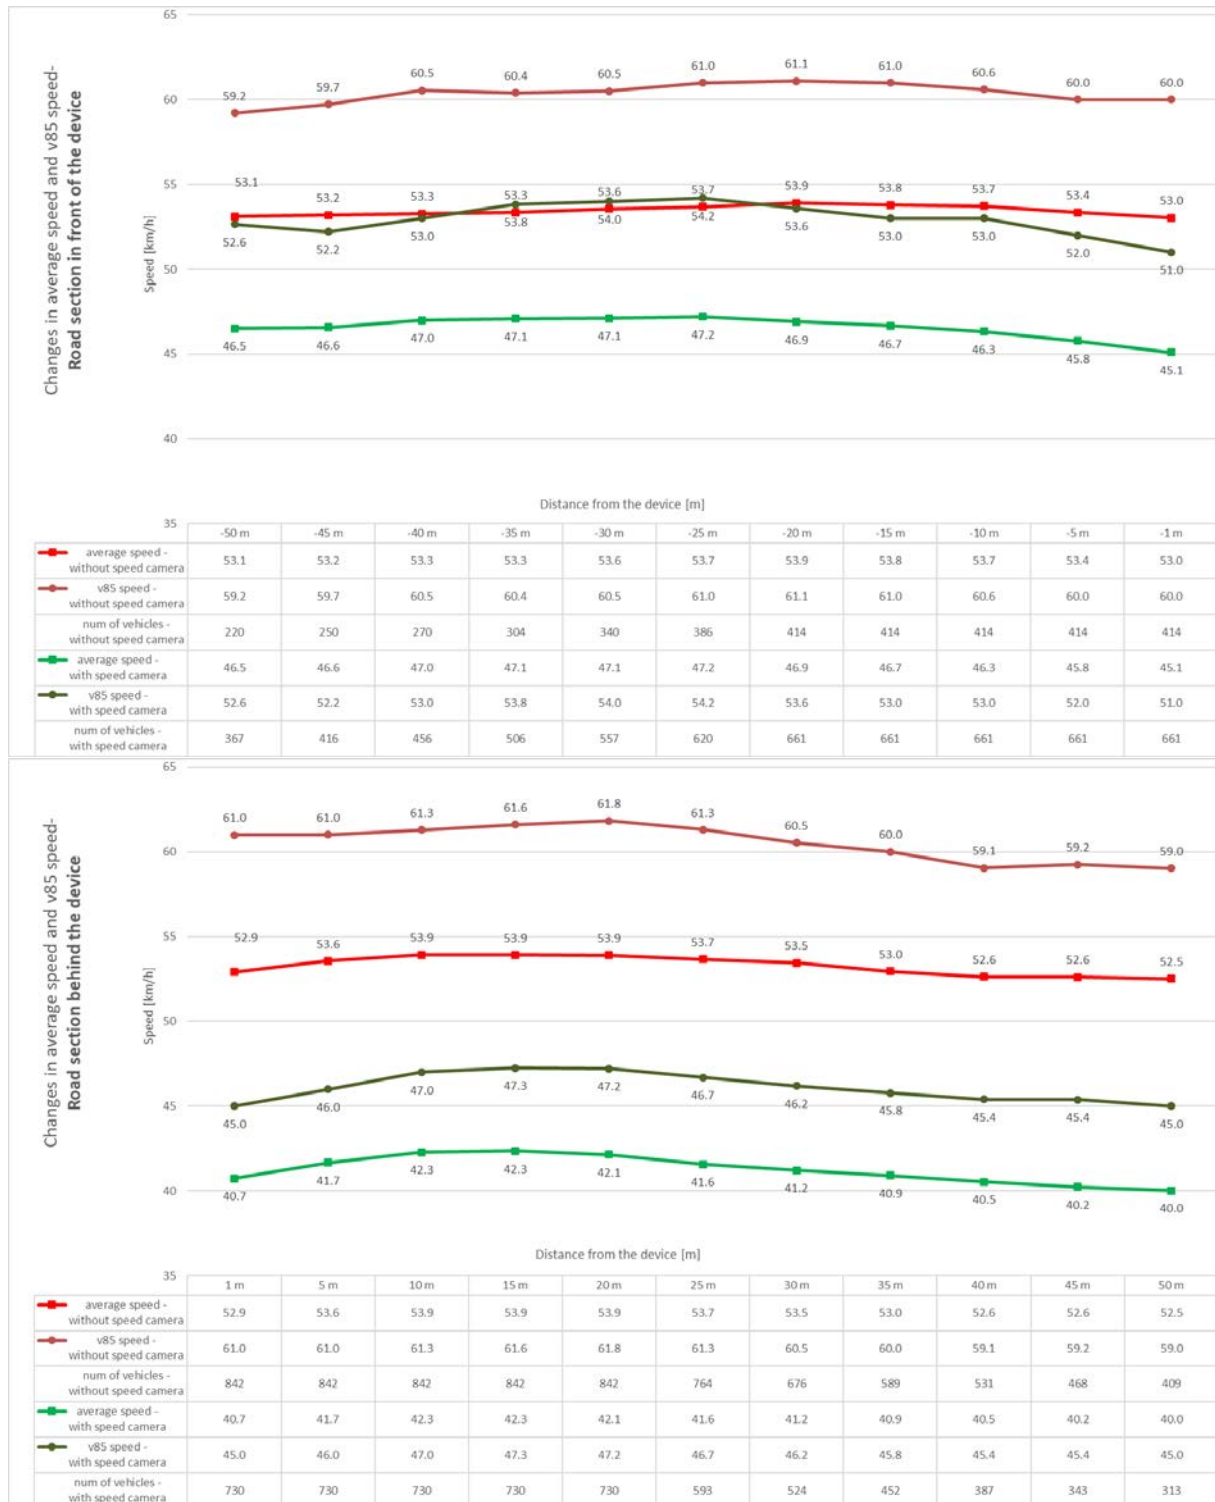
Figure 20: Average and v85 speeds in front of/behind the speed camera- Dunaharaszti, road 510

Values of the average and v85 speeds at different distances (both in case of the road section in front of, and behind the speed camera) have been presented in the following Figure. Red lines indicate those cases when the speed camera was not placed on the roadside, green lines indicate data measured while the speed camera was placed there. The number of measured vehicles has also been indicated.

The differences could be observed also 50 meters in front of the device, indicating that the speed reducing effect arise more than 50 meters away. However, while the average speed was constant in the measured section in front of the device without the speed camera, a 2km/h speed reduction could be observed from -25 meters until the line of the camera in the other case.

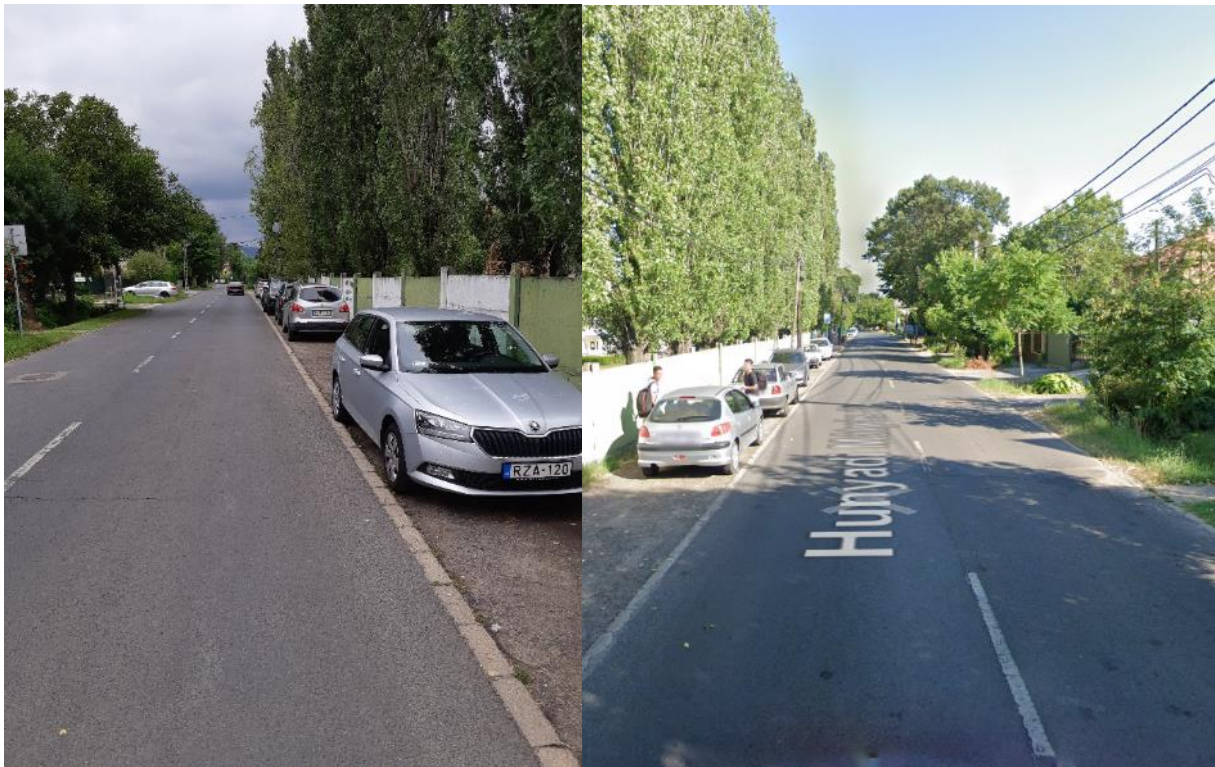
Figure 21: Measured section in Budapest, Hunyadi Mátyás street

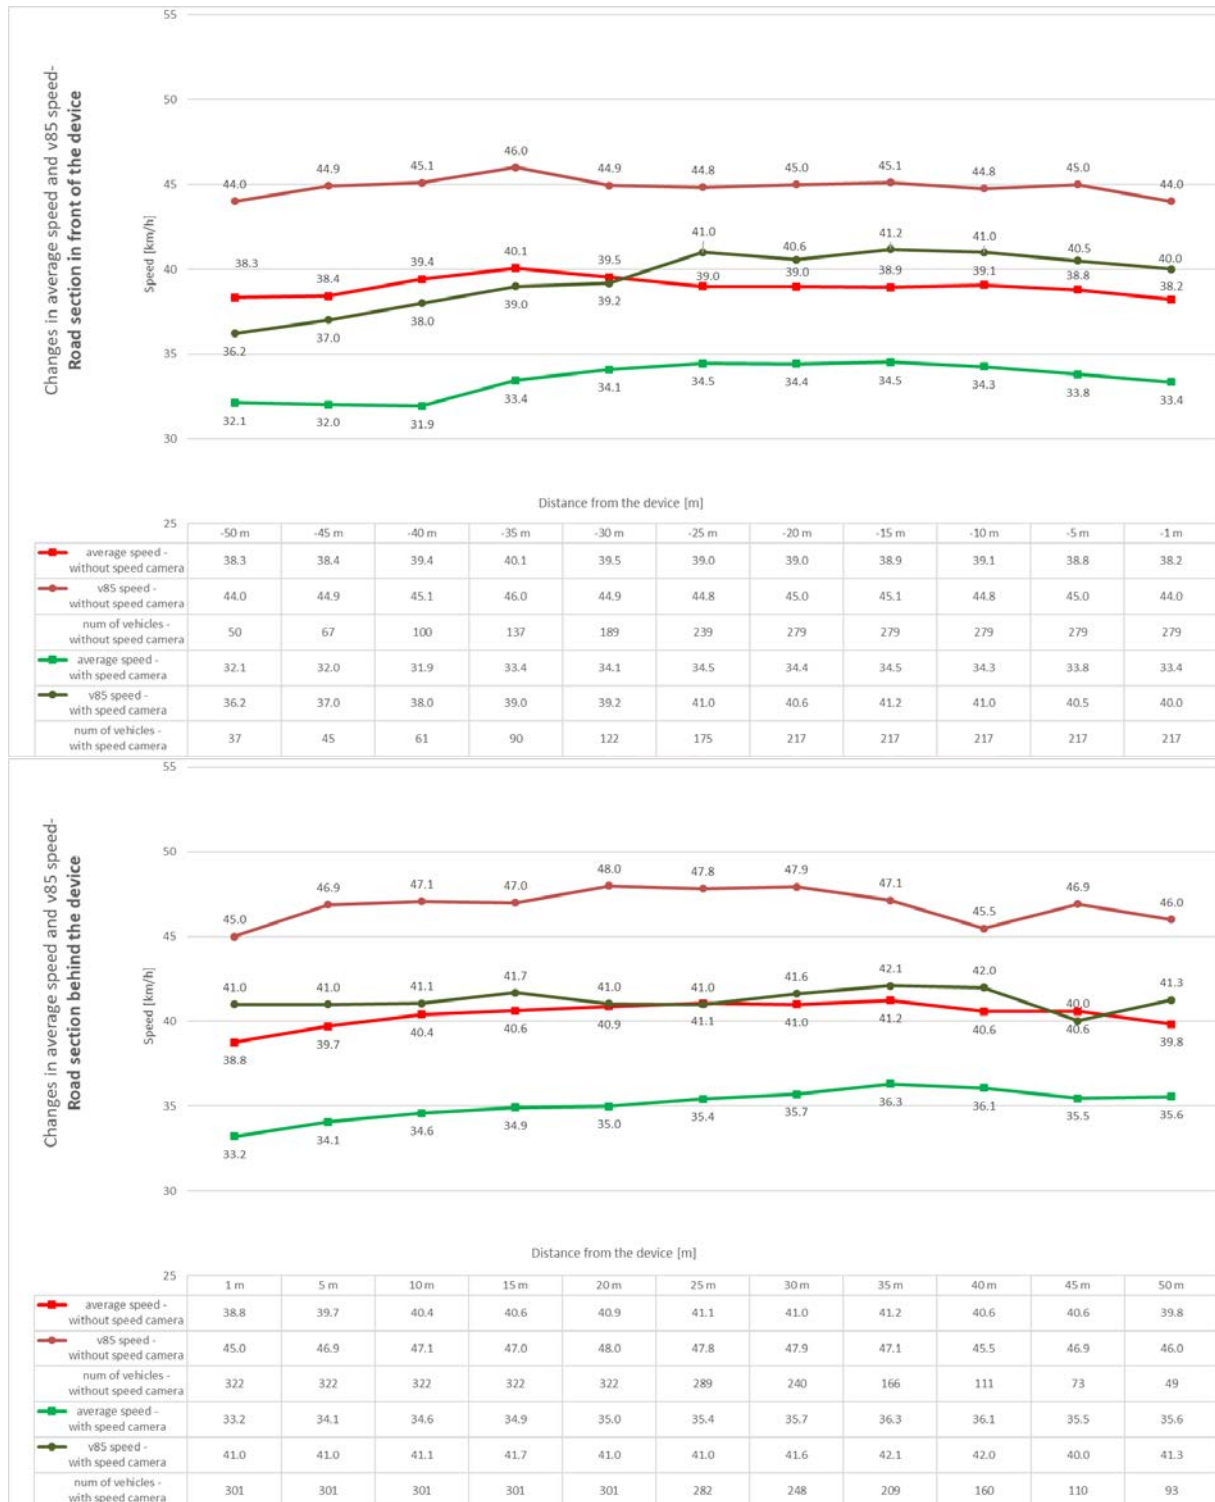
Figure 22: Average and v85 speeds in front of/behind the speed camera- Budapest, Hunyadi Mátyás street

Values of the average and v85 speeds at different distances (both in case of the road section in front of, and behind the speed camera) have been presented in the following Figure. Red lines indicate those cases when the speed camera was not placed on the roadside, green lines indicate data measured while the speed camera was placed there. The number of measured vehicles has also been indicated.

The differences could be observed here also in the first measured points also, indicating that the speed reducing effect arise more than 50 meters away. No difference in the shape of the red and green curves was found here investigating the 30-meter-long section in front of the device.
