RADAR

O.T.3.1.e Pilot Actions on 4 (6) Road Safety Thematic Areas

TA3 ITS - HUNGARY

RADAR – Risk Assessment on Danube Area Roads

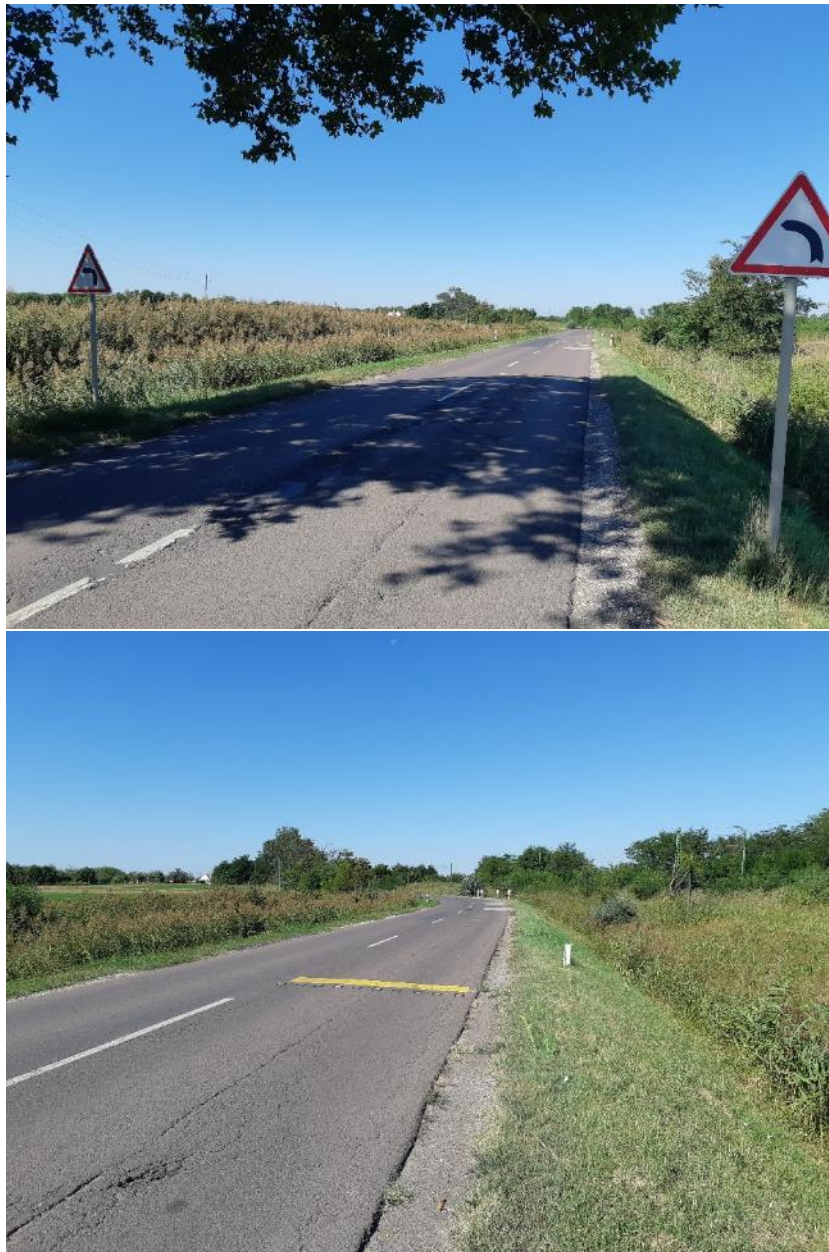
Figure 23: Area of Pilot Action 1 near Cegléd, on road 40 – 1. direction

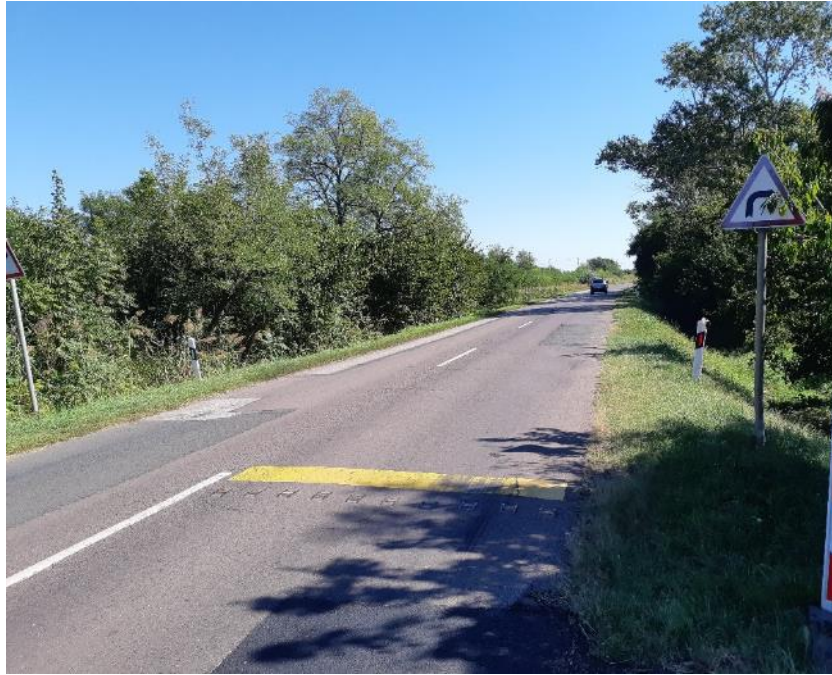
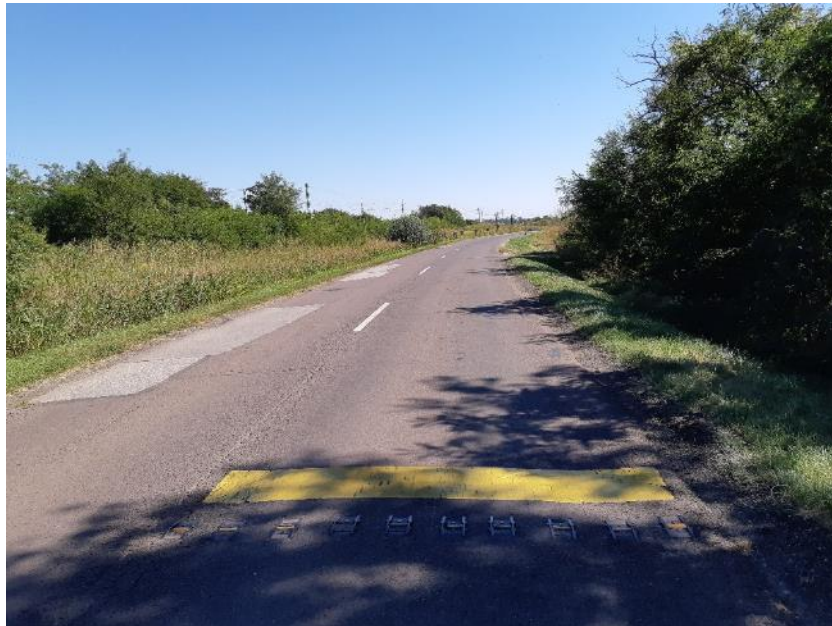
Figure 24: Area of Pilot Action 1 near Cegléd, on road 40 – 2. direction

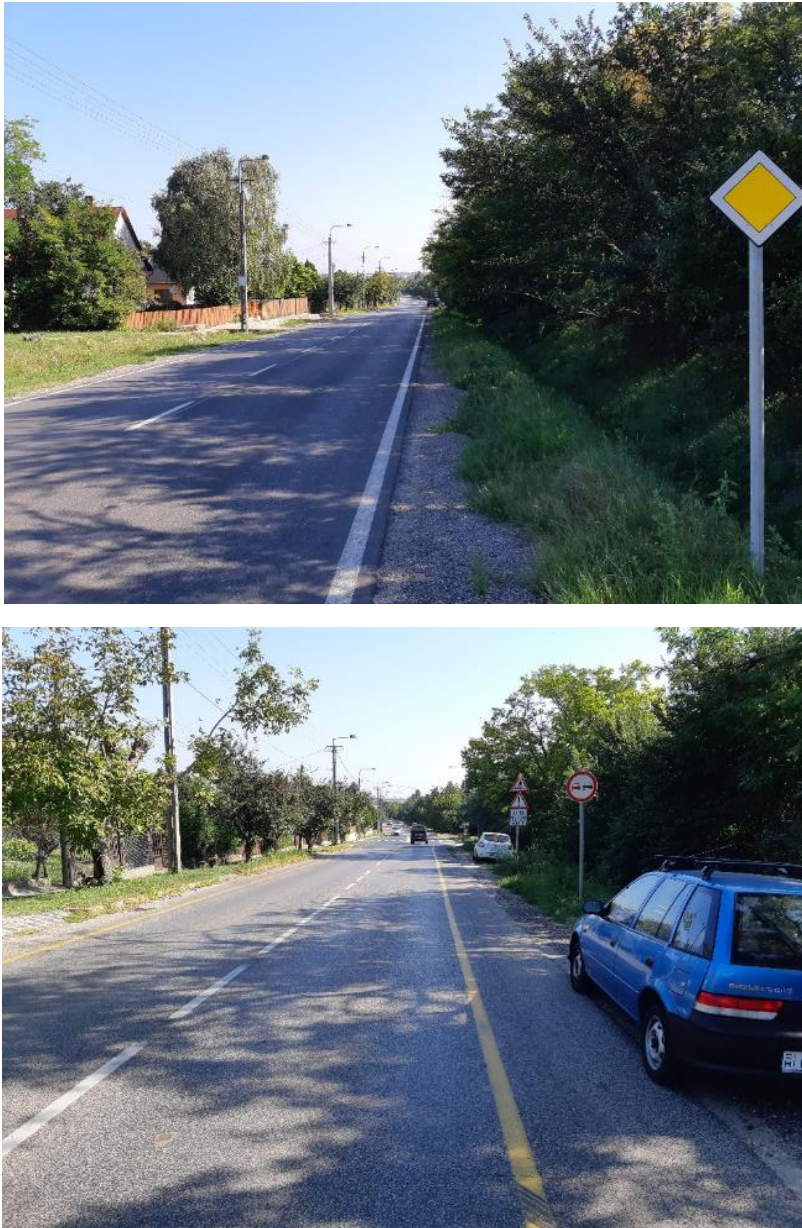
Figure 25: Area of Pilot Action 2 at Martonvásár, on road 7

found starting after the planned cross section of the fixed speed camera. These are “No overtaking” (33+490 km section), “Pedestrian crossing” and “Other danger – refuge island” (33+475 km section) traffic signs due to a pedestrian crossing nearby (33+422 km section). The pedestrian peak-hour flow is around 12-15 across the road.

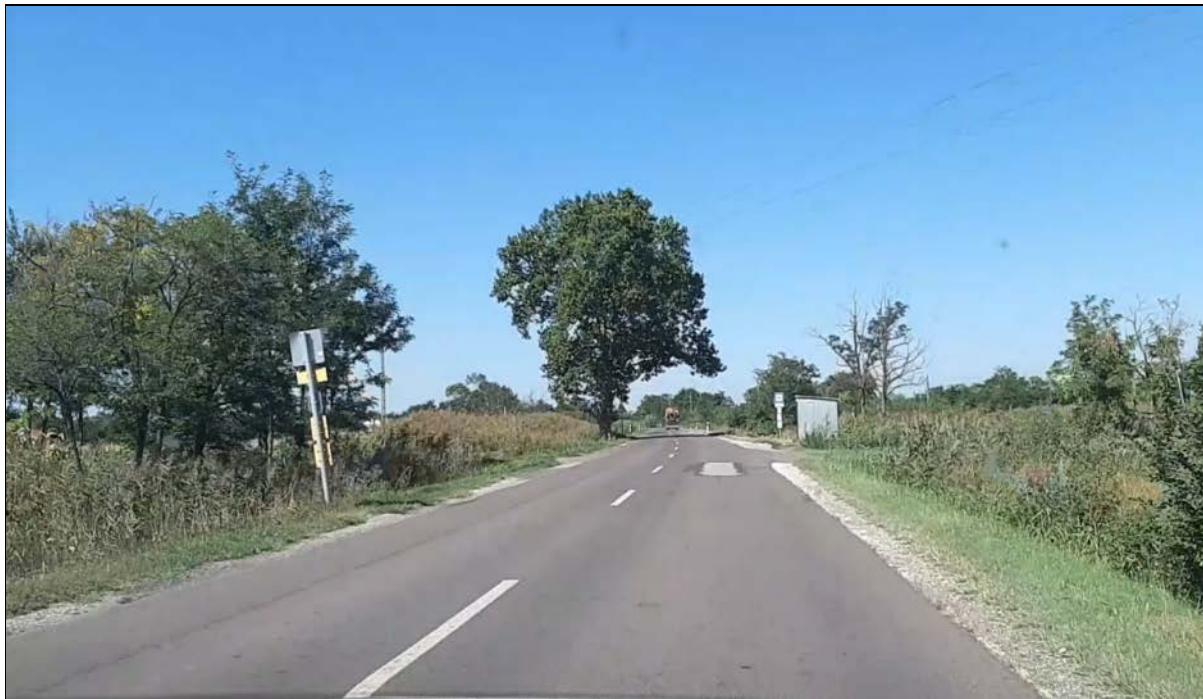
Table 25: Star Rating Scores and coded attributes – Pilot Action 1; road 40; between 27+710 -27+610 km sections

SRS – BEFORE COUNTERMEASURES IMPLEMENTATION

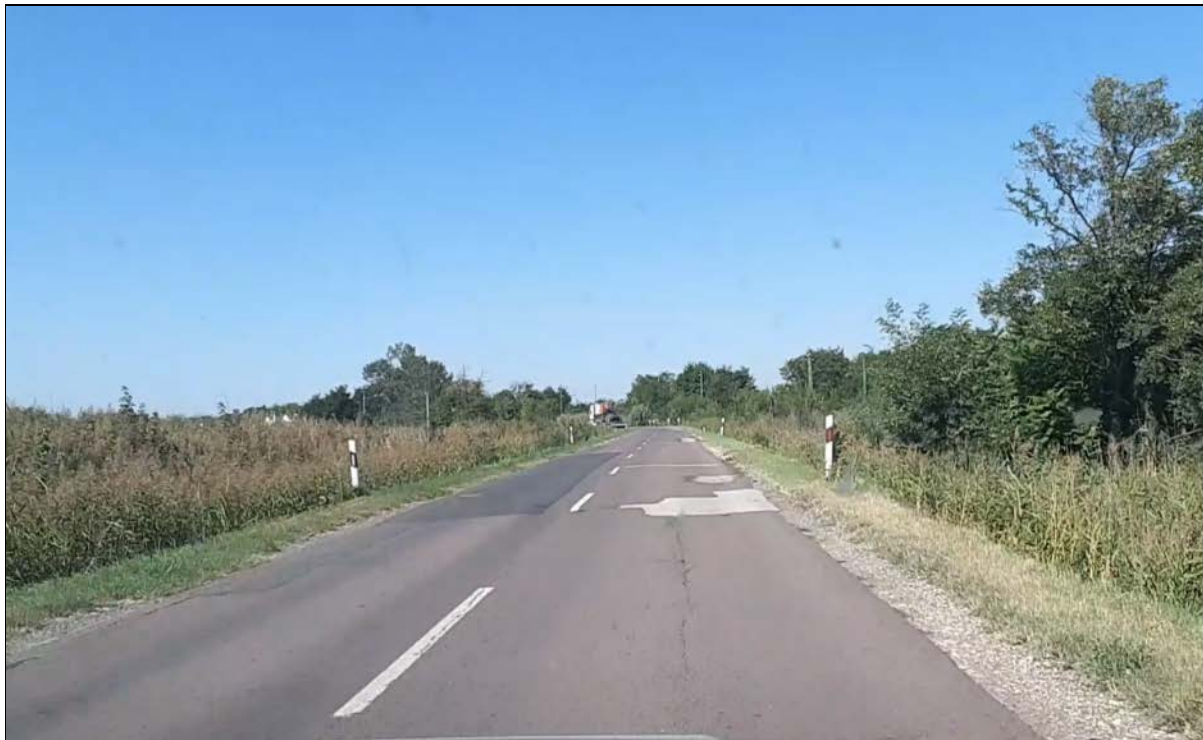
Table 27: Star Rating Scores and coded attributes – Pilot Action 1; road 40; between 27+510 -27+410 km sections

SRS – BEFORE COUNTERMEASURES IMPLEMENTATION

Attribute Group	Before	After
ROADSIDE ATTRIBUTES		
Paved shoulder - driver-side	None	Medium ($\geq 1\text{ m}$ to $< 2.4\text{ m}$)
Paved shoulder - passenger-side	None	Medium ($\geq 1\text{ m}$ to $< 2.4\text{ m}$)
MIDBLOCK ATTRIBUTES		
Road condition	Medium	Good
Skid resistance / grip	Sealed - medium	Sealed - adequate
SPEEDS		
Speed limit	90 km/h	60 km/h
Operating Speed (85th percentile)	85 km/h	70 km/h
Operating Speed (mean)	75 km/h	60 km/h

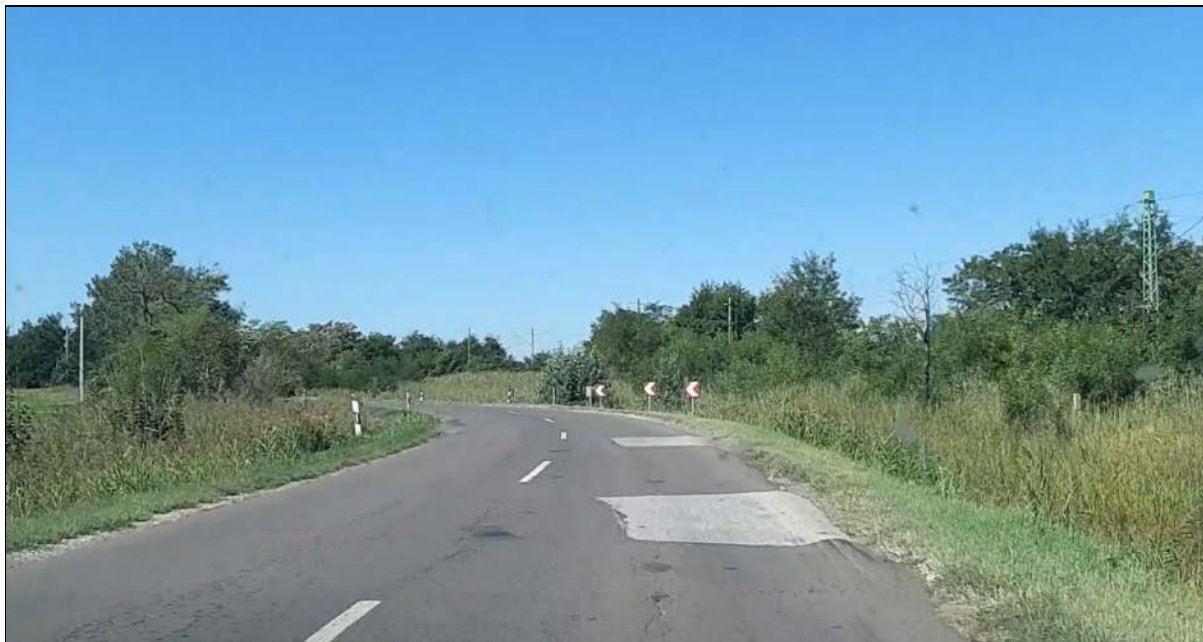
Table 28: Star Rating Scores and coded attributes – Pilot Action 1; road 40; between 27+410 -27+310 km sections

SRS – BEFORE COUNTERMEASURES IMPLEMENTATION

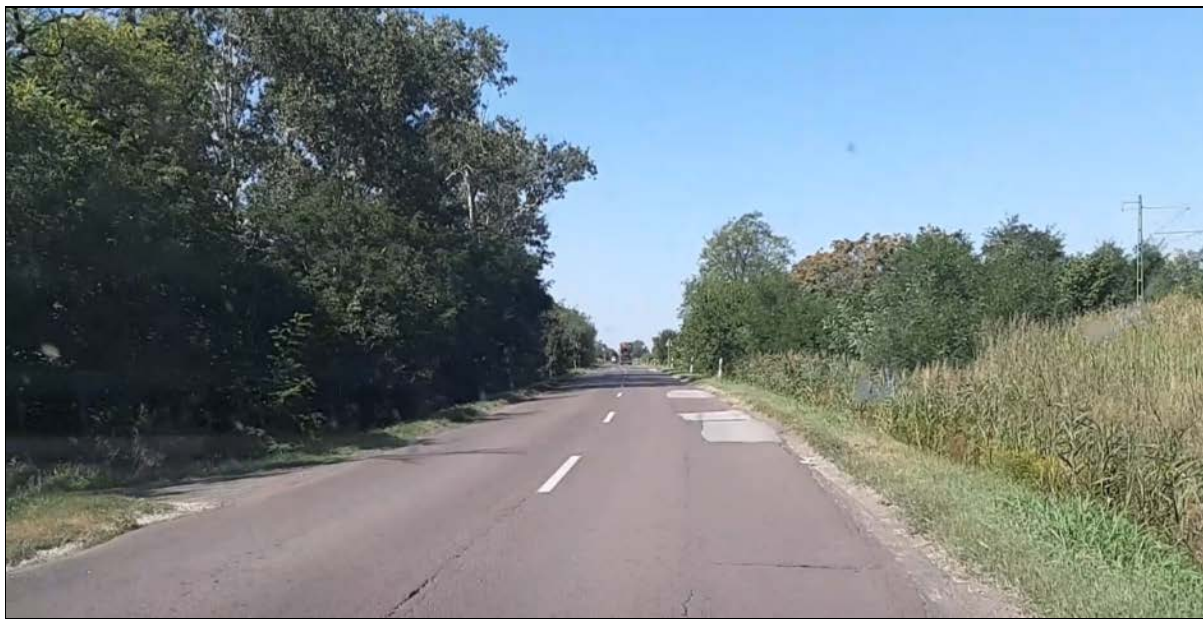
Table 29: Star Rating Scores and coded attributes – Pilot Action 1; road 40; between 27+310 -27+210 km sections

SRS – BEFORE COUNTERMEASURES IMPLEMENTATION

Attribute Group	Before	After
ROADSIDE ATTRIBUTES		
Paved shoulder - driver-side	None	Medium ($\geq 1\text{m}$ to $< 2.4\text{m}$)
Paved shoulder - passenger-side	None	Medium ($\geq 1\text{m}$ to $< 2.4\text{m}$)
MIDBLOCK ATTRIBUTES		
Road condition	Medium	Good
Skid resistance / grip	Sealed - medium	Sealed - adequate
SPEEDS		
Speed limit	90 km/h	60 km/h
Operating Speed (85th percentile)	85 km/h	70 km/h
Operating Speed (mean)	75 km/h	60 km/h

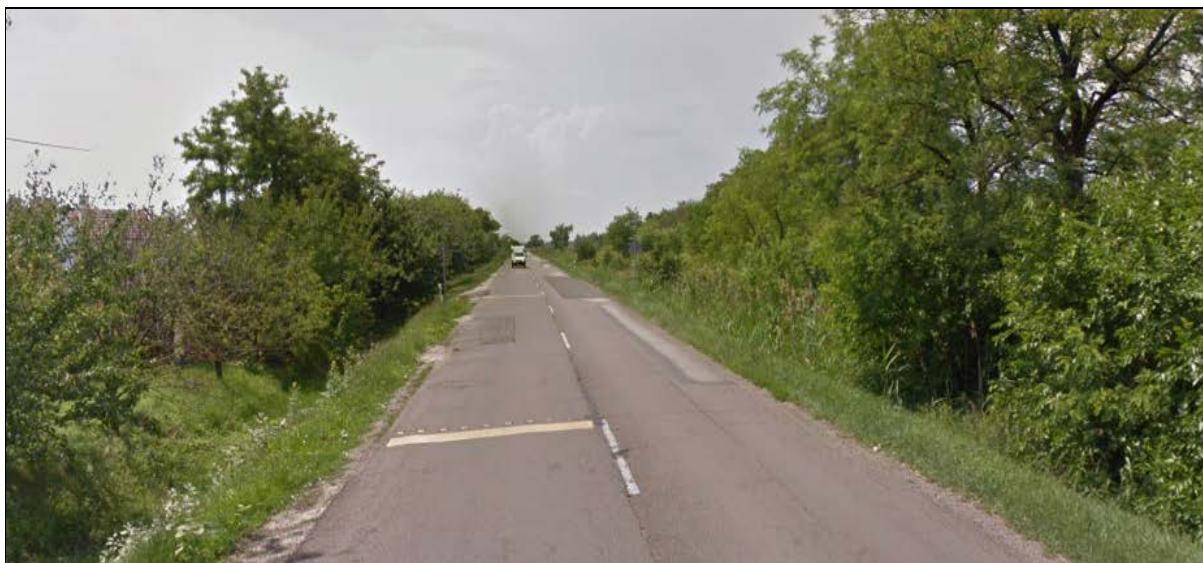
Table 30: Star Rating Scores and coded attributes – Pilot Action 1; road 40; between 27+210 -27+110 km sections

SRS – BEFORE COUNTERMEASURES IMPLEMENTATION

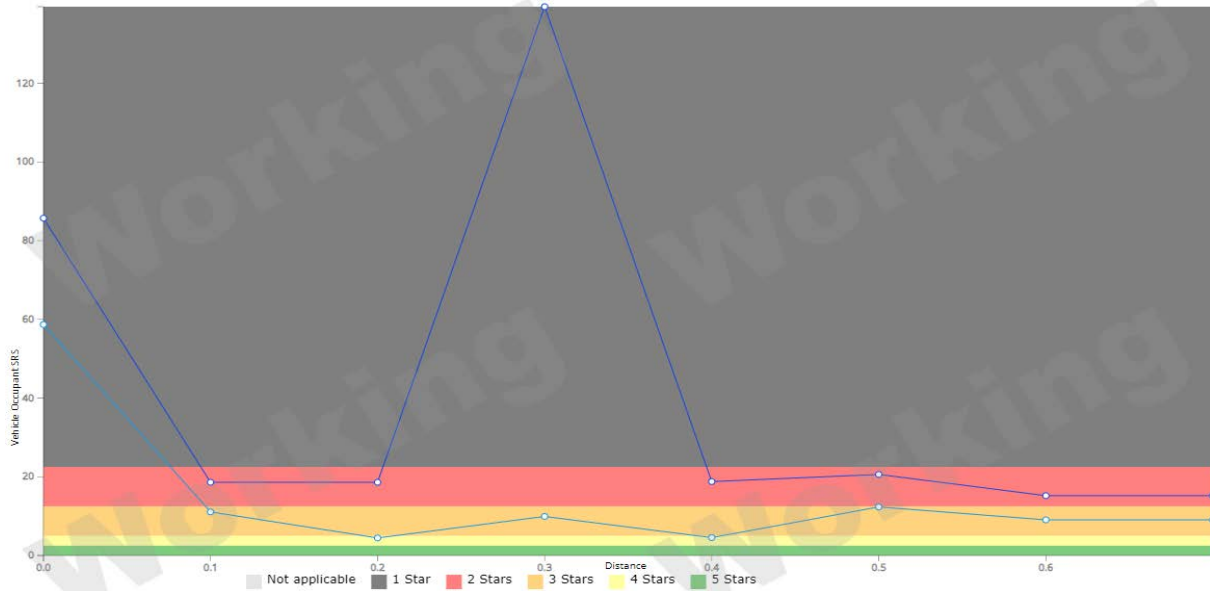
Figure 26: Risk Worm - Pilot Action 1; road 40; between 27+010 -27+710 km sections (direction 2: 0.0-0.1 of the diagram means 27+610-27+710 km section; 0.1-0.2 is 27+510-27+610 km section, etc.)

As can be seen on the charts, the proposed Pilot Action could improve the SRS of the selected road section effectively. The changes are well highlighted and summarized in the following “Risk Worm” diagram (dark blue line: Vehicle occupant SRS before Pilot Action; light blue line: Vehicle occupant SRS after Pilot Action).

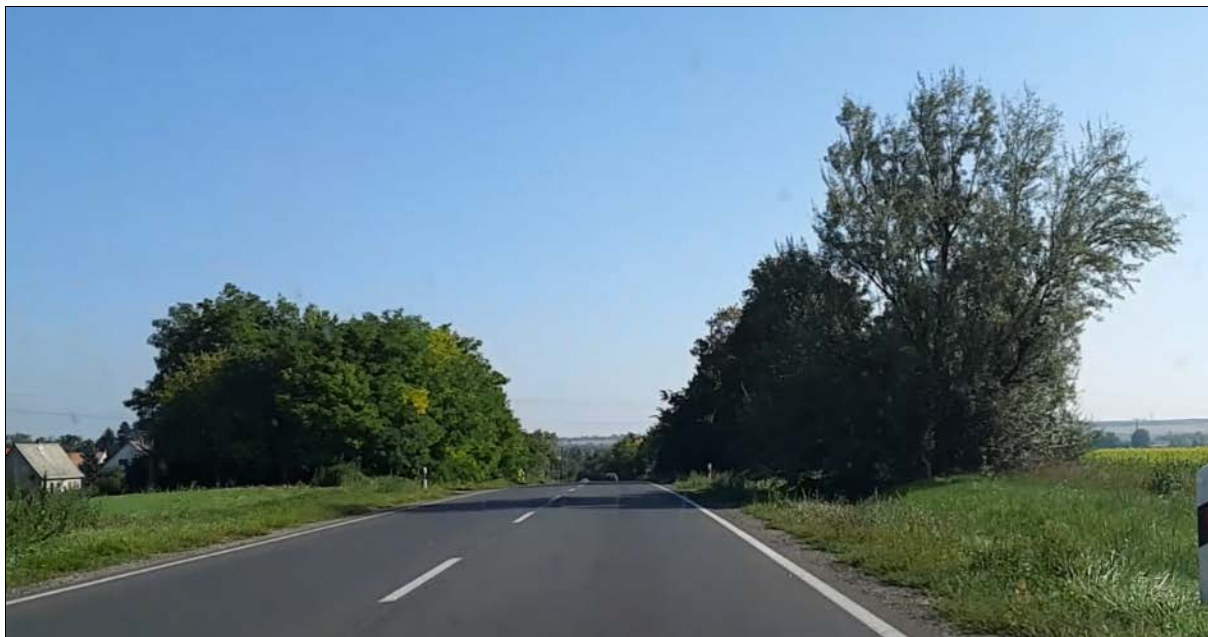
Table 33: Star Rating Scores and coded attributes – Pilot Action 2; road 7; between 33+830 -33+730 km sections

SRS – BEFORE COUNTERMEASURES IMPLEMENTATION

Area type	Rural/open area	Rural/open area
Pedestrian crossing facilities - inspected road	No facility	No facility
Pedestrian crossing quality	Not applicable	Not applicable
Pedestrian crossing facilities - intersecting road	No Facility	No Facility
Pedestrian fencing	Not present	Not present
Sidewalk - driver-side	None	None
Sidewalk - passenger-side	None	None
Facilities for motorised two wheelers	None	None
Facilities for bicycles	None	None
School zone warning	Not applicable	Not applicable
School zone crossing supervisor	Not applicable	Not applicable
SPEEDS		
Speed limit	90 km/h	90 km/h
Differential speed limits	Not present	Not present
Speed management / traffic calming	Not present	Not present
Operating Speed (85th percentile)	85 km/h	85 km/h
Operating Speed (mean)	75 km/h	75 km/h

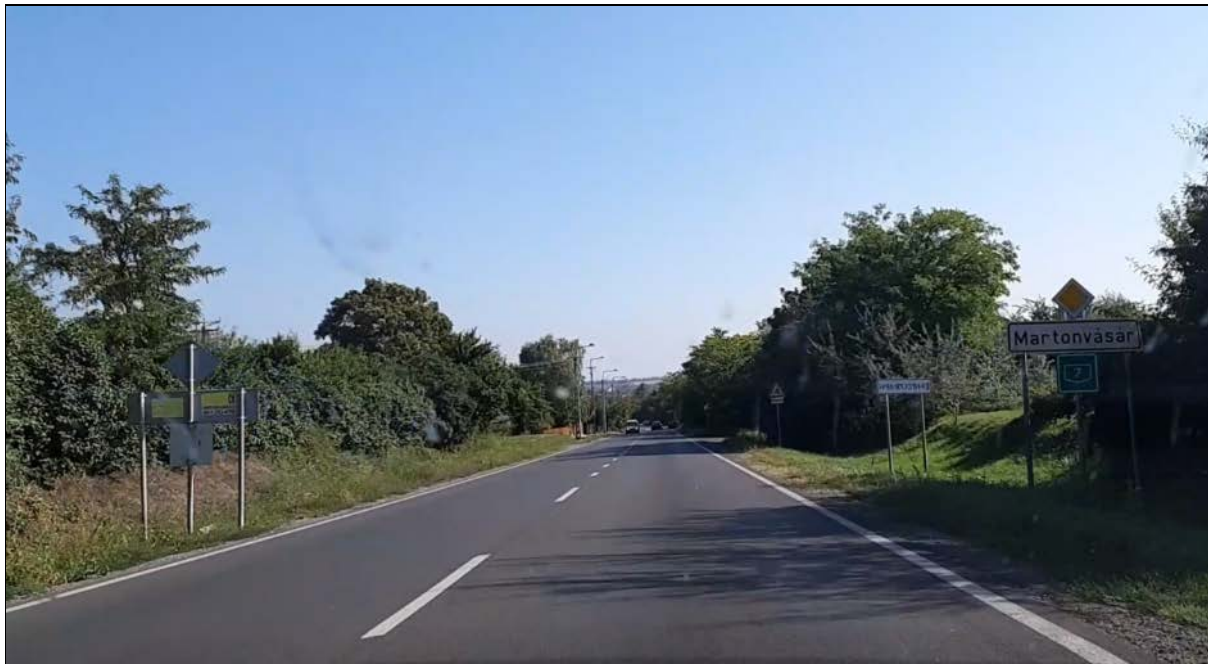
Table 34: Star Rating Scores and coded attributes – Pilot Action 2; road 7; between 33+730 -33+630 km sections

SRS – BEFORE COUNTERMEASURES IMPLEMENTATION

Road	Section	Chainage
Road 7	1	33+730 – 33+630

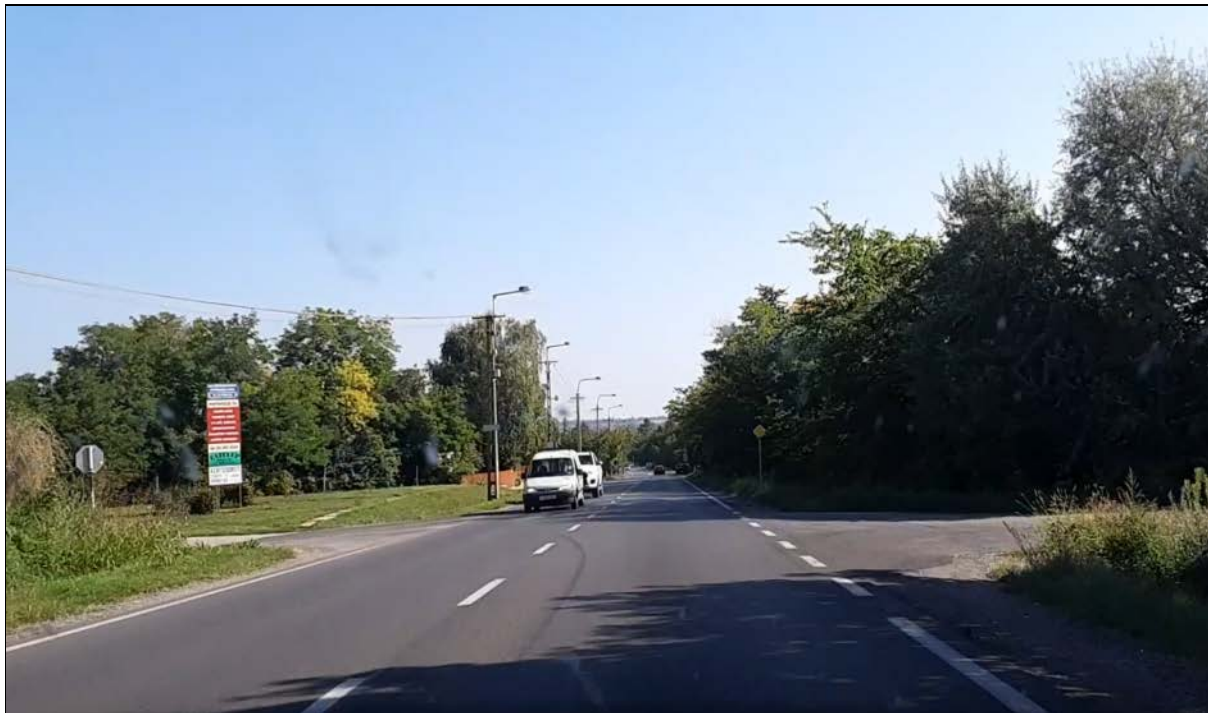
Table 35: Star Rating Scores and coded attributes – Pilot Action 2; road 7; between 33+630 -33+530 km sections

SRS – BEFORE COUNTERMEASURES IMPLEMENTATION

Attribute Group	Before	After
SPEEDS		
Speed management / traffic calming	Not present	Present
Operating Speed (85th percentile)	55 km/h	45 km/h
Operating Speed (mean)	50 km/h	40 km/h

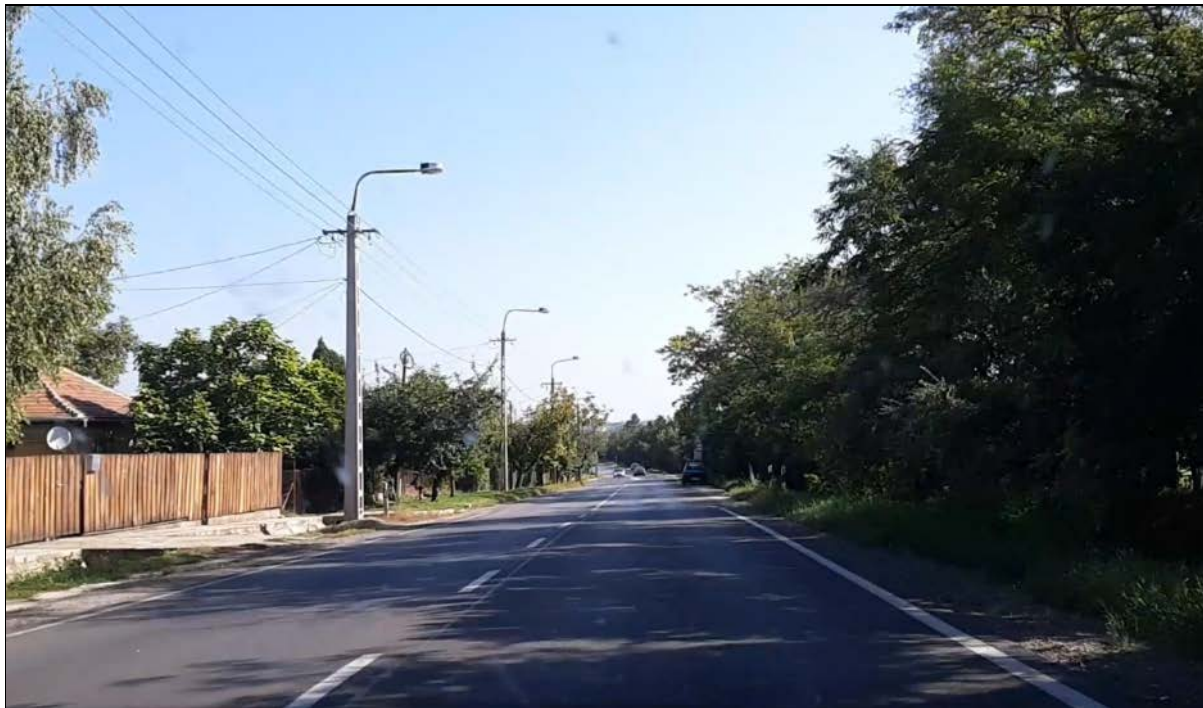
Table 36: Star Rating Scores and coded attributes – Pilot Action 2; road 7; between 33+530 -33+430 km sections

SRS – BEFORE COUNTERMEASURES IMPLEMENTATION

SPEEDS		
Speed management / traffic calming	Not present	Present
Operating Speed (85th percentile)	55 km/h	45 km/h
Operating Speed (mean)	50 km/h	40 km/h

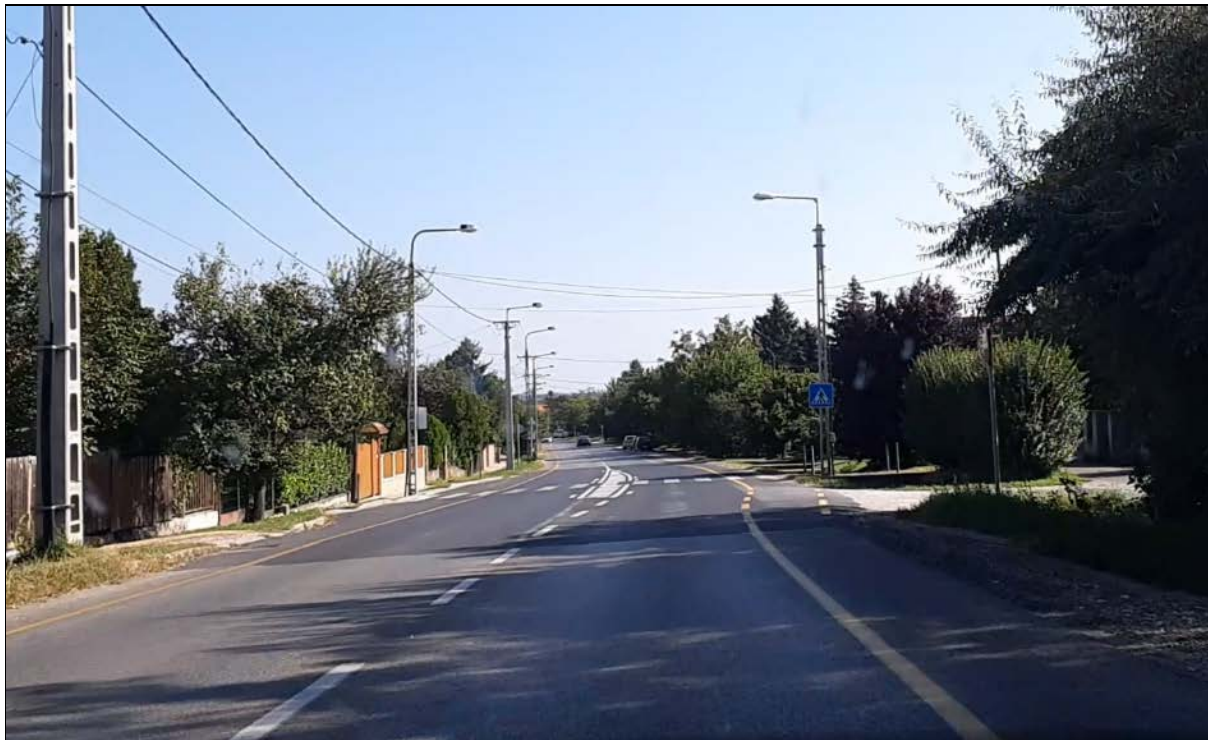
Table 37: Star Rating Scores and coded attributes – Pilot Action 2; road 7; between 33+430 -33+330 km sections

SRS – BEFORE COUNTERMEASURES IMPLEMENTATION
