Best practice bicycle safety – improvement fact sheet

Poor signing

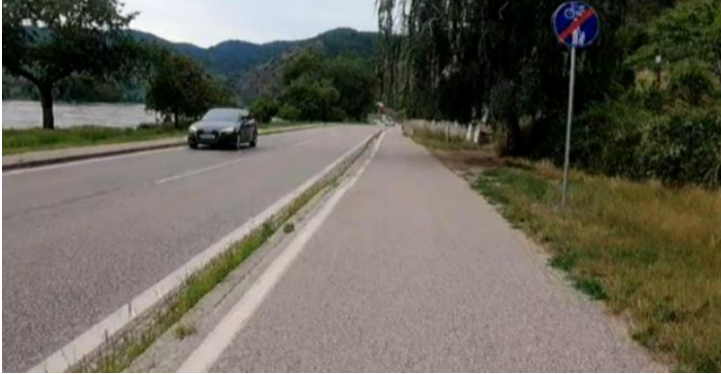
Incomprehensible traffic sign at road section at the EuroVelo 6 in Austria [9]

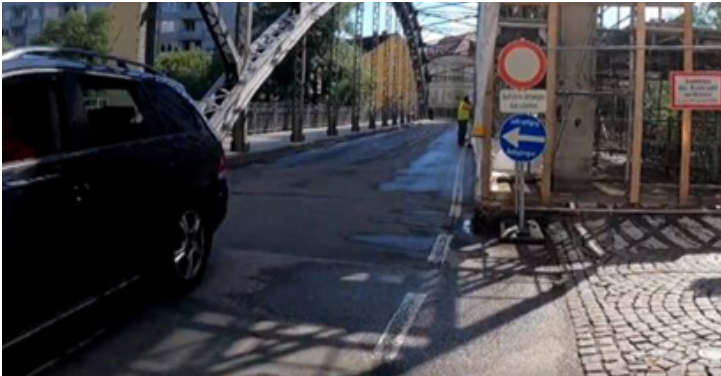
Problematic traffic signs at construction site, with unsafe detour route at EuroVelo 14 in Austria [10]
