Best practice bicycle safety – improvement fact sheet

# Objects on or aside infrastructure

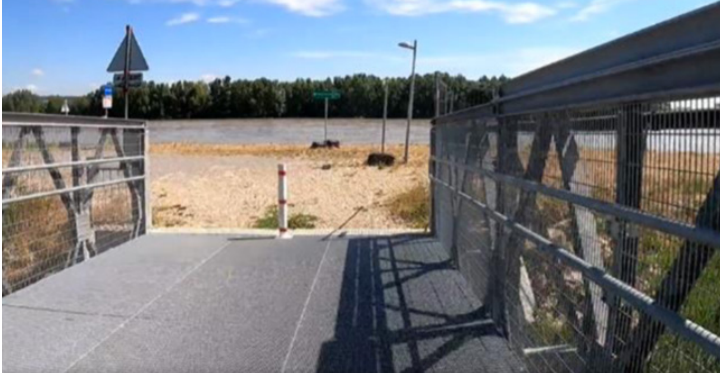
*Bollard in the middle of the cycle path at EuroVelo 6 in Austria [11]*

Bollards, poles or other road equipment are often placed on the road to prevent cars from entering a cycle track, but as they are **often positioned in the middle of the track**, they also present obstacles for cyclists and **decrease the width of the facility** at these locations [7]. Such objects as well as parked cars or garbage cans that are unintentionally placed on the cycle track are **problematic** because of the risk of the cyclists hitting the objects and falling [6, 7]. In addition, sometimes bicycles, but especially cargo bikes or bicycles with trailers, are **not able to pass** (e.g., bollards) or must **enter the path of**

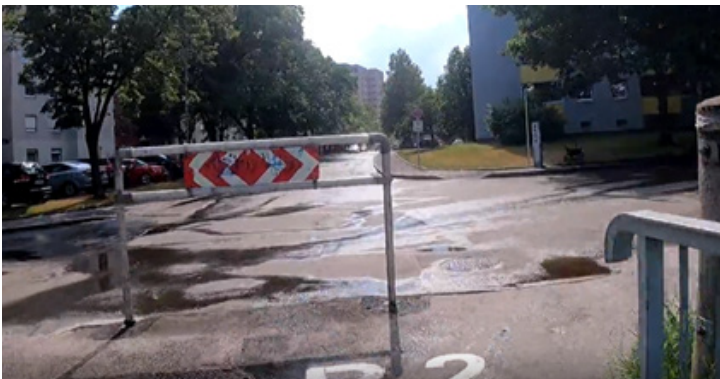
*Railing as obstacle at EuroVelo 14 in Austria [12]*

**oncoming traffic** in order to be able to pass (e.g., parked cars) which can lead to **conflicts and collisions**. These issues are especially problematic at narrow bicycle facilities and a high volume of cyclists, e.g., when objects on the infrastructure are **occluded by cyclists** in front and are **not or too late visible** [1, 8]. Moreover, problems can also arise at **road works** due to objects and devices put out to warn and protect road users, e.g., when cyclists get stuck in fences with their handlebars [5].
