River Training Structures and Historical Mapping within the Mura-Drava-Danube TBR

DTP3-308-2.3- lifelineMDD
D.T1.2.1 „River Training Structures“
Ulrich Schwarz, FLUVIUS
November, 2022

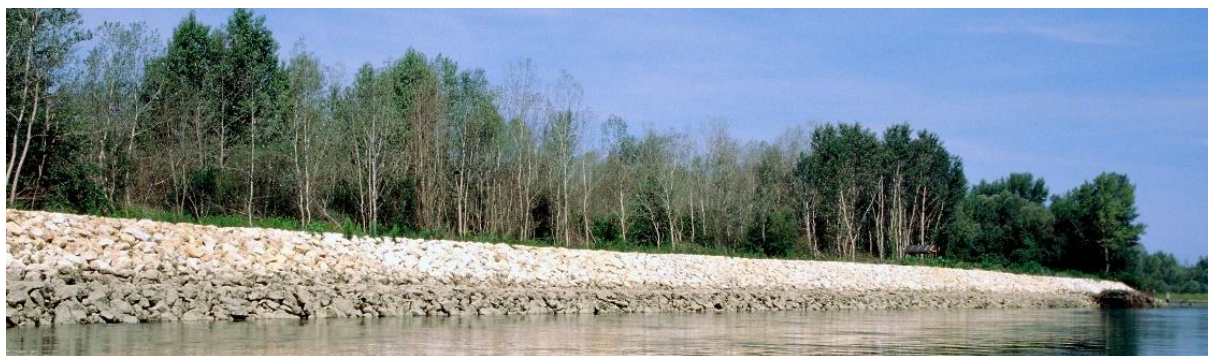
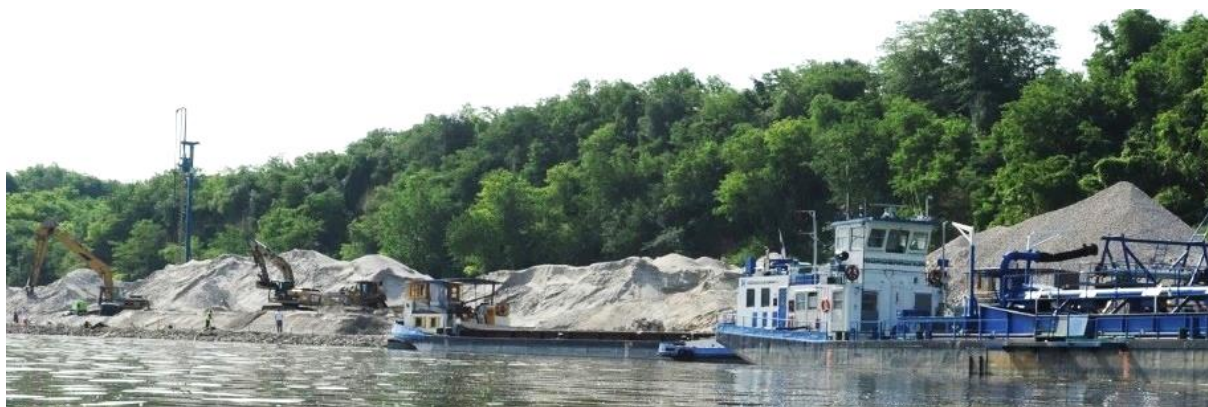
Figure 5&6: Bank reinforcement on the Danube near Vukovar, Images: WWF/Arno Mohl, Darko Grlica.

Downstream of the Drava confluence T-groynes dominate the groyne type in general. Significant training walls can be found at the lower end of the reach (near Bačka Palanka). The Danube bank in Vukuvar is reinforced for several kilometers.

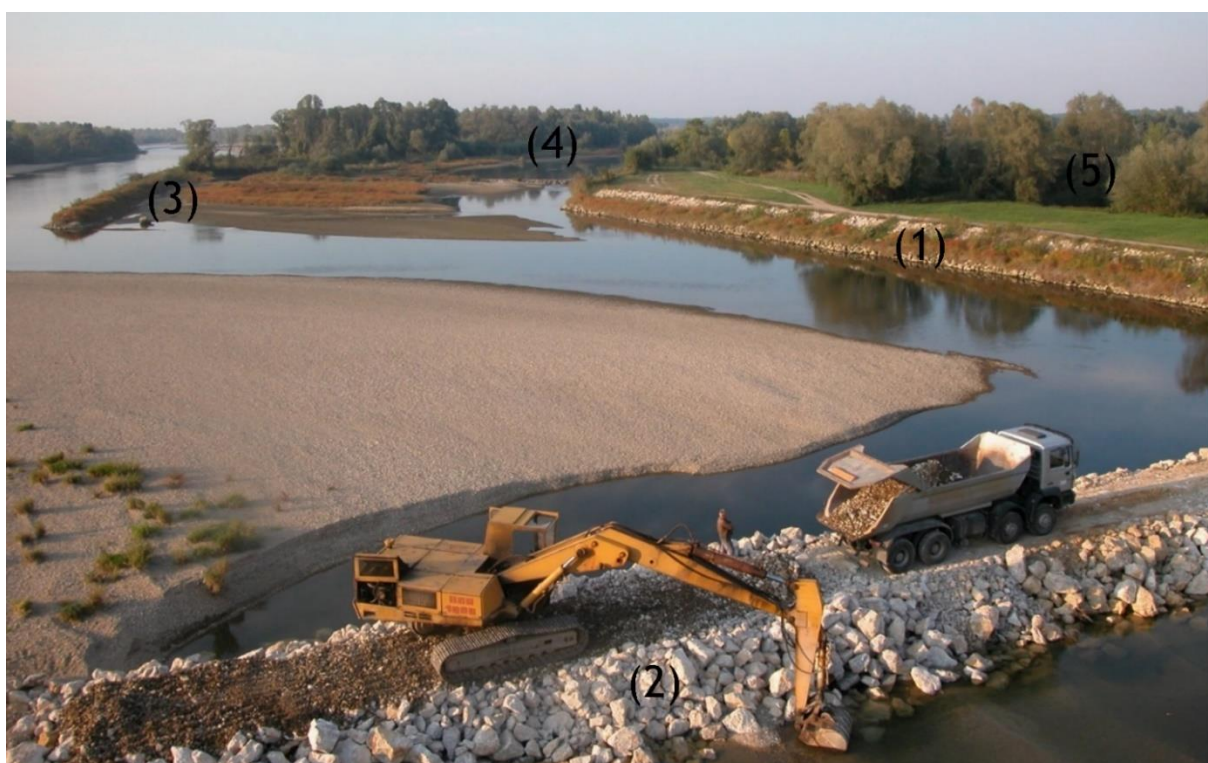
Figure 7: The typical repertoire of river regulation in the project area: Groyne construction in the foreground (2), bank protection on the right side (1), training wall on the left upper side (3) and cross dyke (transversal fill) closing the side channel in the upper central part (4). Finally, the flood dyke (5), immediately behind the softwood (invisible), complement the regulation works. © Credit: WWF/ A. Mohl.

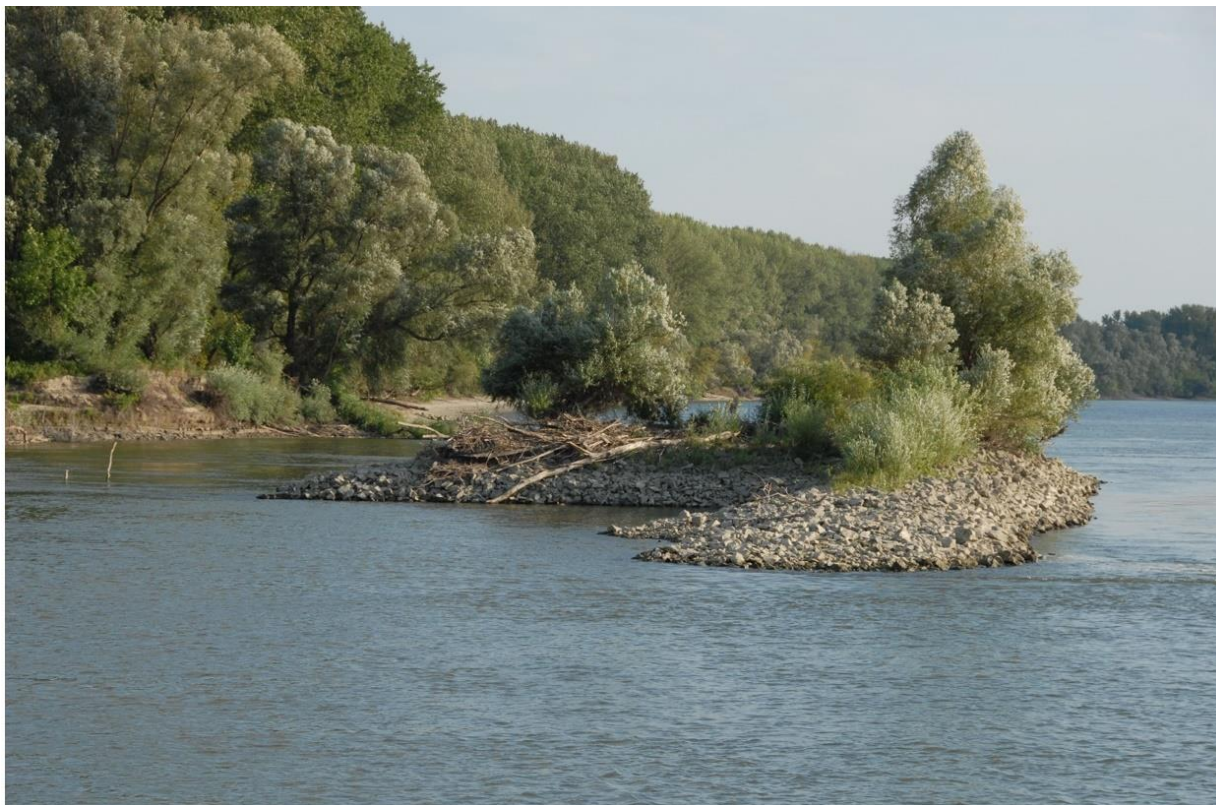
Figure 8: On the Danube T-groynes (in this case disconnected from bank) can be find in larger numbers end size to stabilize the fairway. © Credit: Wolfgang Kraier.

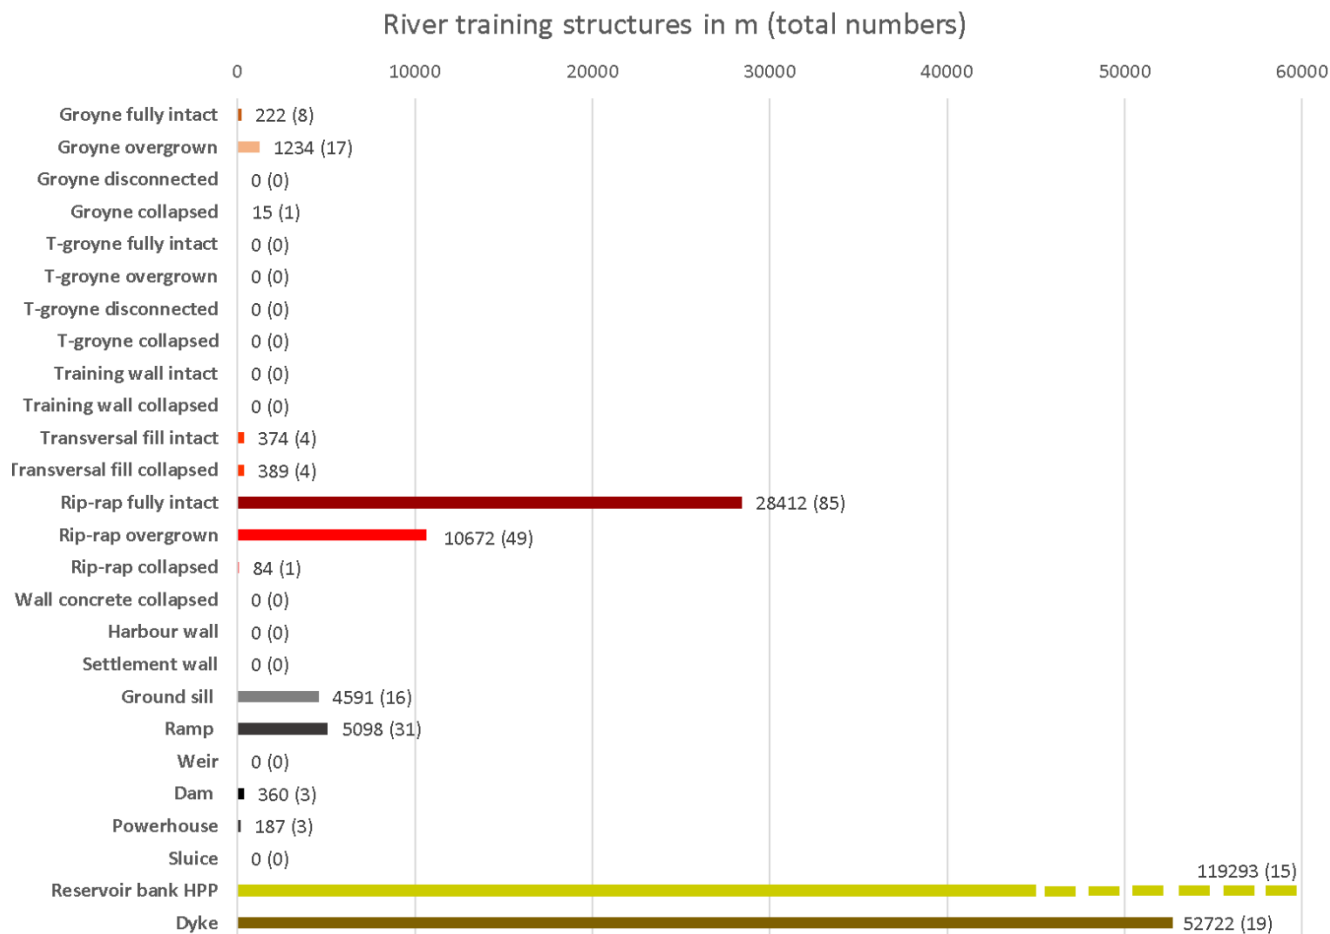
Drava 310-235 upstream Mura DRA1

Figure 15: Starting at the upper end of Drava in the project area the three hydropower plants strongly alter the river. Not all categories can be found but additionally as mentioned the concrete hydropower reservoir and tailrace canal banks comprise 120 km and within the residual “old Drava” reaches in between the hydropower plants all recorded 30 ramps can be found in this mostly altered section.

Regarding the longitudinal barriers and regulation works three major hydropower dams with three powerhouses (turbines) can be found on HR Drava, among ramps and ground sills.
