Pilot Actions Evaluation Report
Municipality of Maribor
Implementation of measures at the main bus station in
Maribor

**Innovative transportation services for blind and partially sighted passengers in Danube
region**
DANOVA

Dissemination level	<i>Confidential/Consortium only/Public</i>
Activity	<i>A.T3.2: Testing – Pilot Actions</i>
Deliverable	<i>D.T3.2.1 Appraisal report on testing</i>
Coordinating partner	<i>Bulgarian Association for Transfer of Technology and Innovation</i>
Produced by:	<i>Vesna Avguštinčič, Municipality of Maribor</i> <i>Tadej Kurent, Municipality of Maribor</i> <i>Katja Hanžič, University of Maribor</i>
Due date of deliverable	<i>07.2022</i>
Actual date of deliverable	<i>12.12.2022</i>
Status (F: final, D: draft)	<i>Final</i>
File name	<i>DANOVA_D.T3.2.1_Appraisal_Report-Template</i>

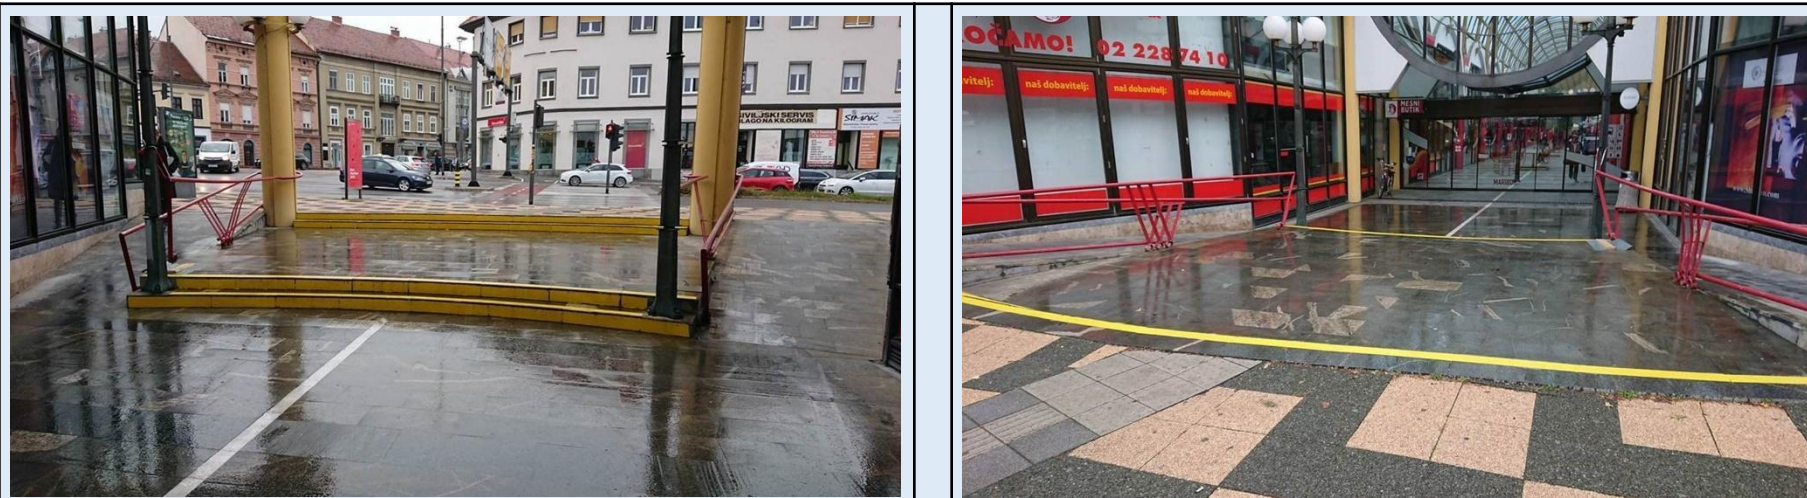
Picture 2: Contrasting strip – main entrance stairs

Contrasting strip – main entrance stairs - add colour contrasting strips at the edge of each step (highest priority, measure 3)

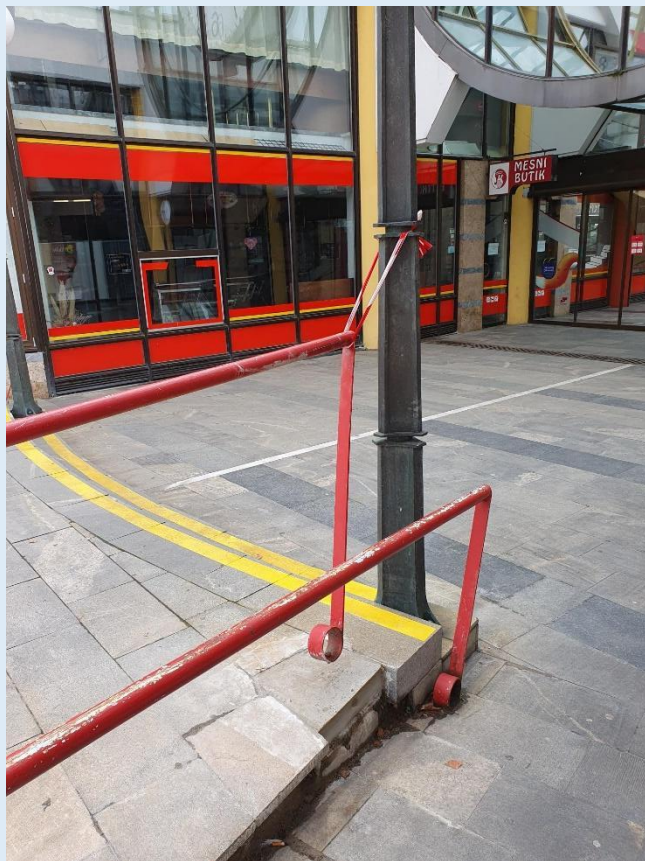
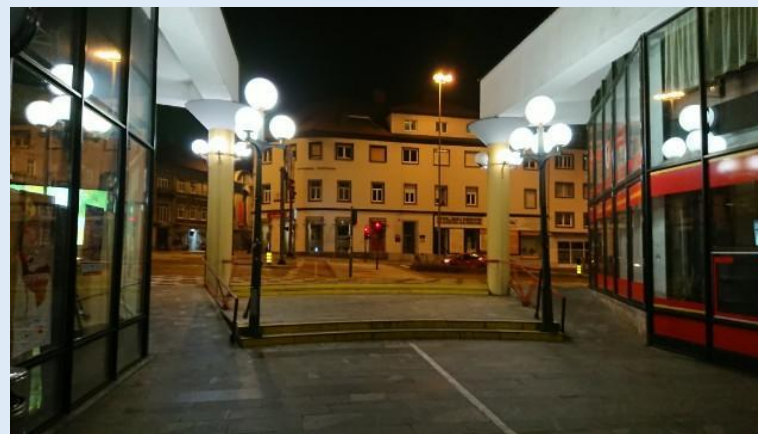
Picture 3: Handrails maintenance at north main entrance and Improved illumination at main entrances

Improved illumination at main entrances - improved illumination at north main entrance (highest priority, part of measure 11)

Handrails maintenance at north main entrance - fixing the handrails (medium priority, measure 1)

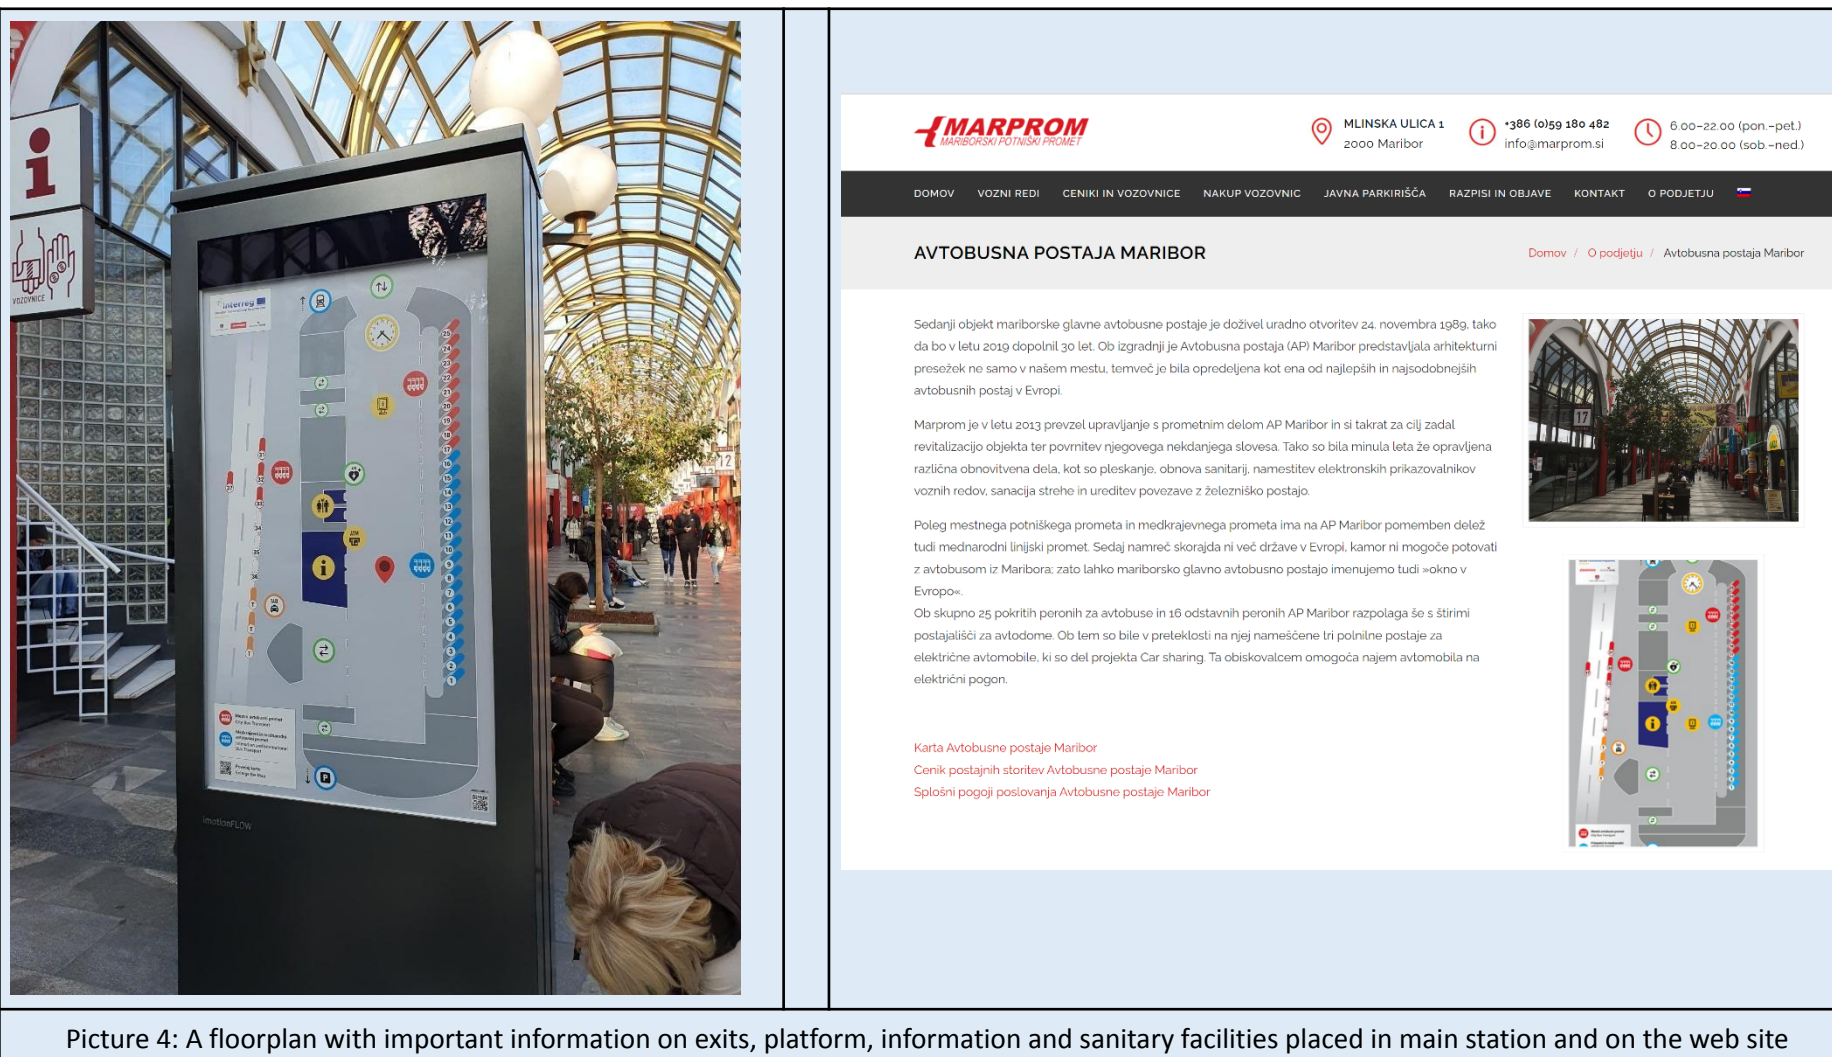
Picture 4: A floorplan with important information on exits, platform, information and sanitary facilities placed in main station and on the web site

Additionally, a simplified map of the main bus station was prepared which enables the passengers easy orientation at the station. Maps are placed at the entrances of the bus station, in the station itself and on the web site of the Maribor local bus operator. This enables the users also to download the map and enlarge it if needed.

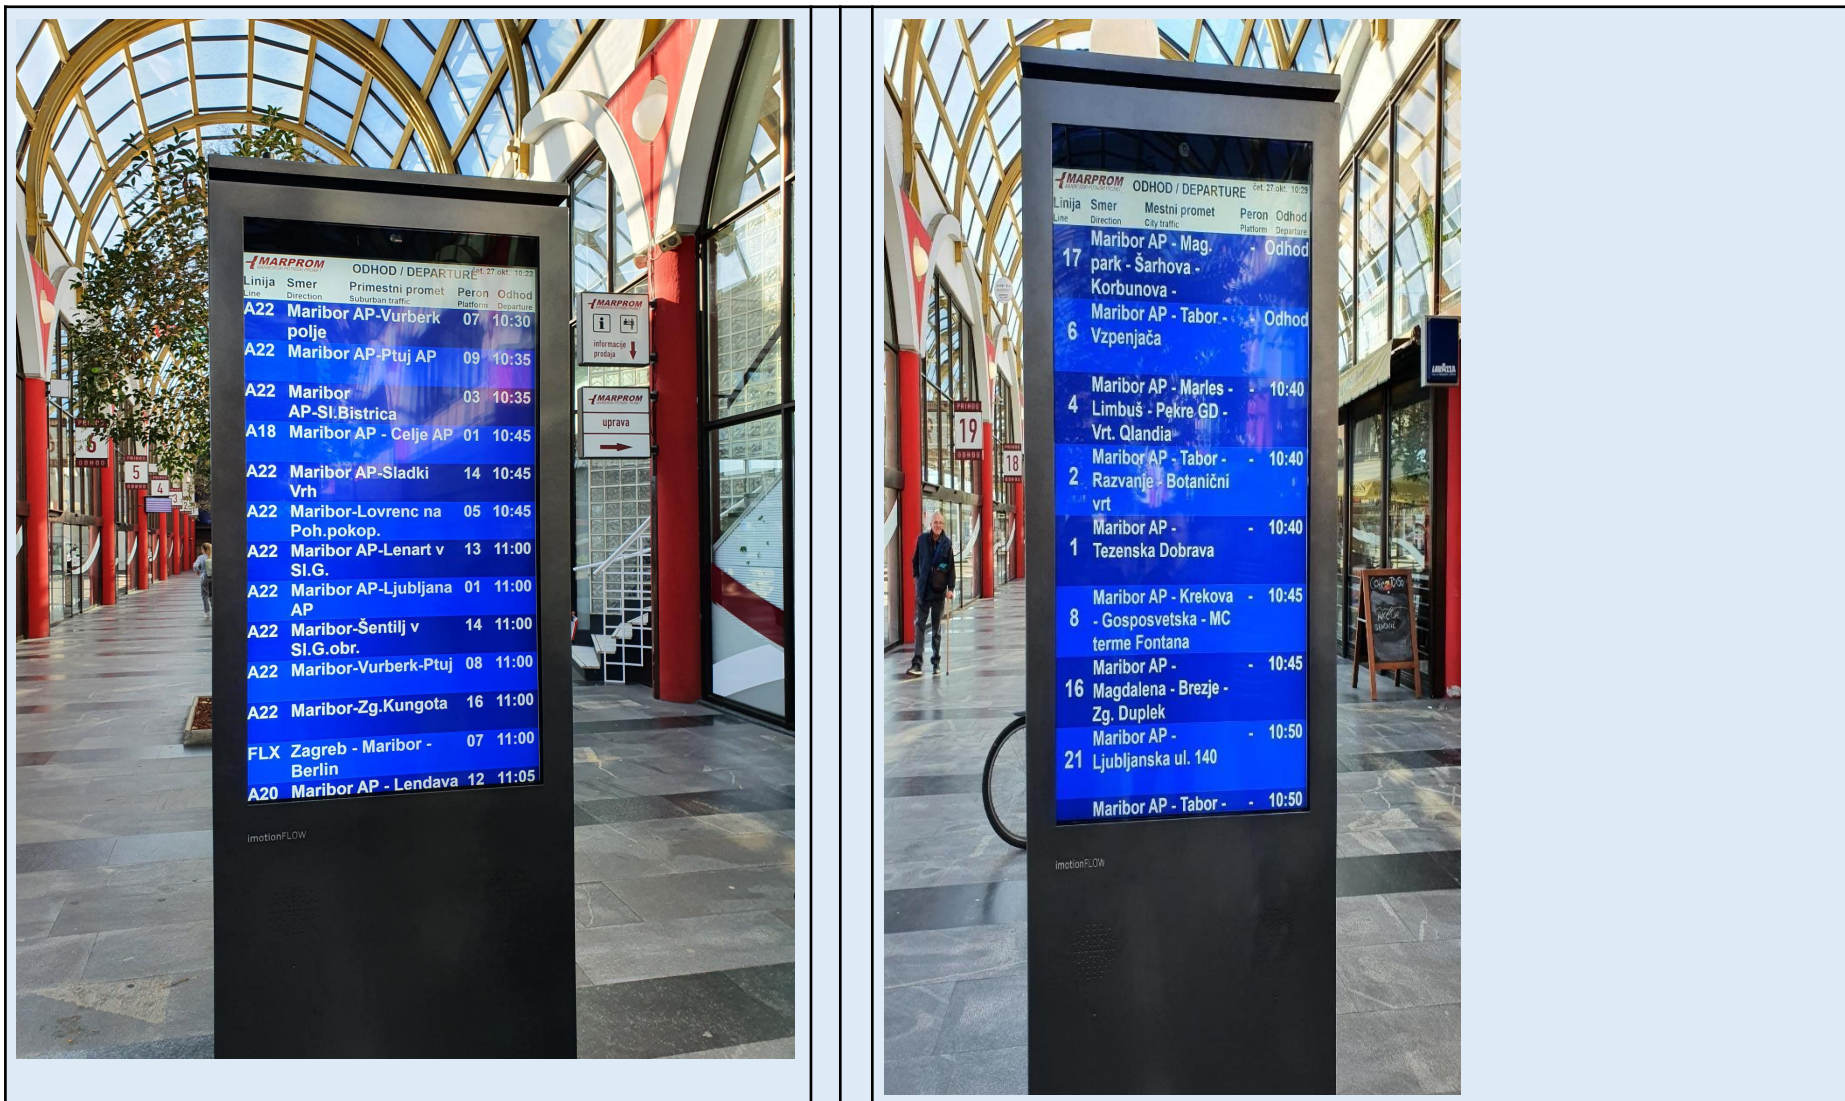
Picture 6: Two large freestanding indoor bus timetable display

Most significant measure implemented relates to installation of two large freestanding indoor bus timetable displays in the waiting area on the main bus station.

After the pilot action implementation there are two large free-standing displays installed at the main bus station with the information in format (size, fonts and colours) specifically adopted to partially sighted passengers. Additionally, also larger printed formats of bus timetables were placed on the platforms of the local city busses. Before timetables were printed in A4 format, now there are in A3 format. On the web page timetables shown in PDF format were transferred to readable PDF format so blind and partially sighted passengers are able to read them with reading apps.
