EuroVelo 6 – Atlantic-Black Sea
Transdanube.Pearls

Route Assessment of EuroVelo 6 Atlantic-Black Sea

in Germany, Austria, Slovakia, Hungary and Romania
Final Report

Written by Aleksander Buczyński,
Ernst Fahrenkrug and Ed Lancaster (ECF)
November 2018

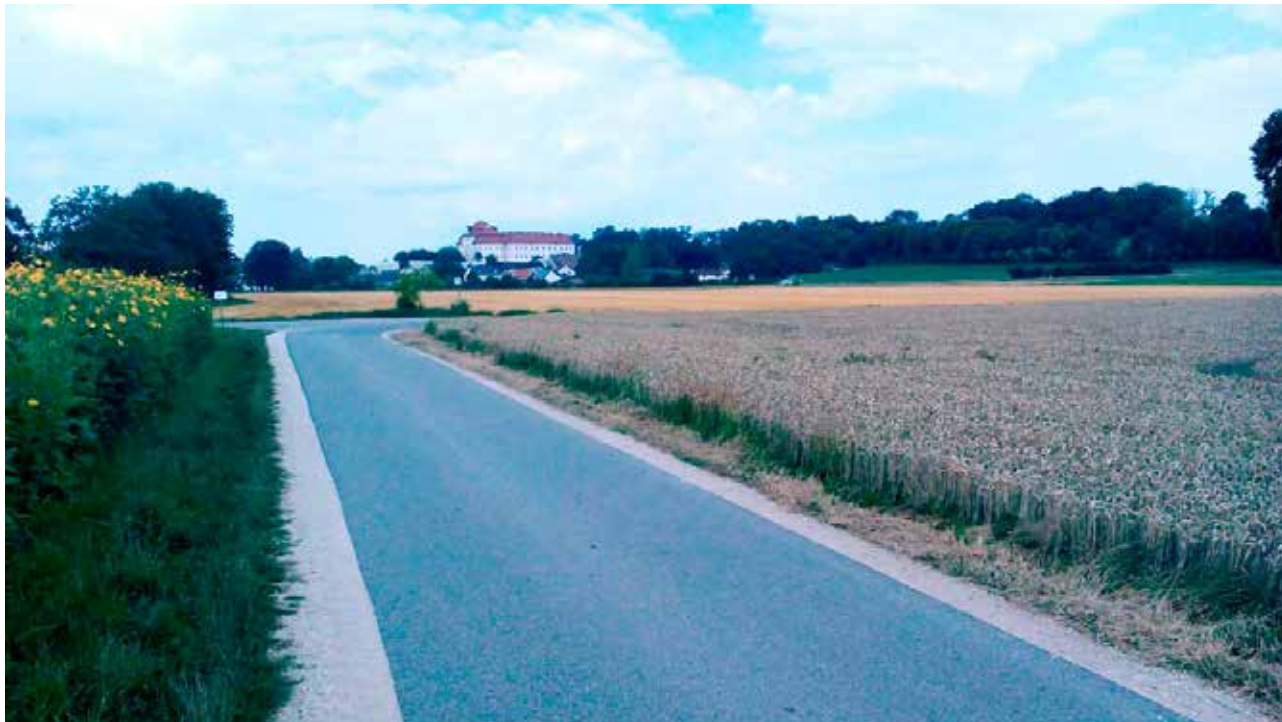
Public road with low traffic behind Grünau castle (section 7).

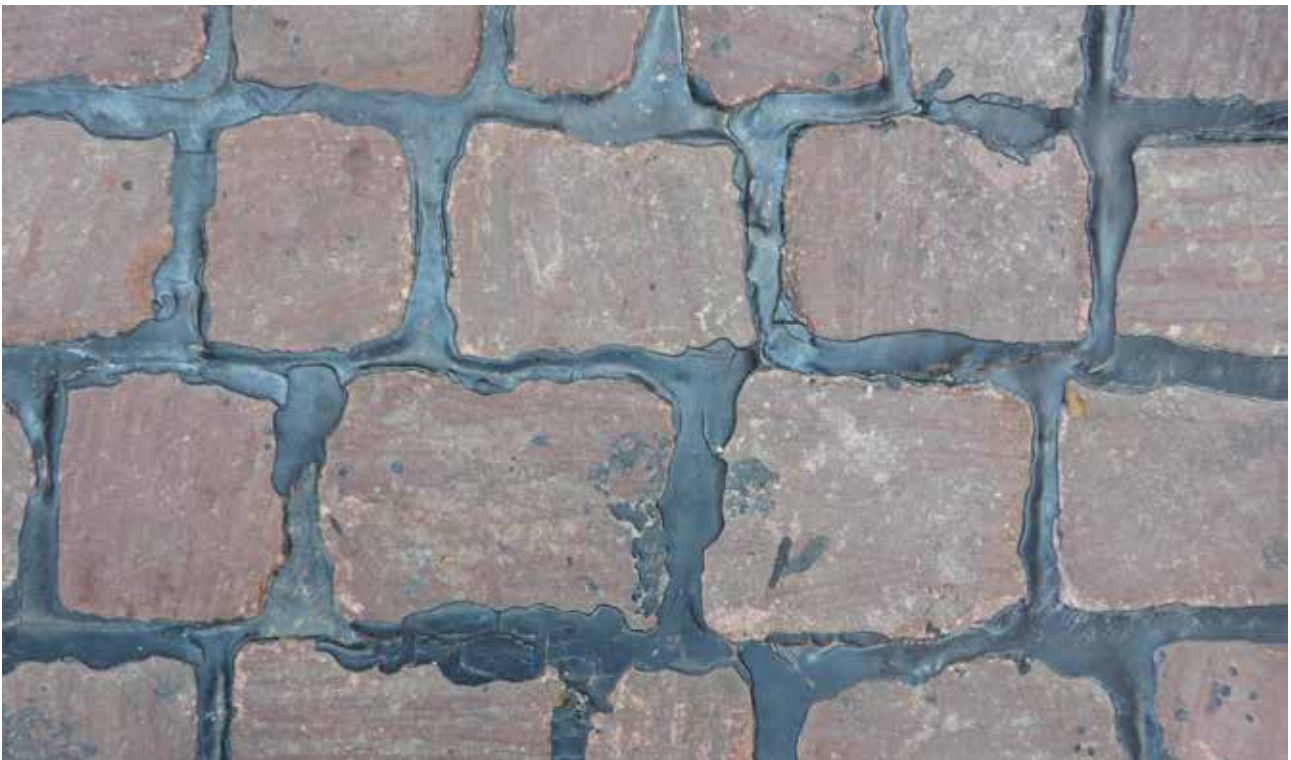
Bike friendly cobblestone treatment in Freiburg im Breisgau – similar measures could be applied in Ybbs an der Donau.

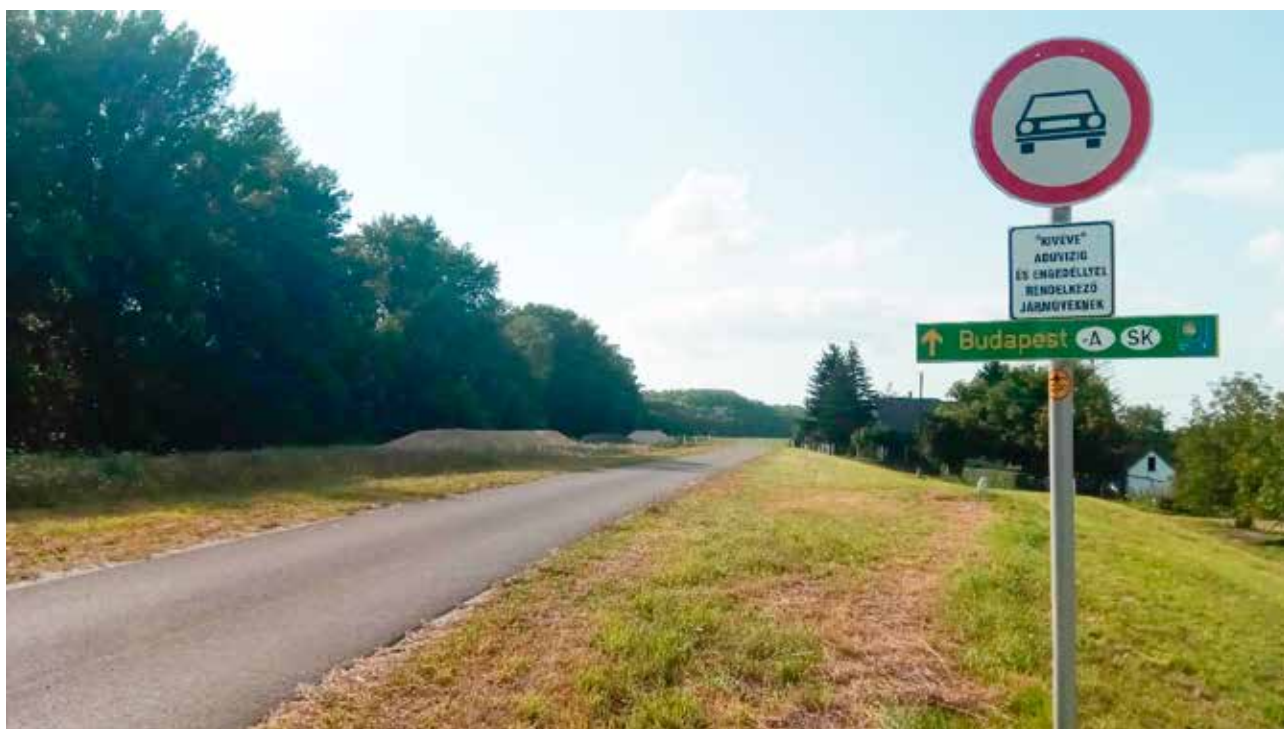
Section 45 near Mohacs – good example of long-distance route branding.

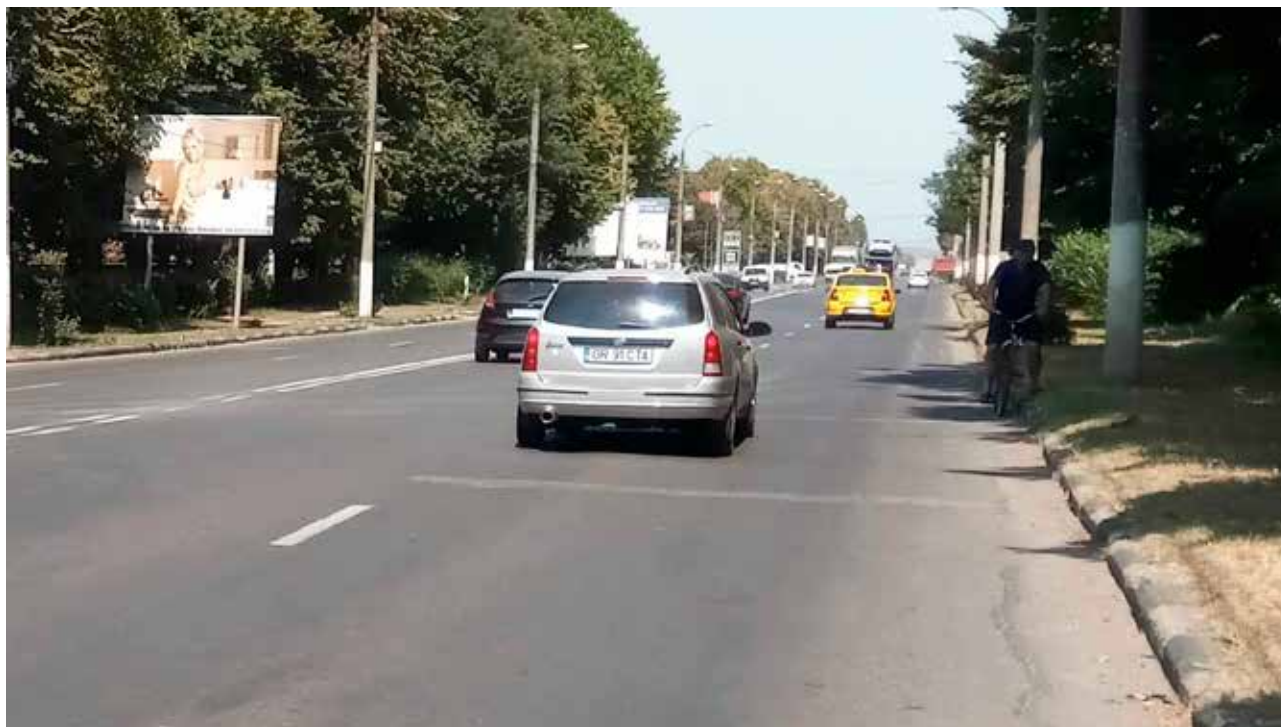
Daily section 75. Traffic on road number 5 leaving Giurgiu estimated to reach 25-30,000 vehicles/day.

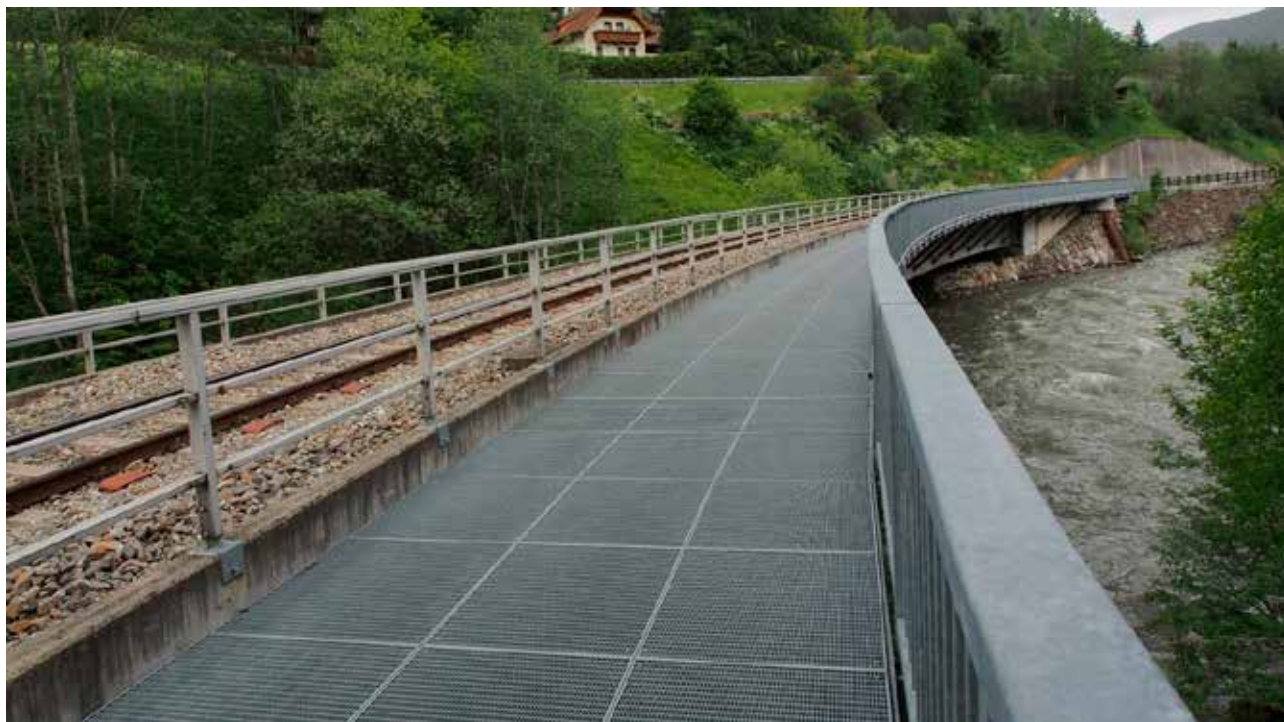
Cycle path attached to railroad embankment – one of the possible solutions for daily section 66. Photo from Murradweg between Tamsweg and Madling (Austria).

Daily section 66: Orsova - Drobeta-Turnu Severin. To verify whether there is a possibility to construct a cycle path at a lower level, next to the railroad track. Otherwise, an extension that overhangs partially could be constructed at the carriageway level.

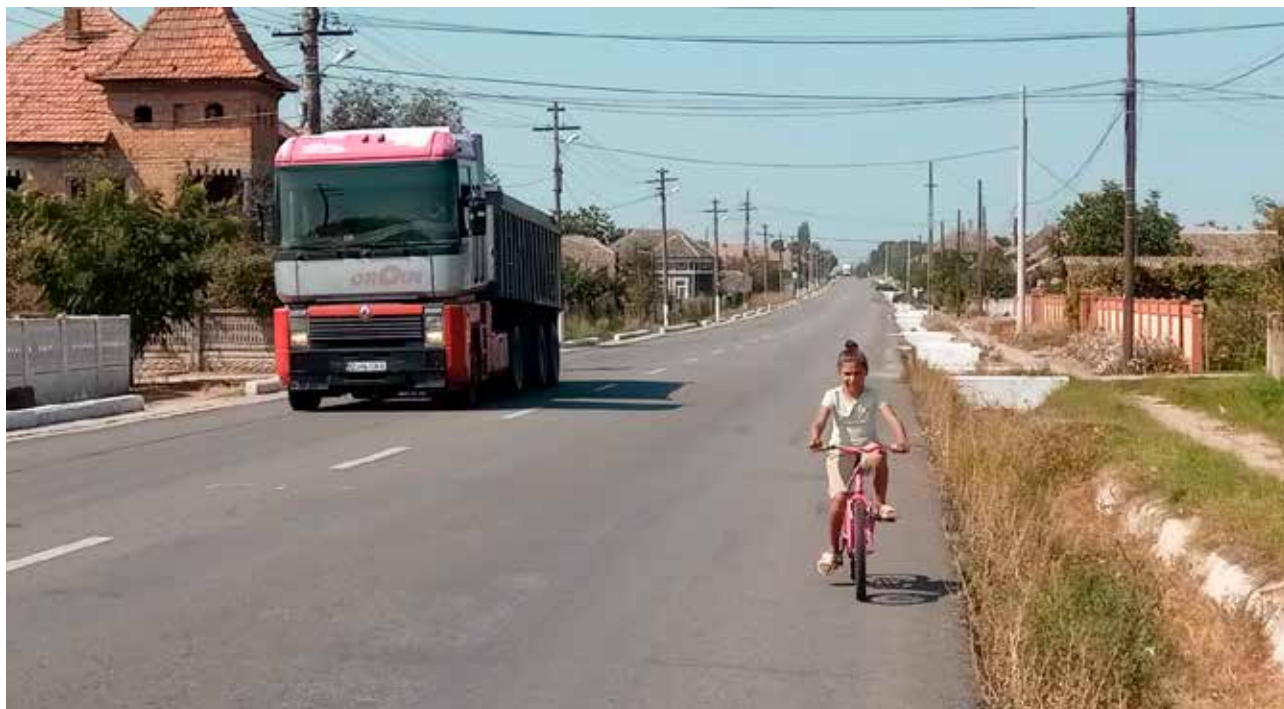
In many locations, the construction of a cycle path would improve also safety of local inhabitants. Basarabi near Calafat, daily section 69.

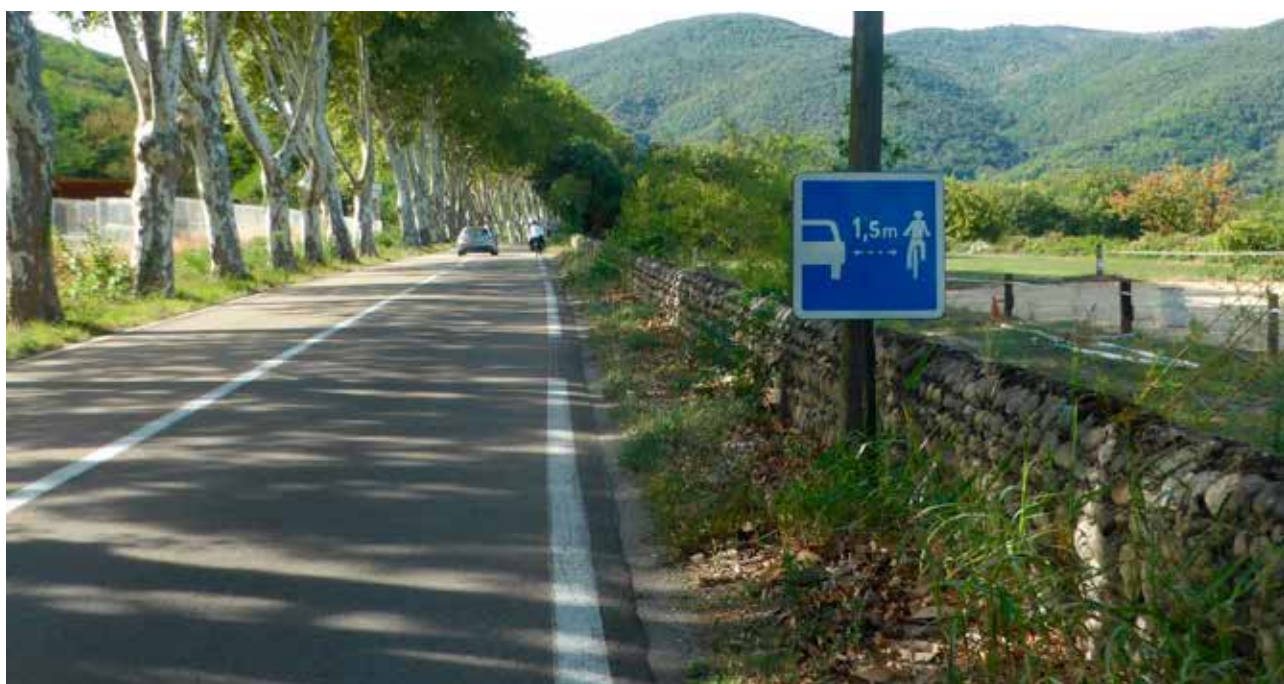
Example (from France) of a sign for drivers indicating the minimum distance to cyclists that needs to be observed when overtaking.
