EuroVelo 6 – Atlantic-Black Sea
Transdanube.Pearls

Route Assessment of EuroVelo 6 Atlantic-Black Sea

in Germany, Austria, Slovakia, Hungary and Romania
Final Report

Written by Aleksander Buczyński,
Ernst Fahrenkrug and Ed Lancaster (ECF)
November 2018

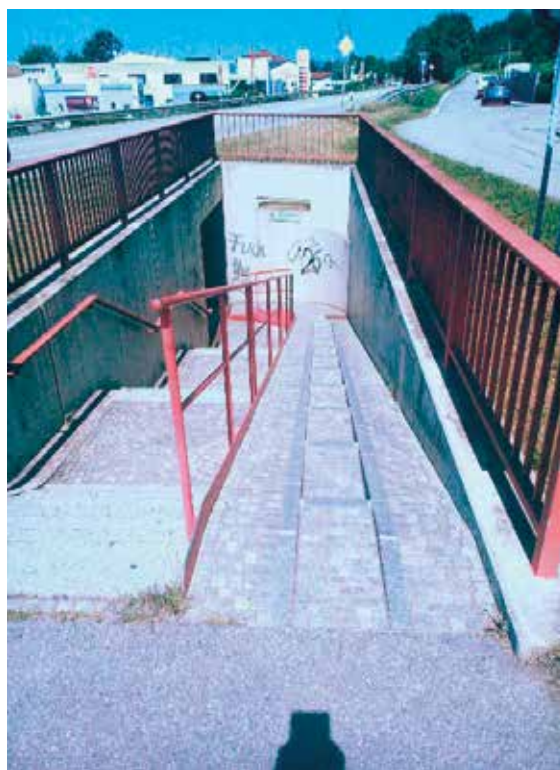
Maierhof, west of Passau, DE

- Stairs: The fittest cyclists, travelling with light luggage, can carry their bike up or down stairs, but for the majority of potential users, this is an important obstacle that might even be insurmountable. A total of three stairs were encountered during the route survey, including two in Germany and one in Croatia. However, these stairs were equipped with ramps, so they can be climbed with standard bikes.
- Chicanes and other bottlenecks with less than 1.3 m clearance: Such chicanes make it difficult to use the route with bicycles with trailers or with tandems, hand-bikes etc. They were encountered from time to time in most of the countries, slightly more often in Germany and Slovakia.
- Non-rideable surface (deep sand, mud, big rocks etc.) – this will be covered in the section on surface.

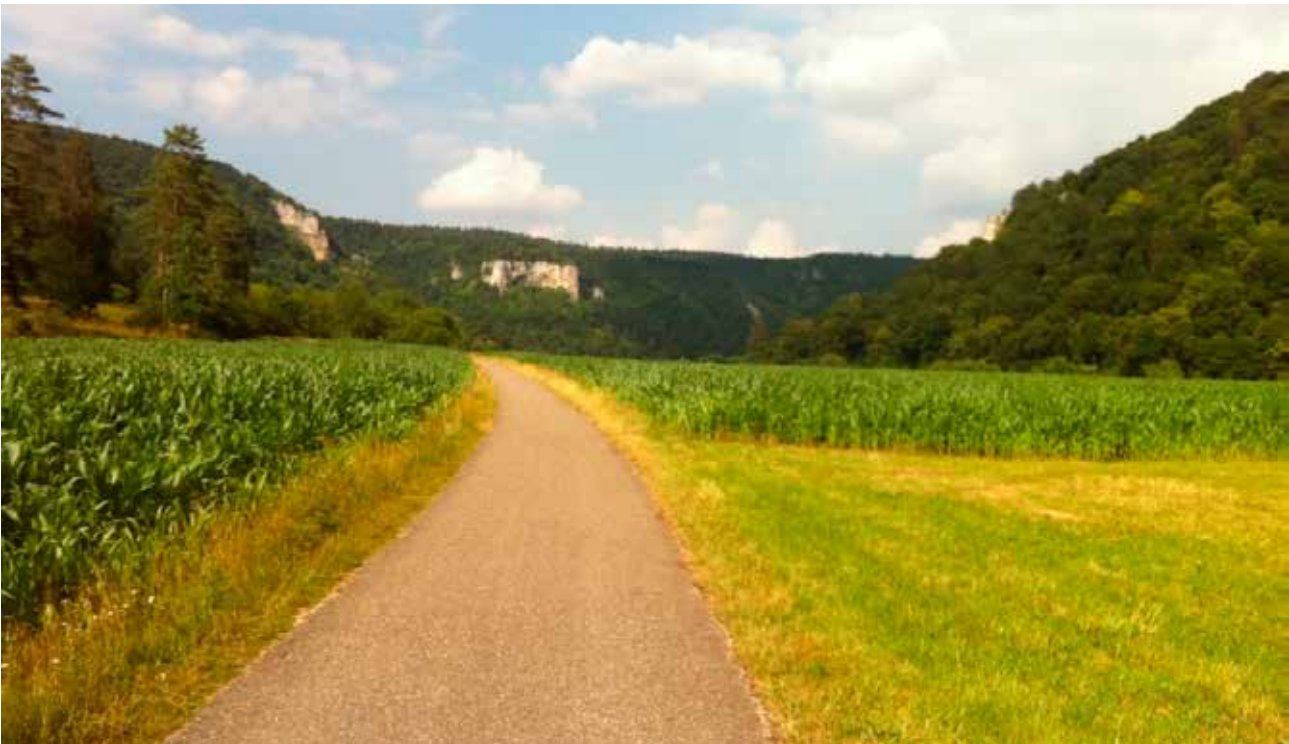
Quiet cycle path between Donaueschingen and Fridingen (section 1).

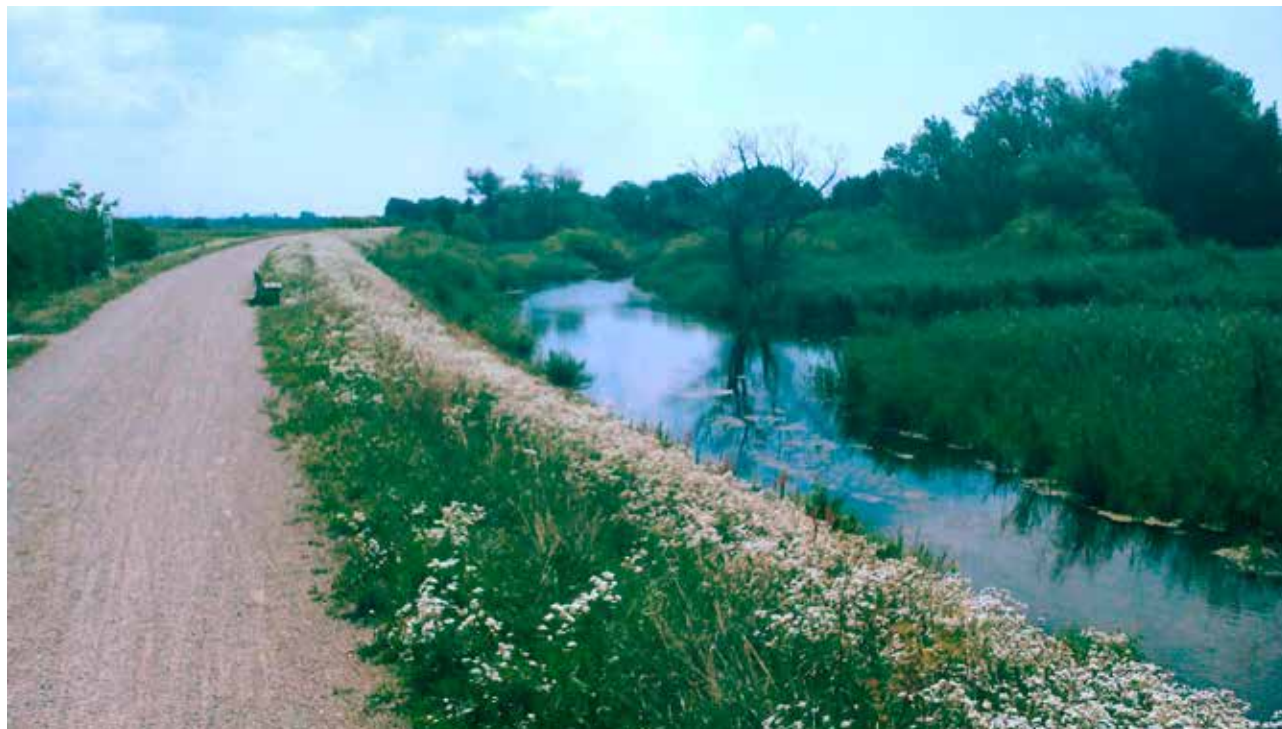
Stabilised-gravel cycle path behind Pondorf (section 10) next to beautiful floodplain area.

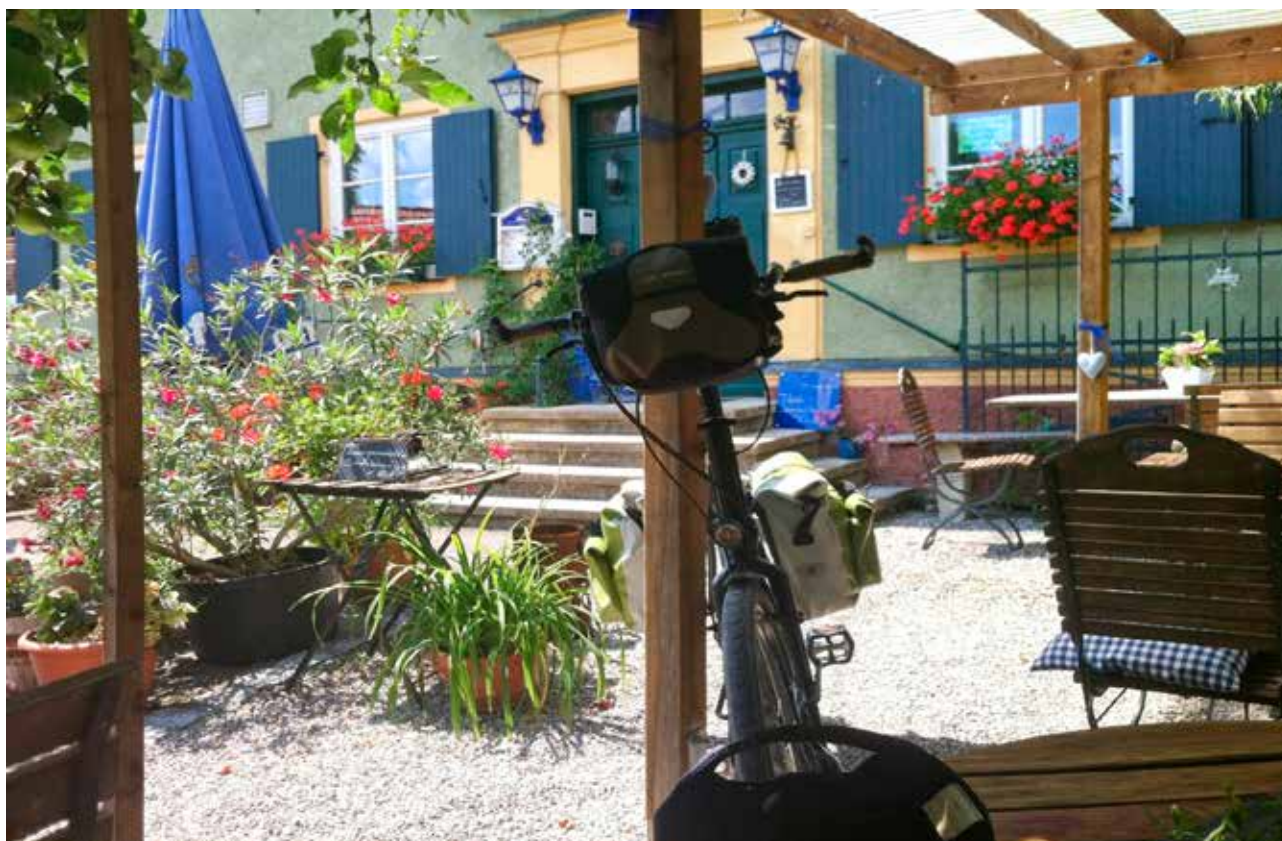
Traditional „Wirtshaus“ in Marxheim (section 6).

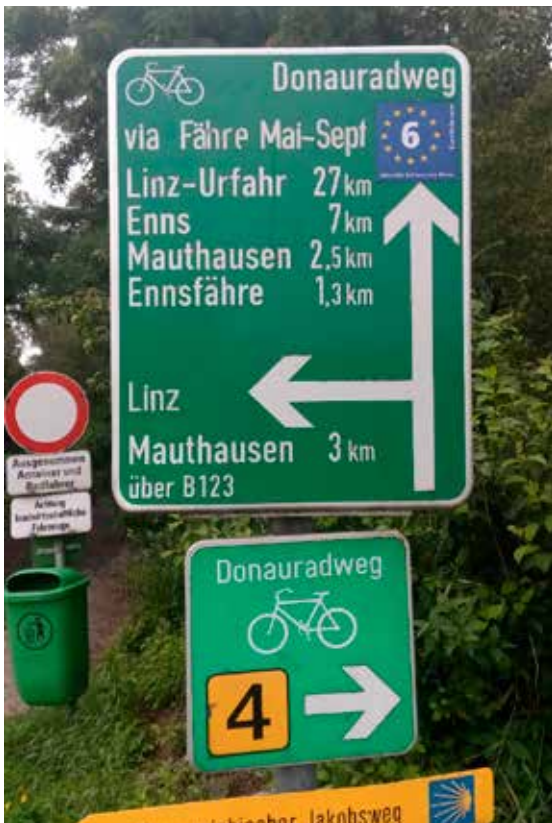
EuroVelo logo integrated in the upper, but not in the lower sign.

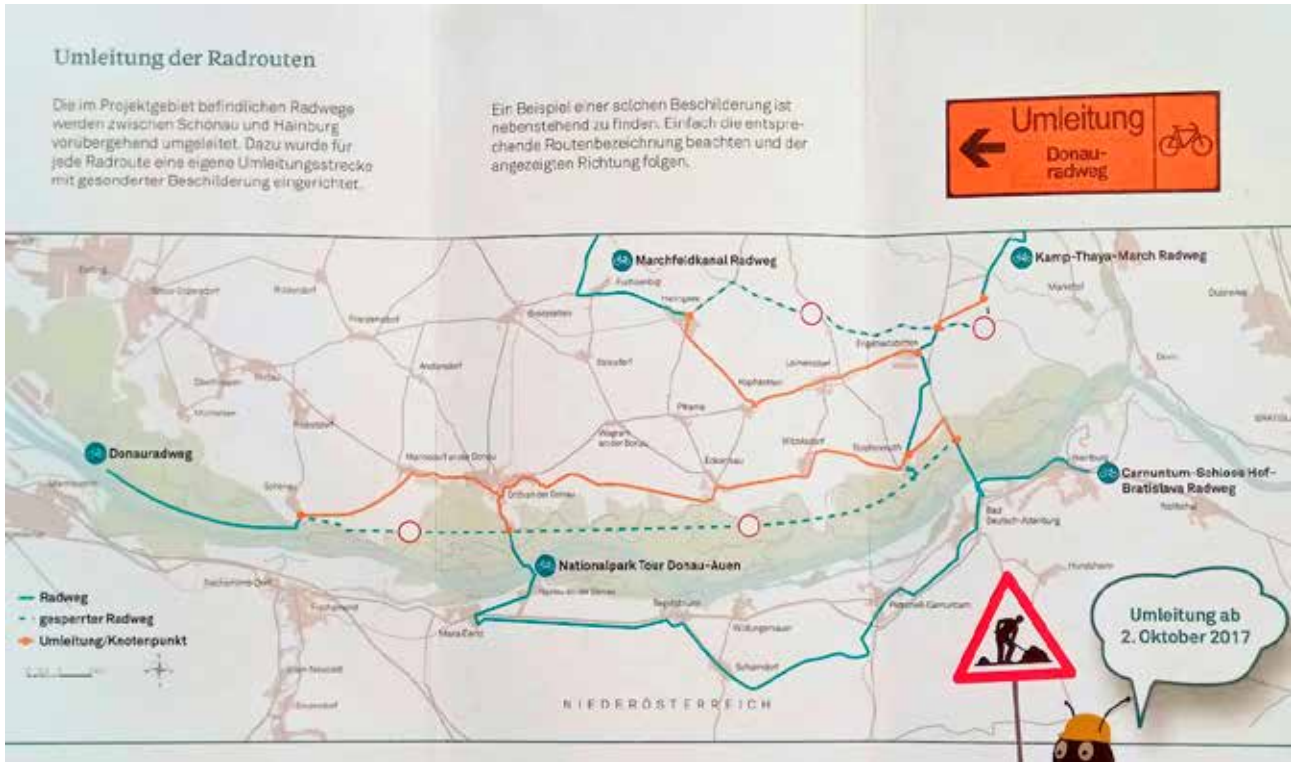
Significant parts of the main route were under reconstruction during the field survey.

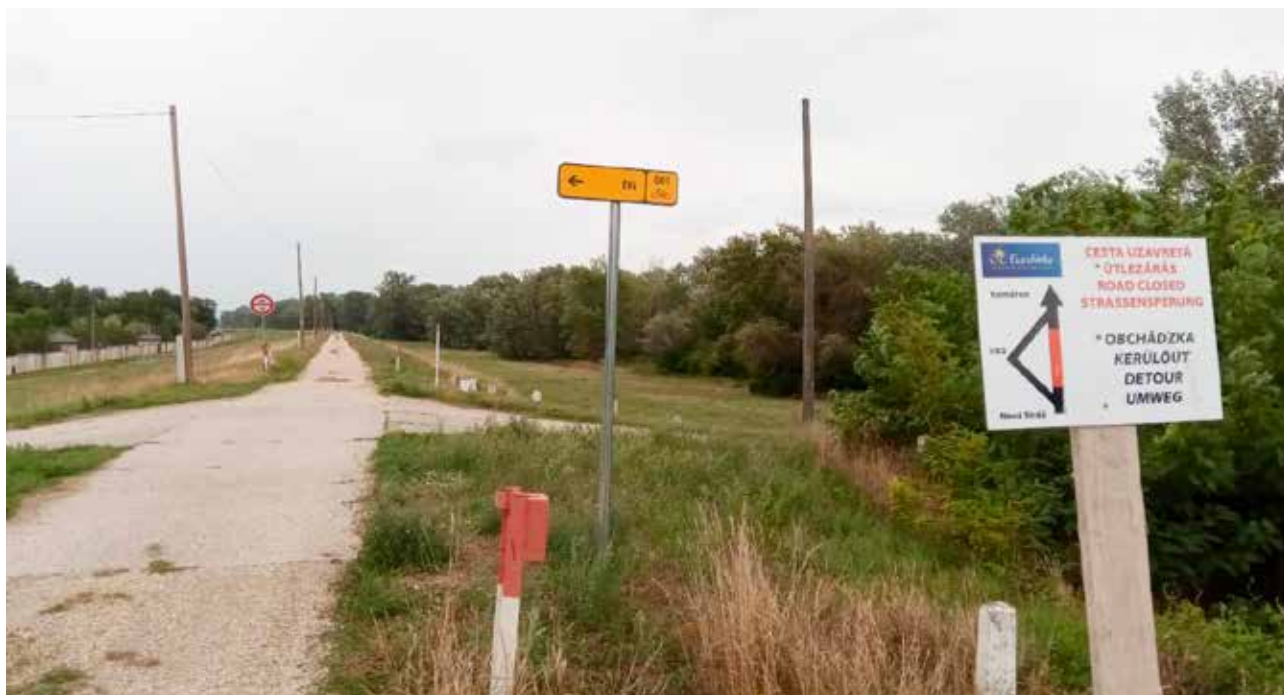
Detour to busy road between Nová Stráž and western border of Komárno.

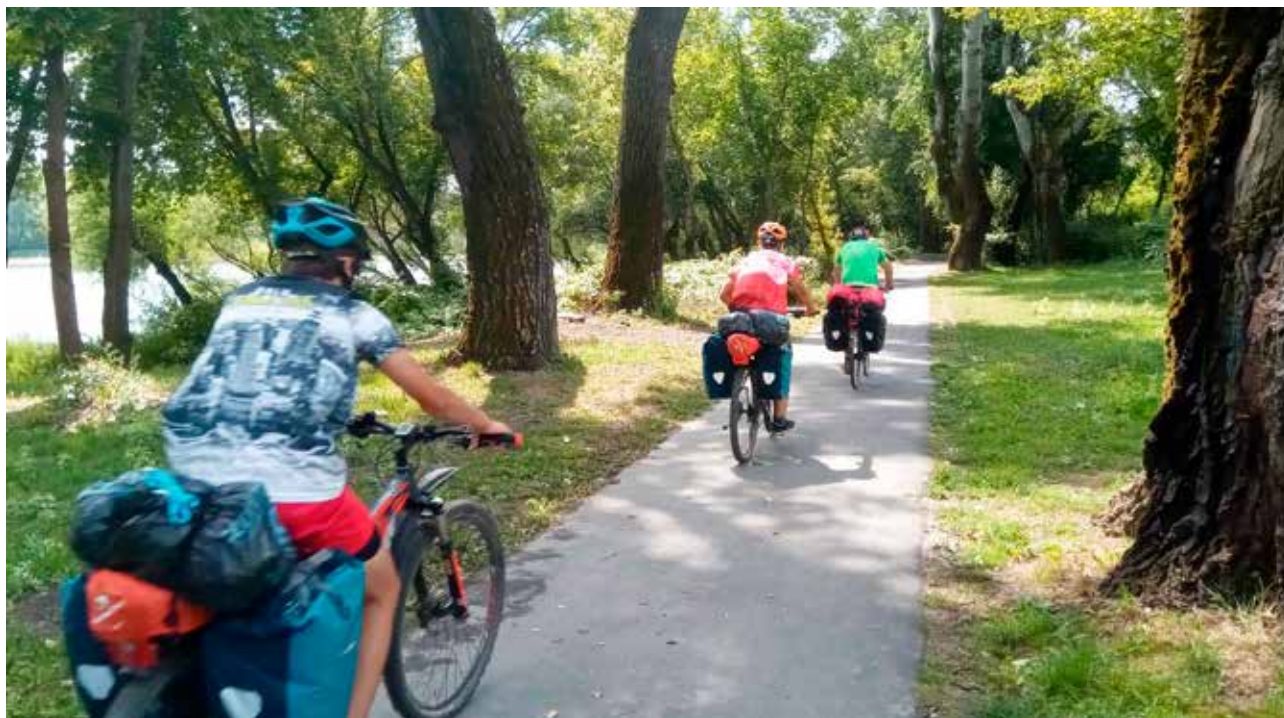
Section 41 – approaching Budapest.

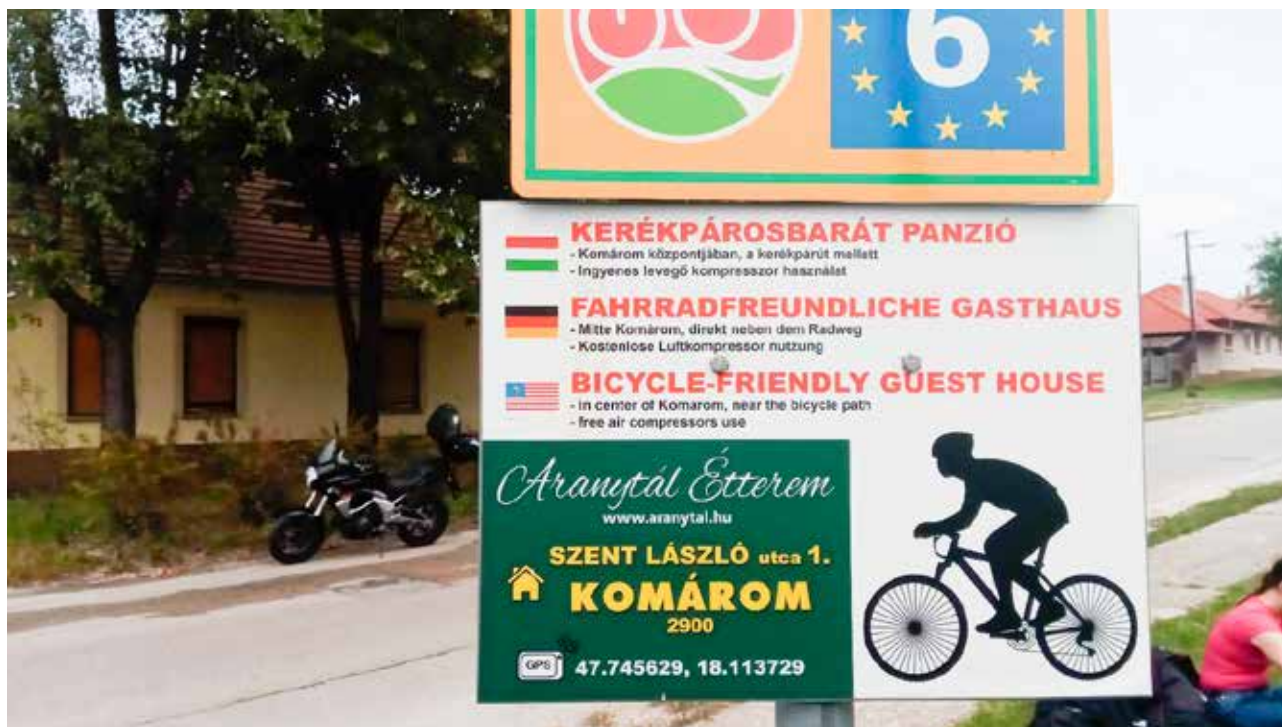
Bicycle-friendly services in Komárom.

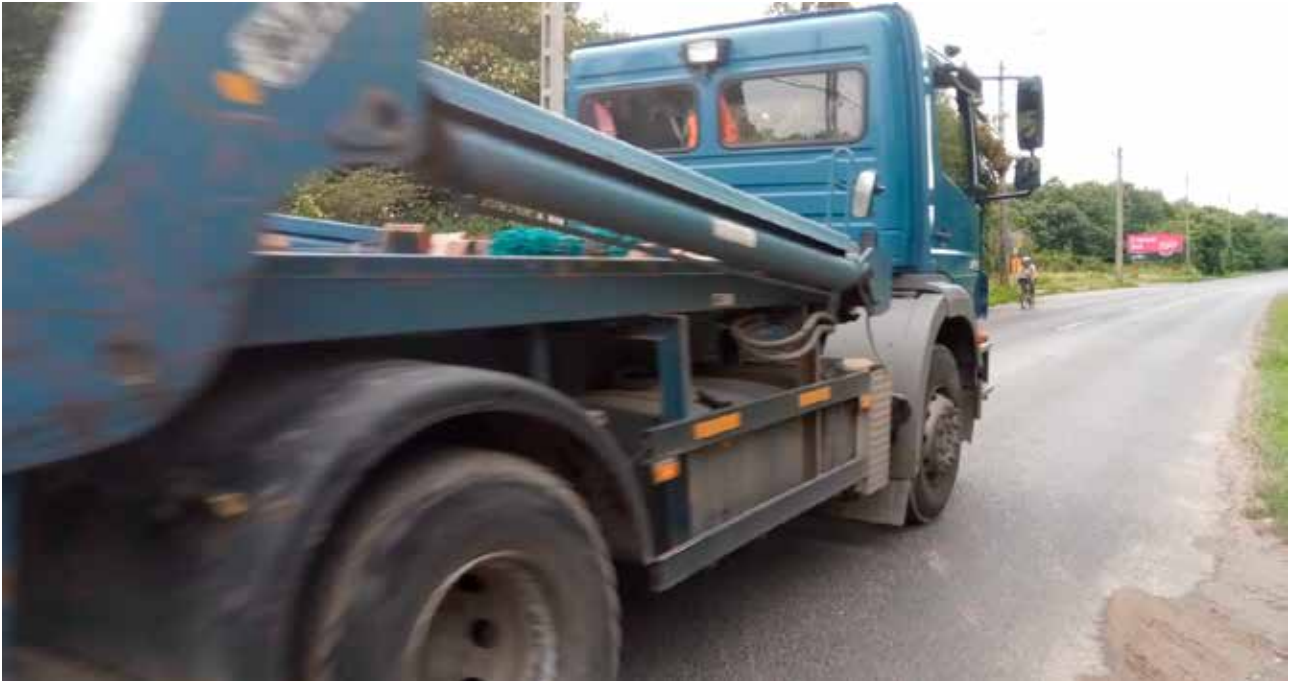
Route on public road with heavy traffic in section 41.

1. Approximately 90 km of cycle path need to be constructed. This is only a preliminary estimate, as in some locations...:
 - a) A cycle path does not necessarily have to be constructed directly along the main road but could be located closer to the river. This would create a route that is more attractive, provides more opportunities to enjoy nature and less exposure to noise from motorised traffic. This means that the total length of cycle path to be built can differ. It could be longer or shorter, depending on the section.

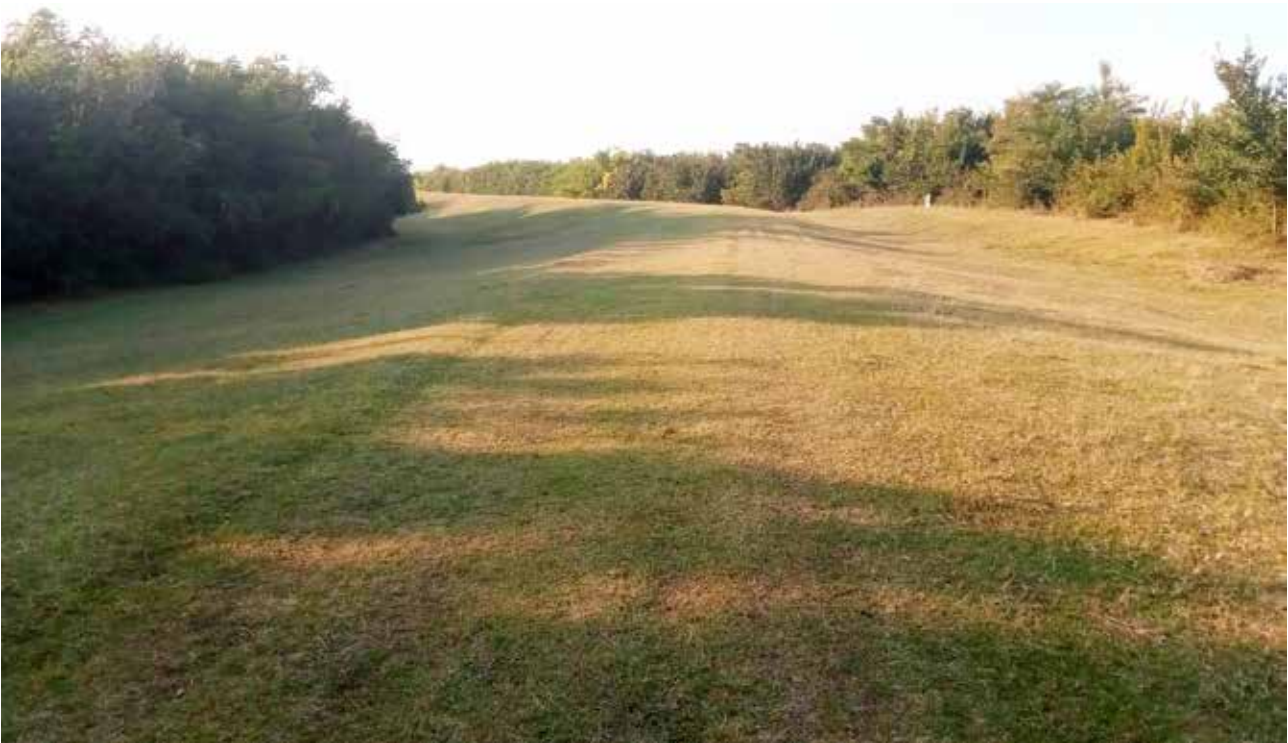
A perfect location for a cycle path – section 43 north of Dunavecse.

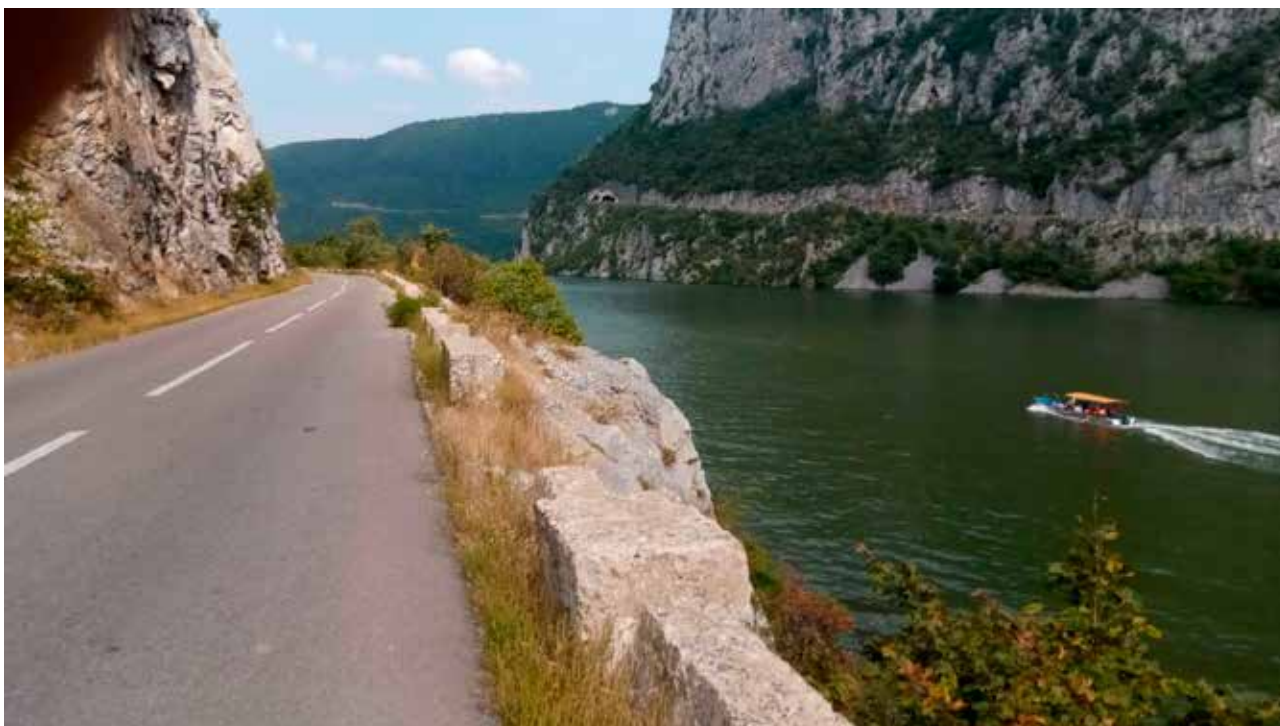
Highly attractive part of the route through the Iron Gates gorge (daily section 65).

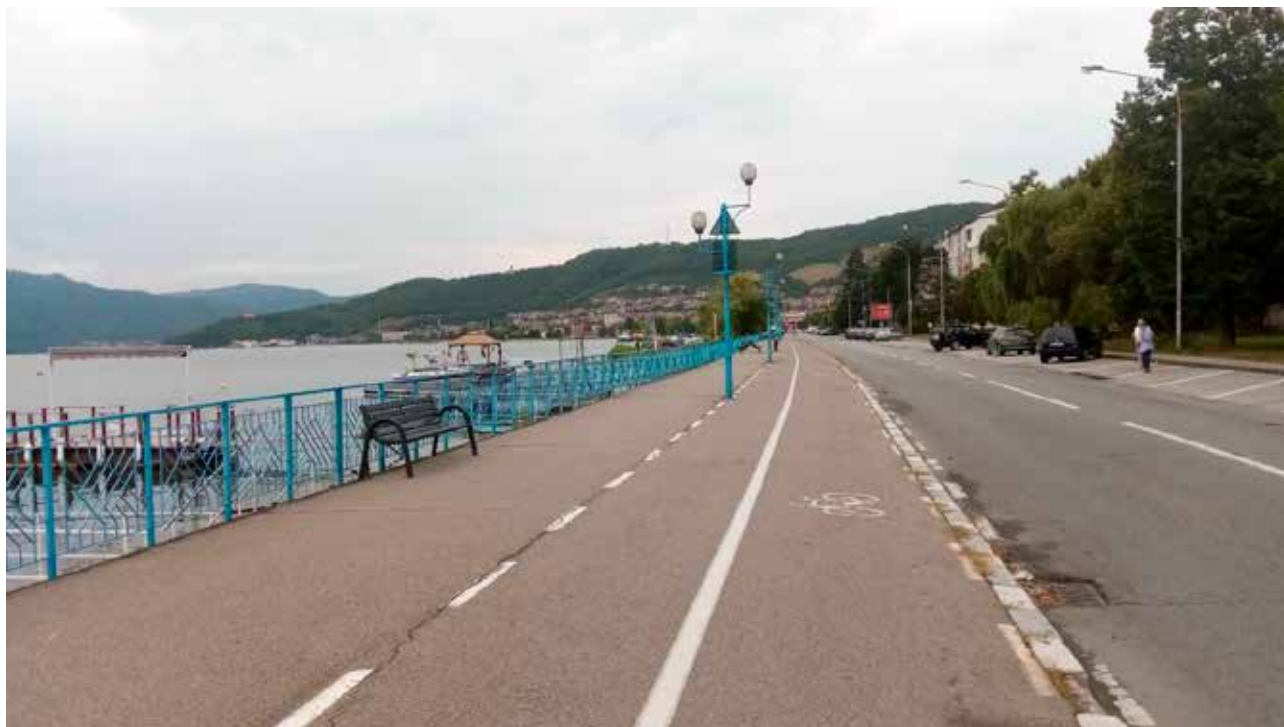
Orsova – one of the few locations with a dedicated cycle path.

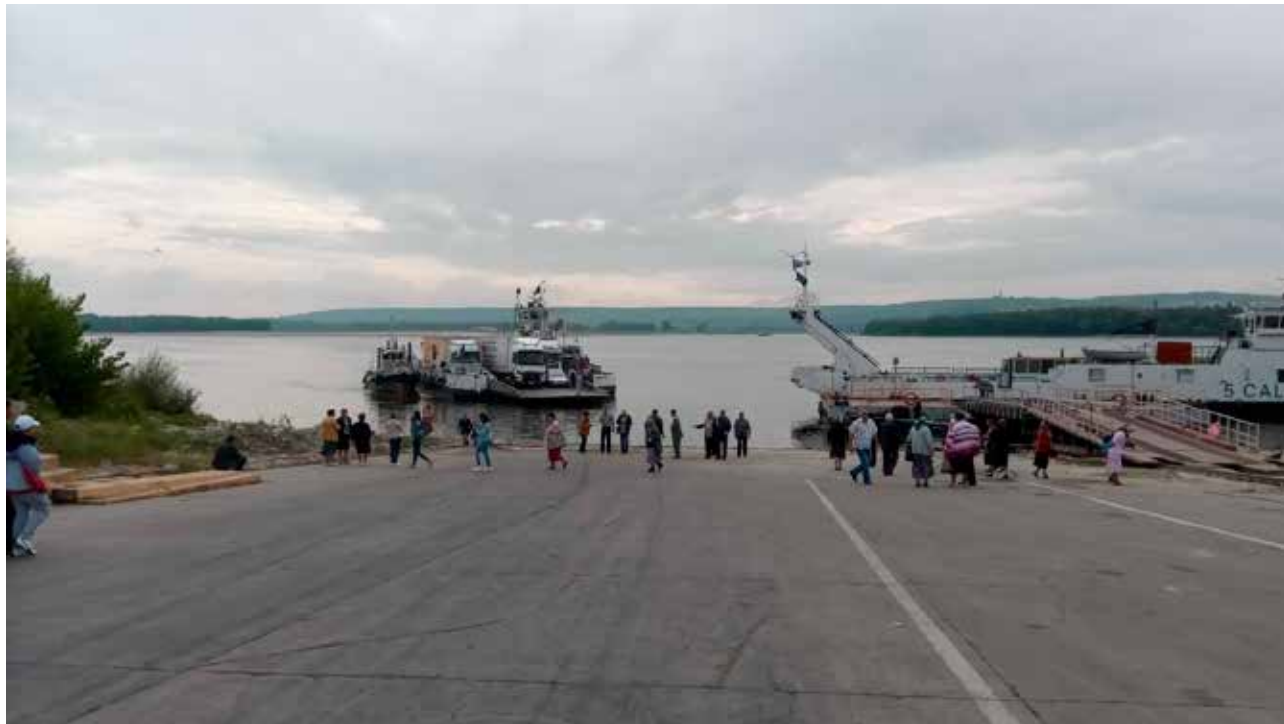
Daily section 78: ferry Călărăși-Silistra.

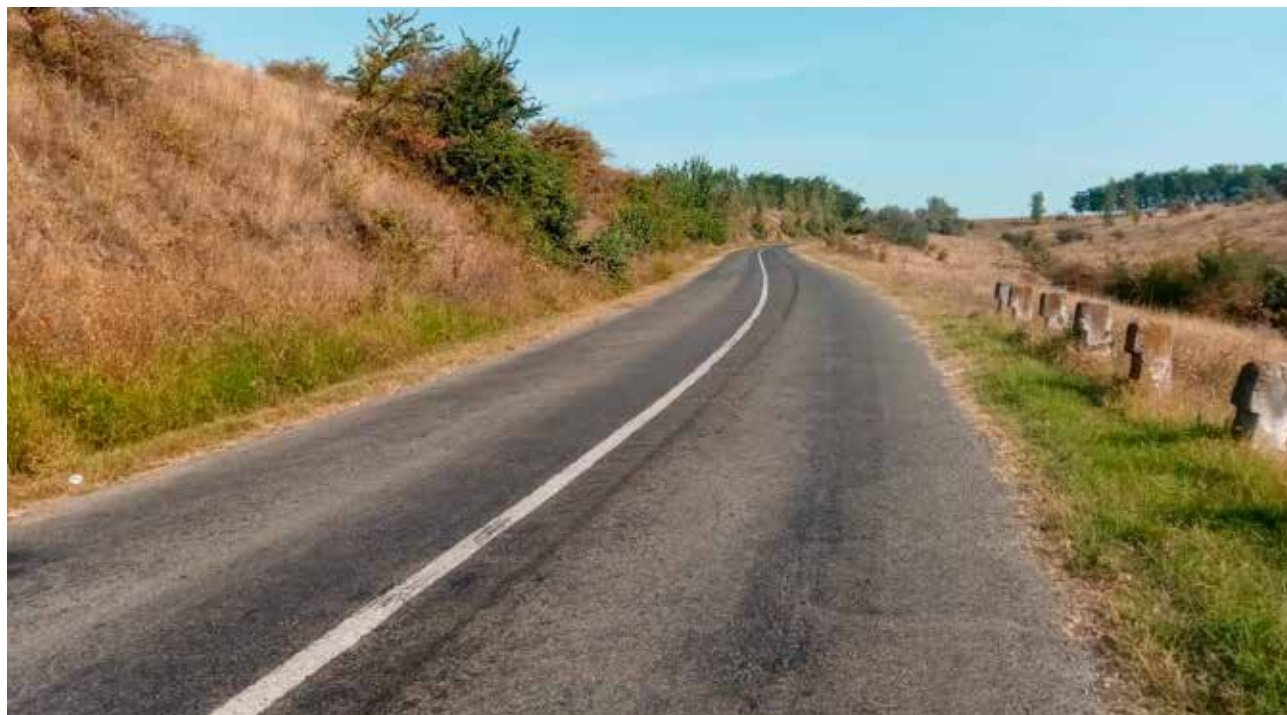
Daily section 81: long sections of the route comprise pleasant roads with low traffic.

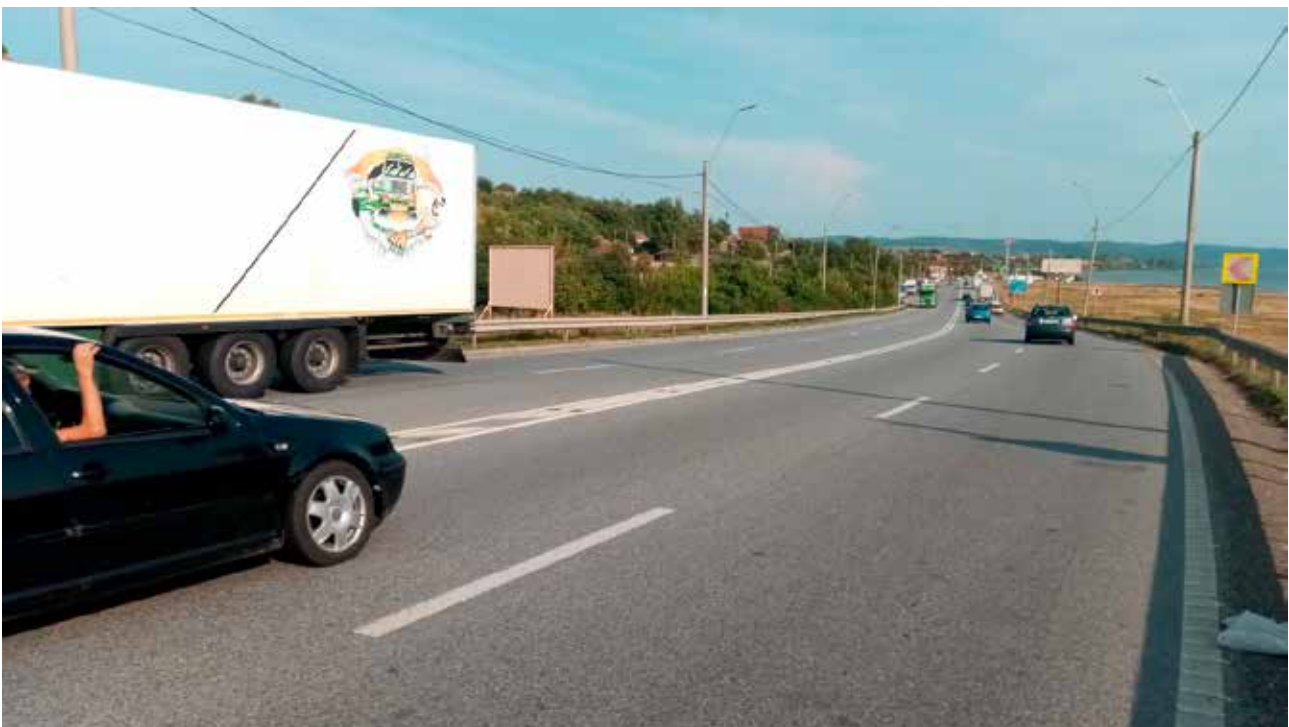
Daily section 67, between Drobeta-Turnu Severin and Simian.

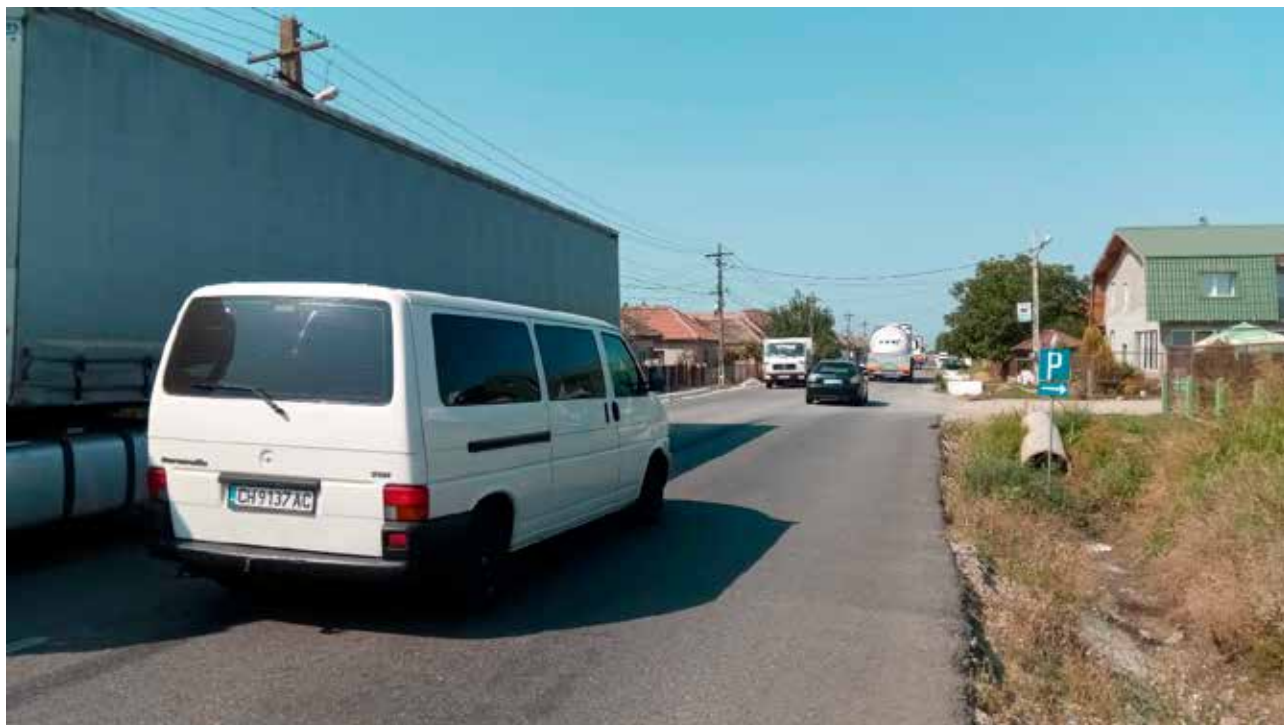
Daily section 69: Garla Mare-Calafat.
